WINDEGO AMPHITHEATER CONDITION REVIEW

Subject: Condition Assessment – Anoka Amphitheatre, Anoka, MN

The purpose of this letter is to report the findings of a structural engineering review of the distressed cast-in-place concrete amphitheater along the Rum River in Anoka, Minnesota.

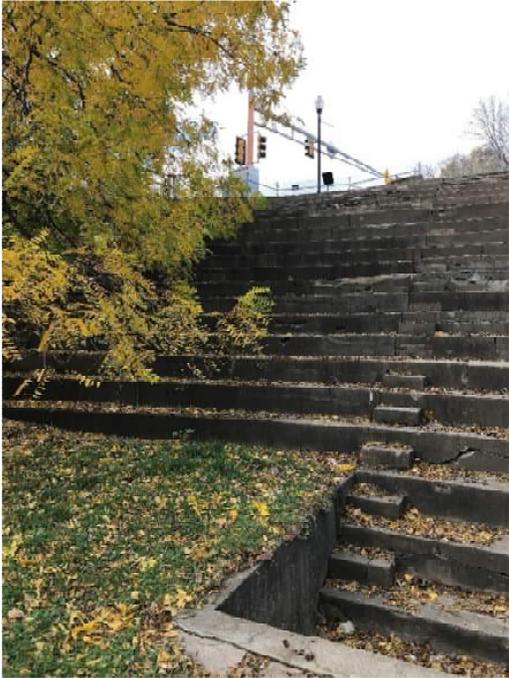
Area A

- c. In Section A, every row of seating had moderate to severe concrete spalls and cracks and most of the rows had one or more surface offset from the adjacent surface at a crack or joint.

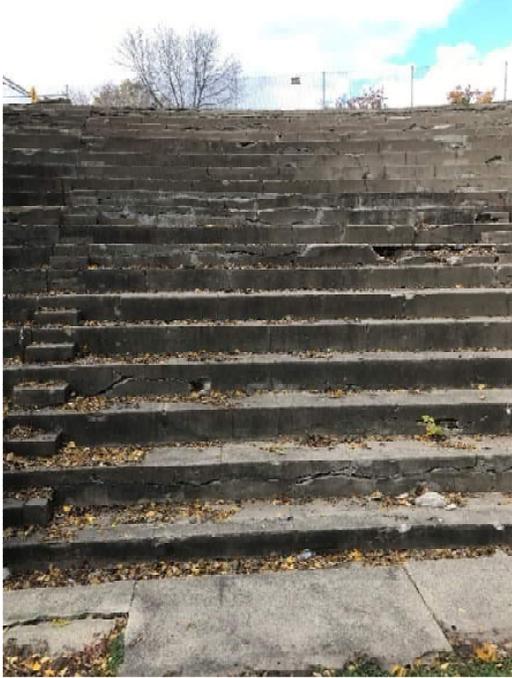
Area B

- d. In Section B, every row of seating had severe concrete spalls and cracks, almost all the rows had one or more surface offset from the adjacent surface at a crack or joint, and about half of the rows had moderate to severe outward leaning of the vertical riser of the seating.

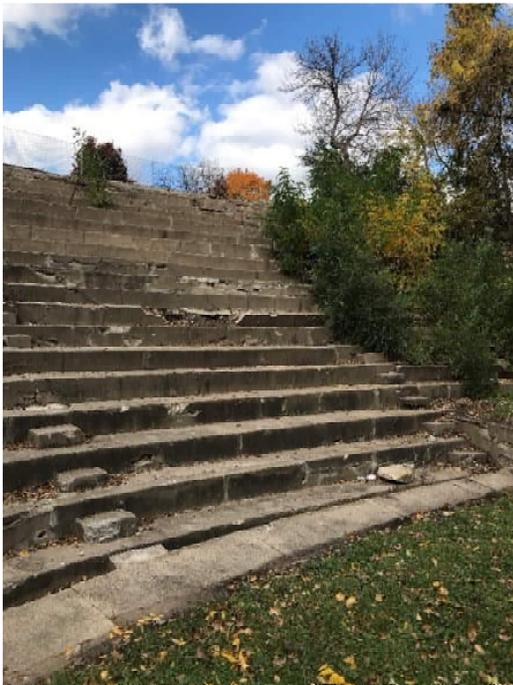
Area C

- e. In Section C, every row of seating had severe concrete spalls and cracks, offset surfaces at cracks and joints, and severe outward leaning of the vertical riser of the seating. Some rows were deteriorated so severely that large pieces of the concrete were missing and the exposed soil was washing out.

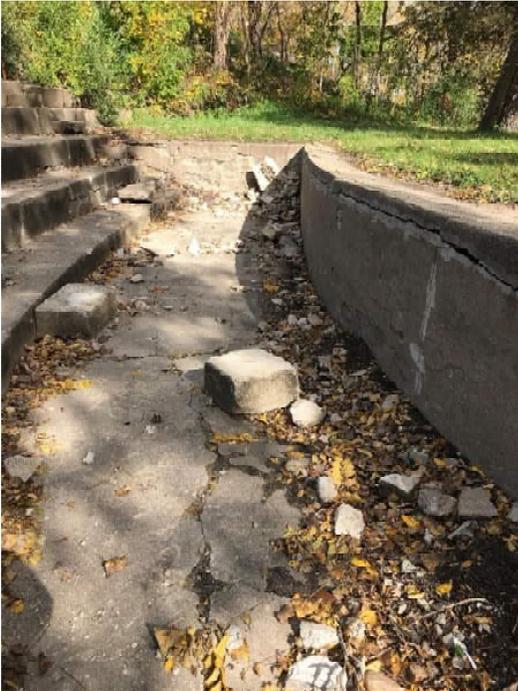
Orchestra Pit

The walls surrounding the orchestra pit are bowing inwards and are unstable. The concrete is heavily cracked and with significant spalling of the surfaces.

- g. The orchestra pit floor and walls were severely cracked and spalled. The walls had concrete delamination of the exposed surface. The top of the east wall had a severe horizontal crack that allowed the wall to separate from the concrete walk at grade above the wall. The floor drain in the southeast corner of the orchestra pit was noted to be in poor condition, cracked and eroded and can't provide support for the floor drain grating.

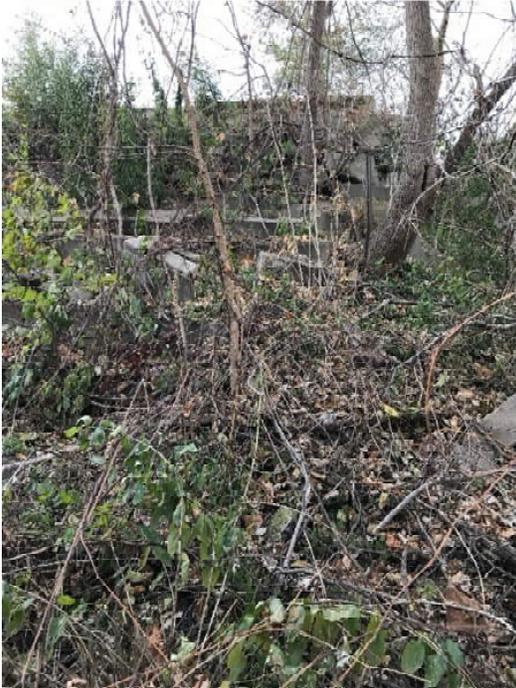
- m. The concrete walls along the north side of Section D were severely cracked and in extremely poor condition.
 - n. Many cracks in the amphitheater seating and orchestra pit walls were epoxy patched sometime in the past, but all the cracks have since reflected through and opened up.

Area D and North Wall Failure

- f. Section D, the majority of section C, and the concrete walls along the north edge of section D are in such severe condition and are structurally unstable that these areas absolutely have to be removed and replaced.

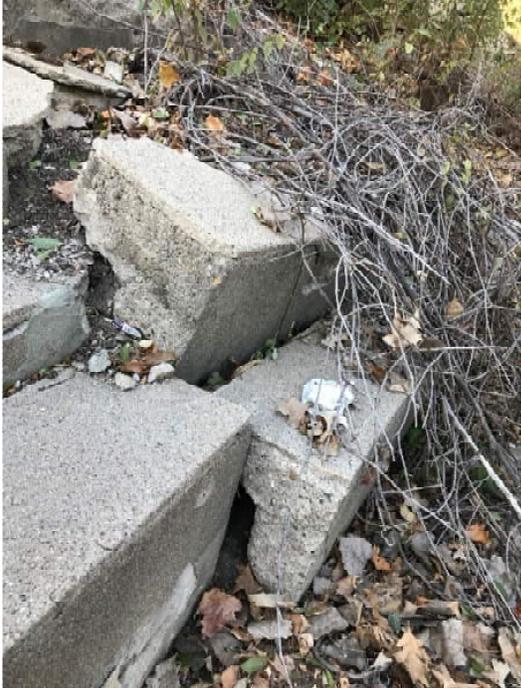
- f. In Section D, every row of seating was severely cracked, spalled, offset, and leaning, and deteriorated so badly that mature vegetation had taken over almost the entire section.

Area D Unstable Seating

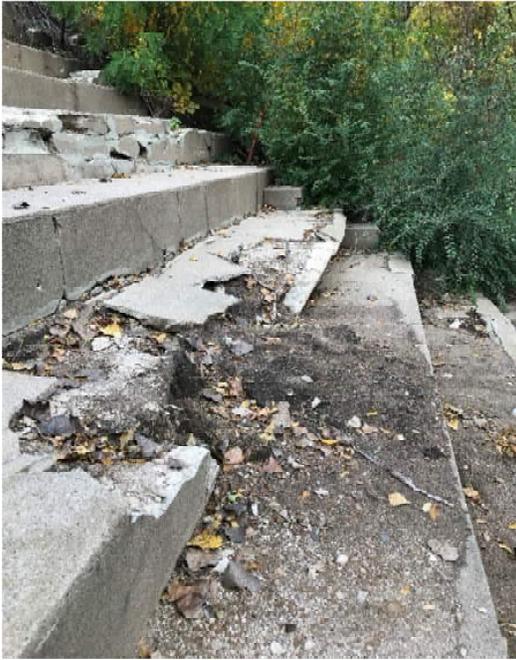
Area C Seating Failure (typical other areas)

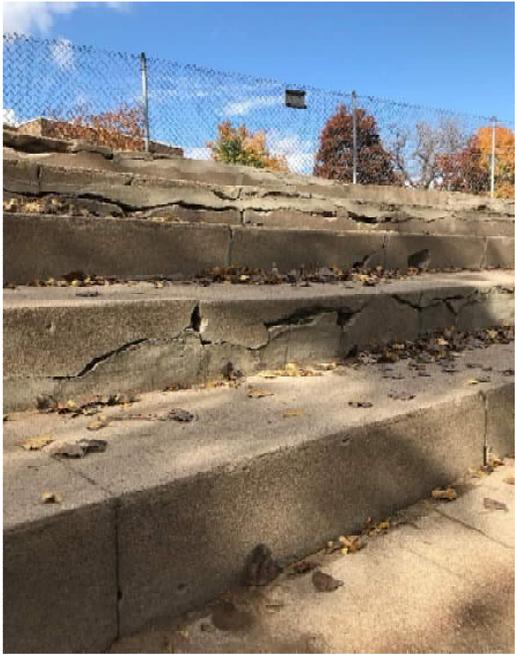
The concrete where it is not overgrown is extensively cracked with significant areas of heaving and spalling. Stair risers and treads are bowing, misaligned, and otherwise displaced. The cracking has allowed water to infiltrate to the subgrade which led to significant freeze thaw action. This combined with vegetation that has grown over the years has led to the significant deterioration that is now evident. Previous repairs that appear to consist of concrete patches over cracked and spalled areas have failed and it is evident there has been significant additional deterioration since these repairs were completed.

Typical Cracking and Spalling (all areas)
