ANOKA AMPHITHEATER

ANOKA, MINNESOTA

CONDITION ASSESSMENT

ANOKA AMPHITHEATER
CDG PROJECT NO. 05074.00
June 2006

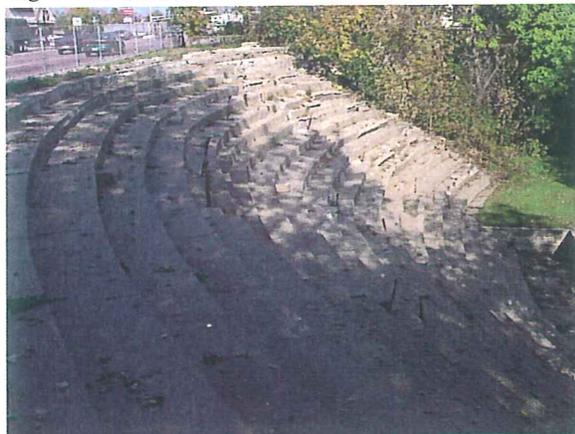
Fig. 4 Section A overview

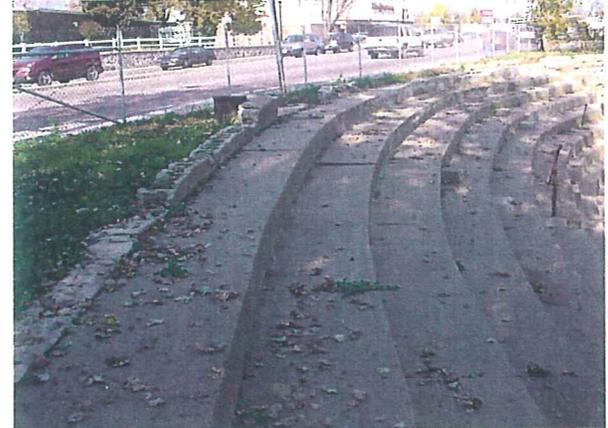
Fig. 5 Section A typical existing conditions

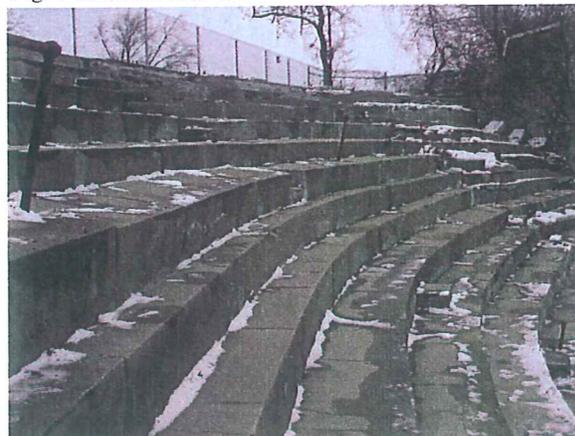
Fig. 6 Section A typical existing conditions

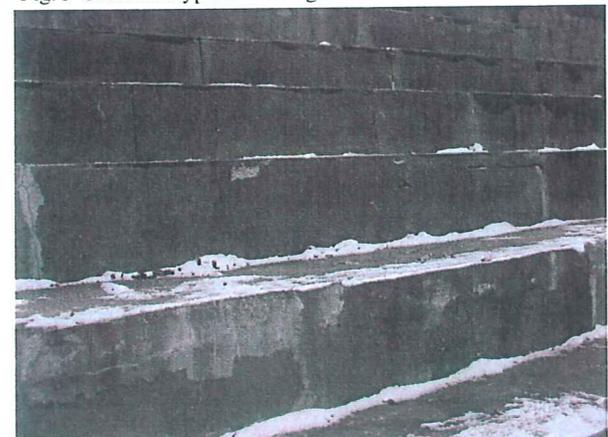
Fig. 7 Section A previous patching

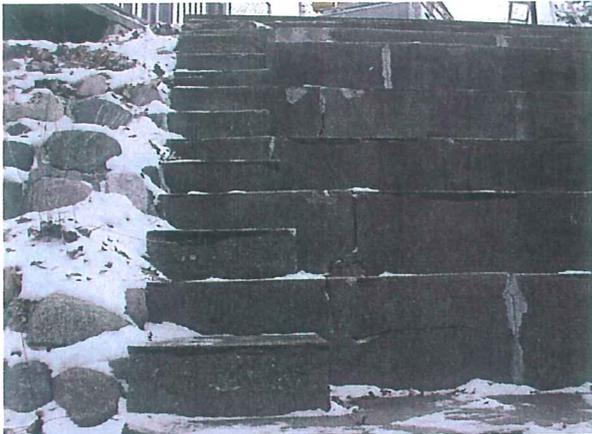
Fig. 8 Section A typical existing conditions

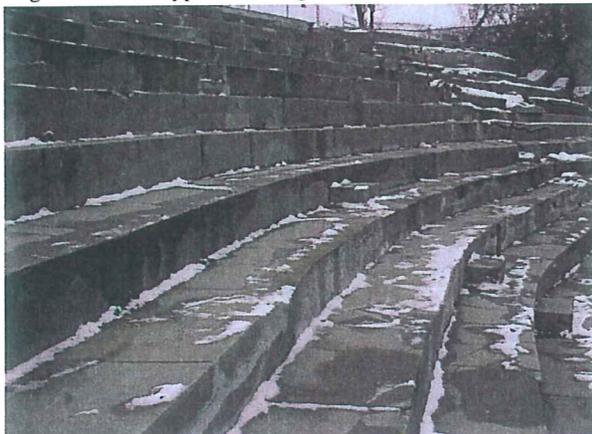
Fig. 10 Section B typical existing conditions

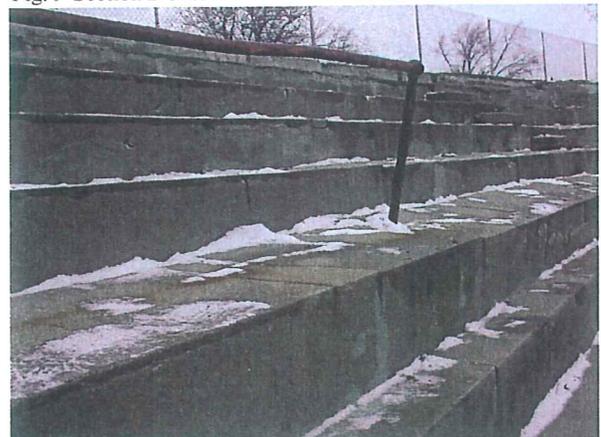
Fig. 11 Section B typical existing conditions

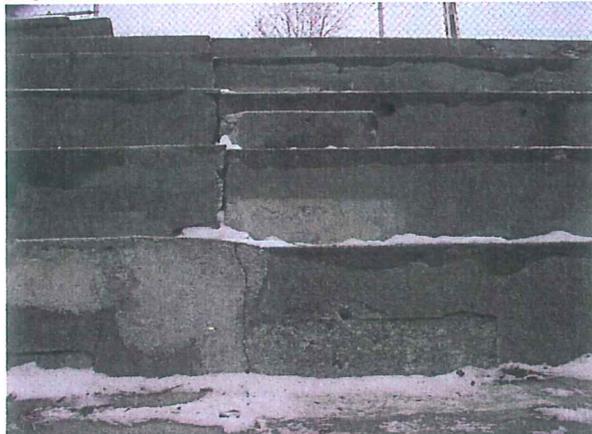
Fig. 12 Section B previous patching

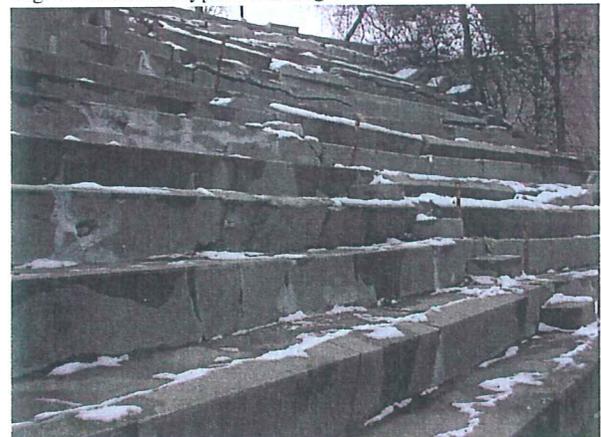
Fig. 13 Section C typical existing conditions

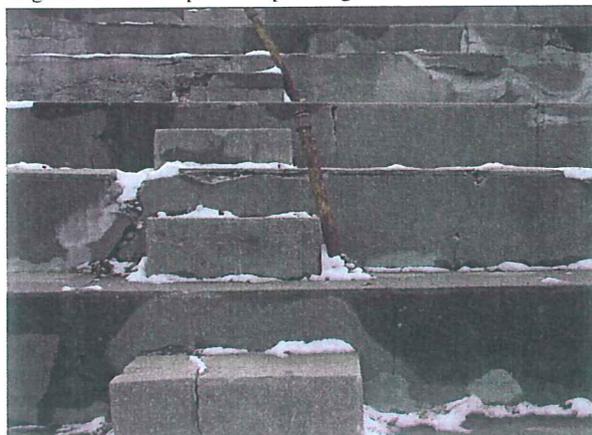
Fig. 14 Section C typical existing

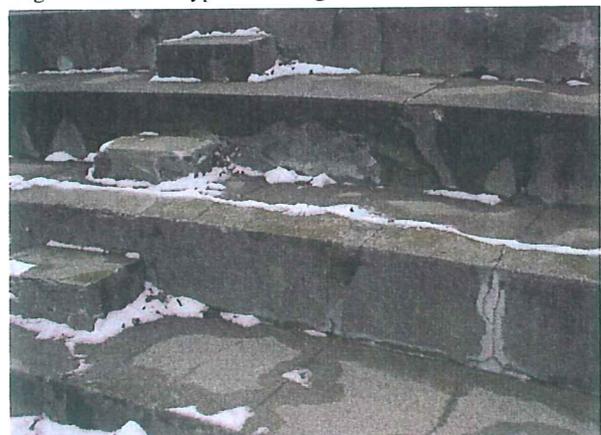
Fig. 15 Section C previous patching

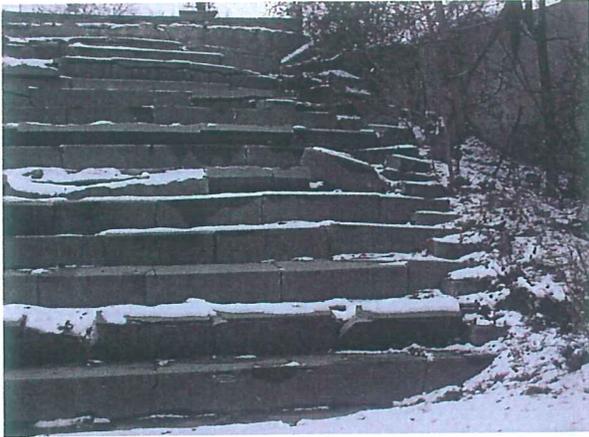
Much of the broken concrete in Section D appears to be from unstable soil conditions. The soil in this area was indicated on the original drawings to have been compacted cinder fill. The observed movements of the concrete seating areas may have been due to poorly compacted fill, or possible erosion of the fill.

Fig. 16 Section D overview

The majority of Section D will need complete replacement of the concrete. This replacement will include removal of all broken and deteriorated concrete, and removal of all poor fill materials. The soil should be replaced with compacted granular material. The new seating surface should be constructed as a slab-on-grade with integral steps. This new concrete structure would be monolithic, and constructed with thicker, more durable concrete than the original construction. Joints should be cut into the seating area to replicate the original pattern. Soil testing should be undertaken at the beginning of the project.

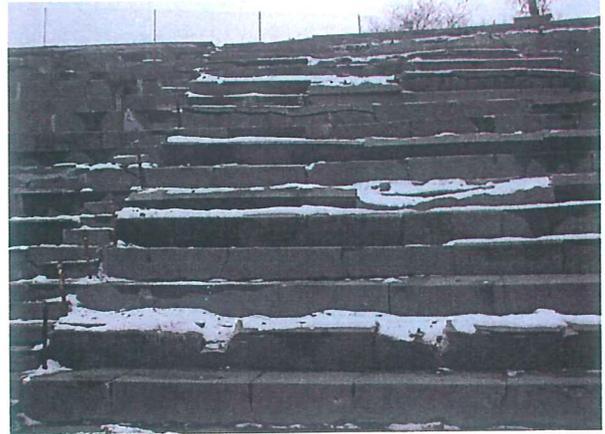
Fig. 17 Section D overview

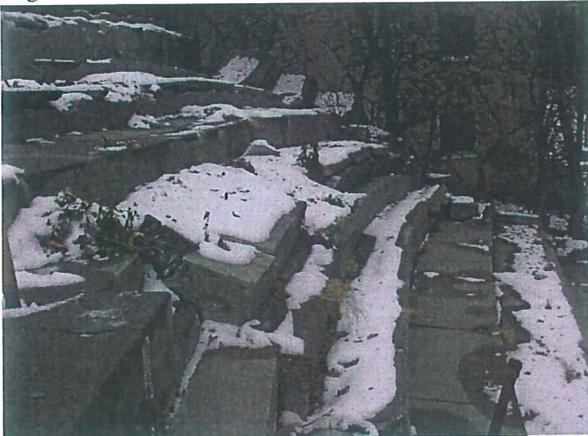
Fig. 18 Section D severe deterioration

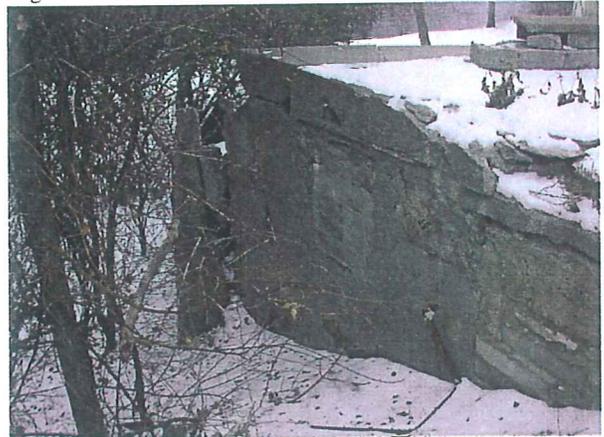
Fig. 19 Section D typical existing conditions

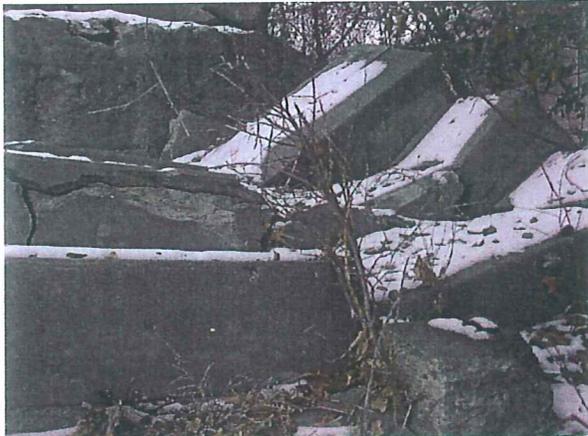
Fig. 20 Section D severe deterioration

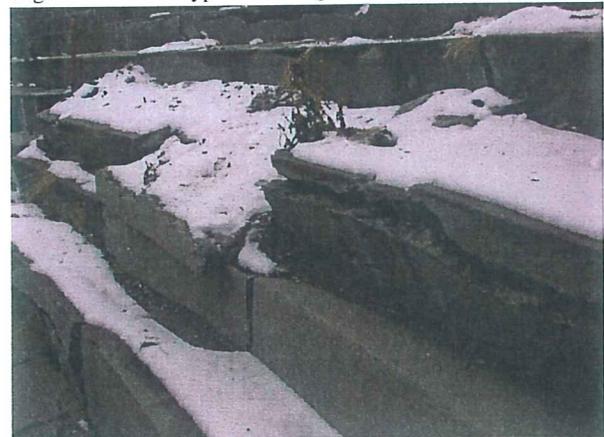
Fig. 21 Section D severe deterioration

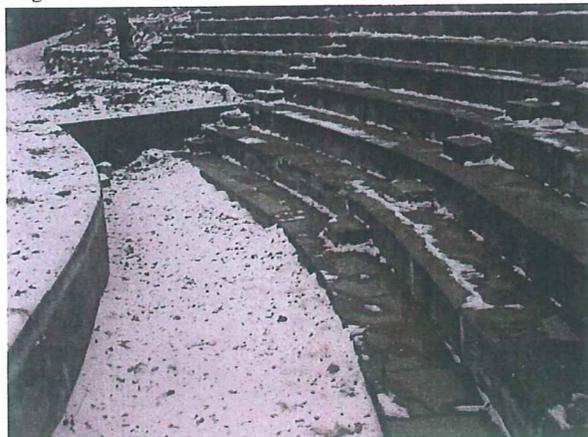
Fig. 22 Orchestra Pit overview

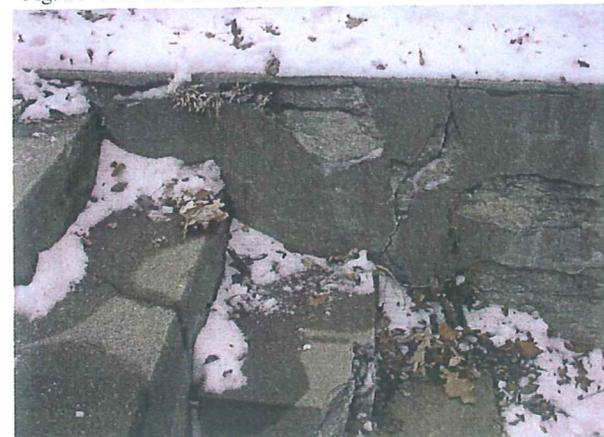
Overall, the surviving walls are in average-poor condition at this time. Some cracking and spalling is evident on the walls of the dressing room and those surrounding the orchestra pit. These conditions are likely due to non-air entrained concrete as discussed above.

Fig. 23 Orchestra Pit typical existing conditions

All walls should be repaired by removing deteriorated concrete and replacing with suitable materials. A waterproof sealer should be applied on all wall surfaces.
