2023 Dam Inspection Report

Rum River Dam

Prepared for
City of Anoka

November 2023

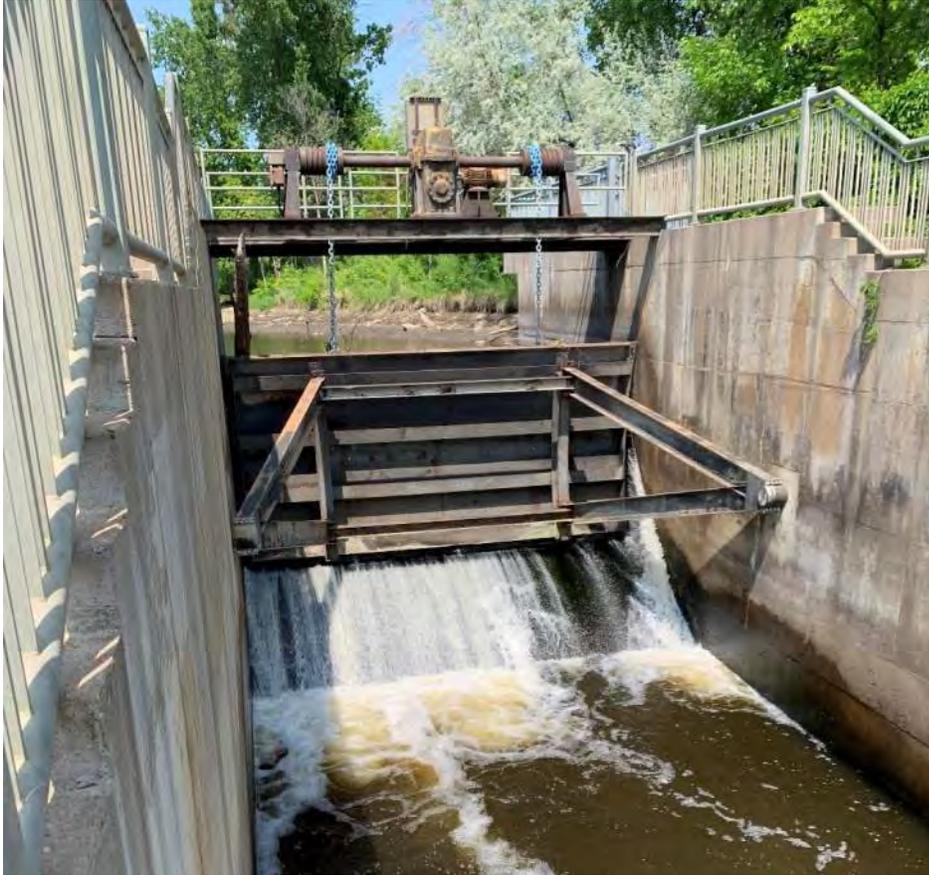
Figure 5 Tainter gate leakage

The tainter gate exhibited superficial surface rust throughout. Left uncorrected the structural steel elements would continue to deteriorate and possibly render the gates unusable for their intended function. Leakage was observed along the sill (concentrated on the right side) and along the left edge (concentrated at the bottom) as shown in Figure 5. The primary structural elements in the gate appeared undamaged and in satisfactory condition.

The dive inspection and surface inspection indicated satisfactory condition of the stoplog slots. These slots could be used with stoplogs or bulkheads to dewater the tainter gate bay and permit the above recommended repairs to be completed.

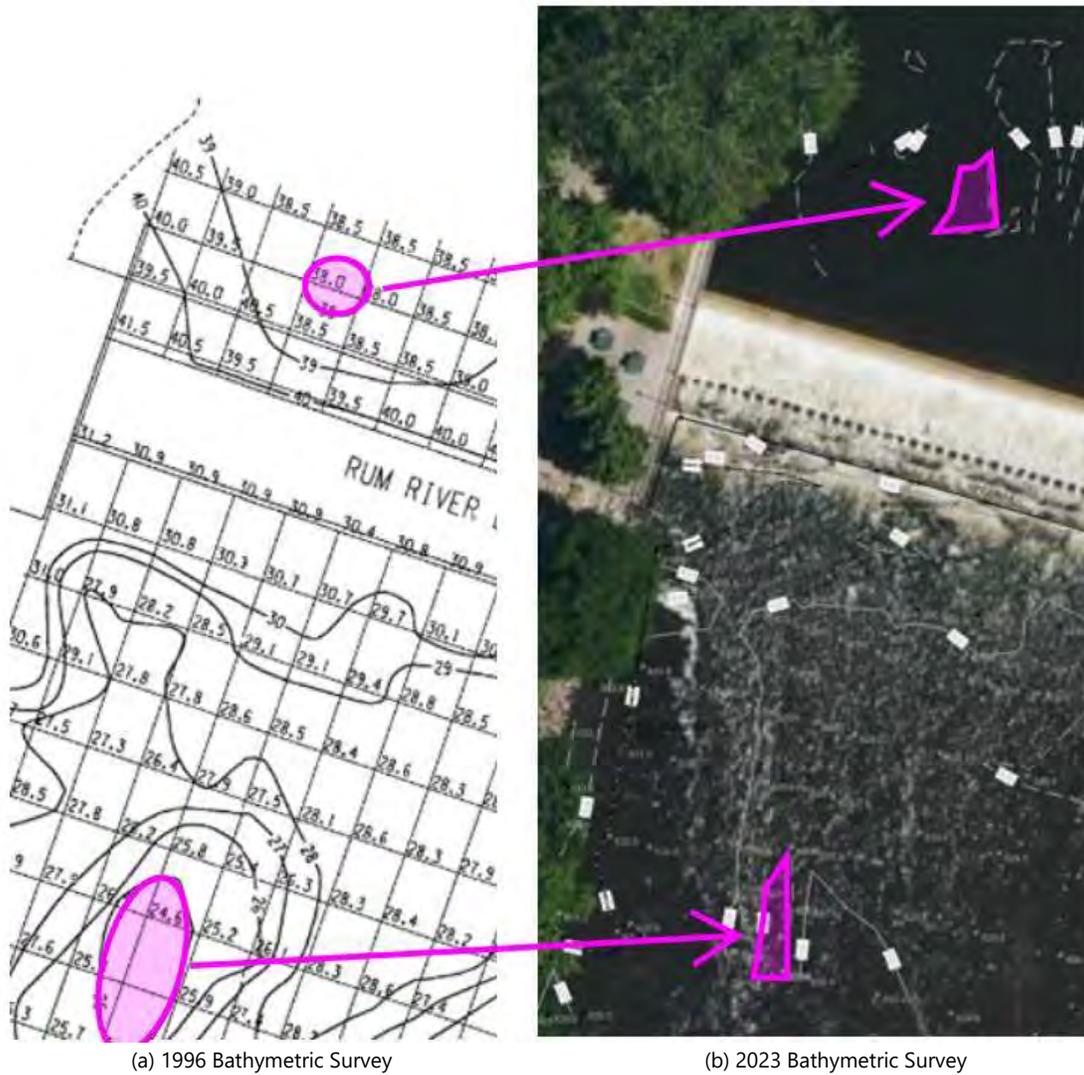
Figure 7 Localized depressions observed in bathymetric survey

Dam safety engineers typically look for scour holes and accelerated changes when comparing current with past bathymetric surveys. There are localized depressions observed in the 1996 bathymetry that were still present in the 2023 survey as shown in Figure 7. The magnitude of these depressions do not appear to have changed since the last surveyed. There are no other significant changes observed.

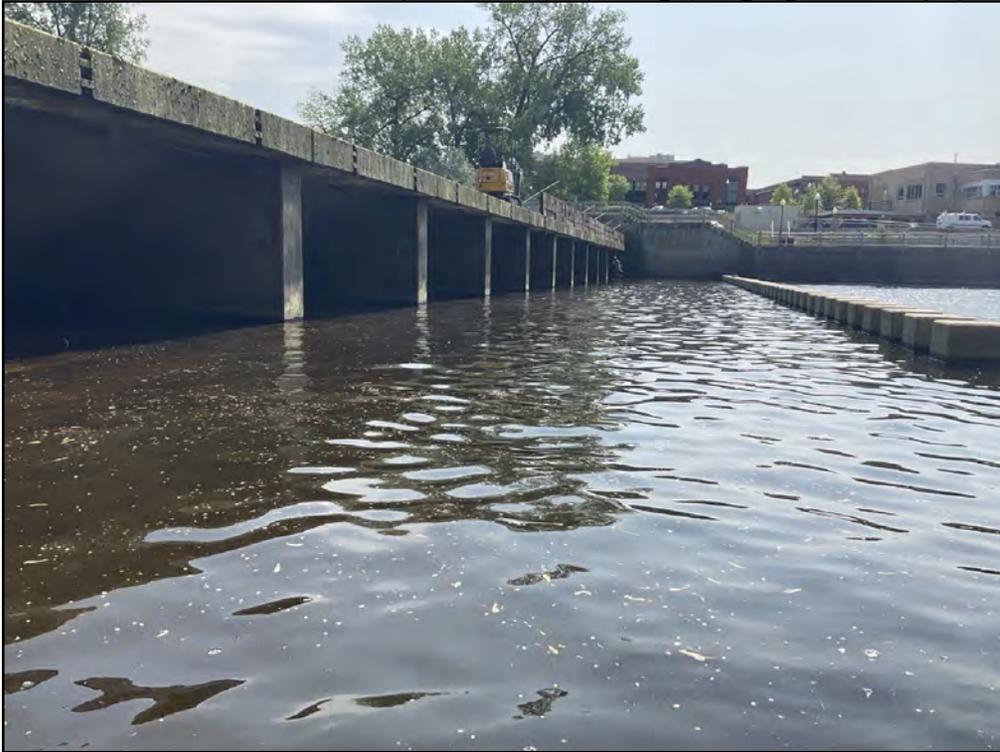
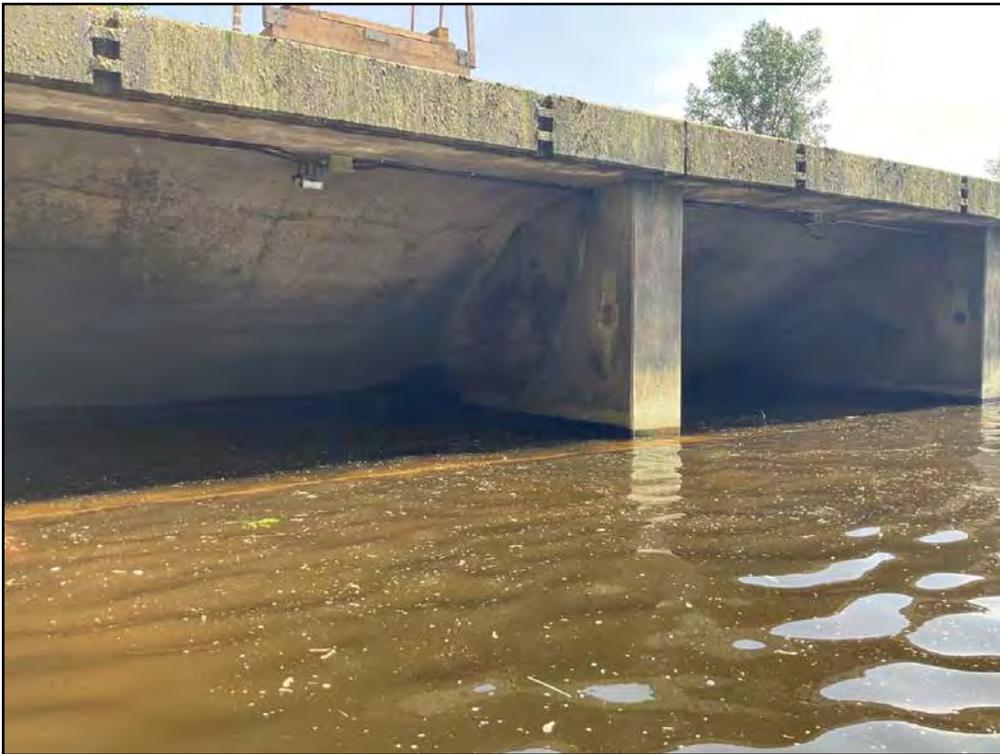
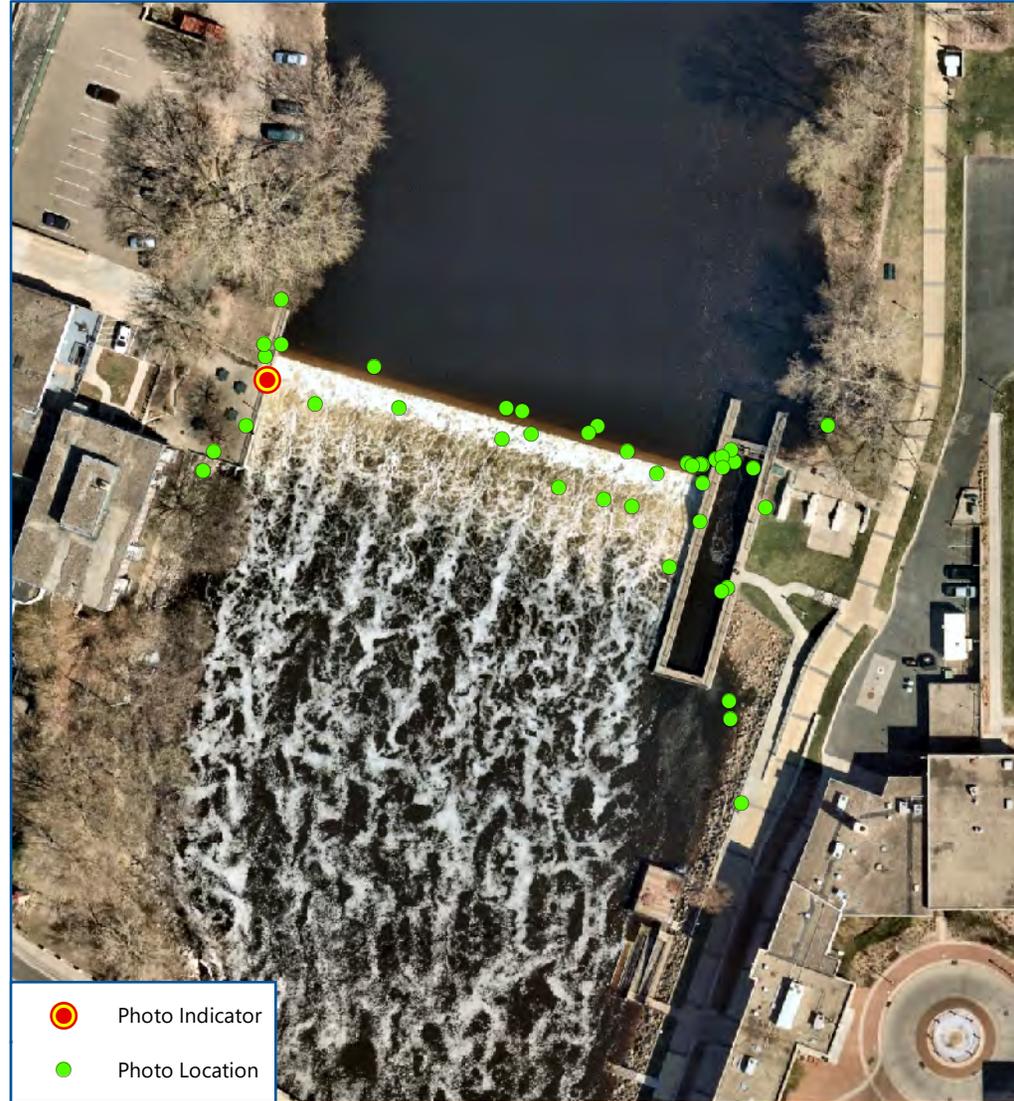
Comment: Right abutment wall,
superficial degradation

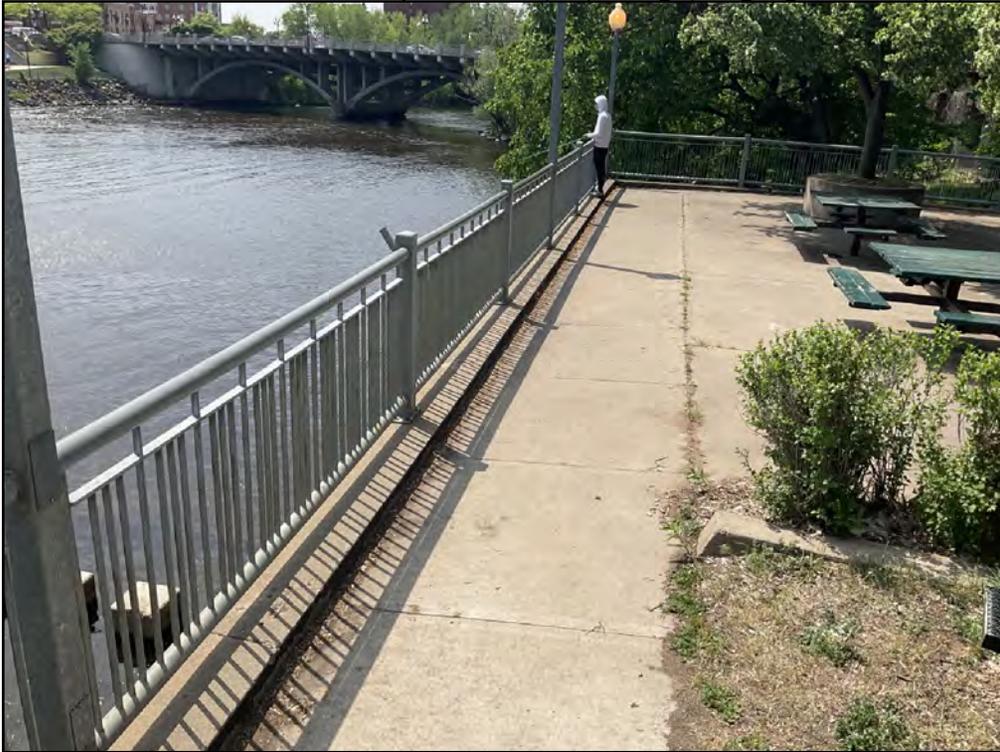
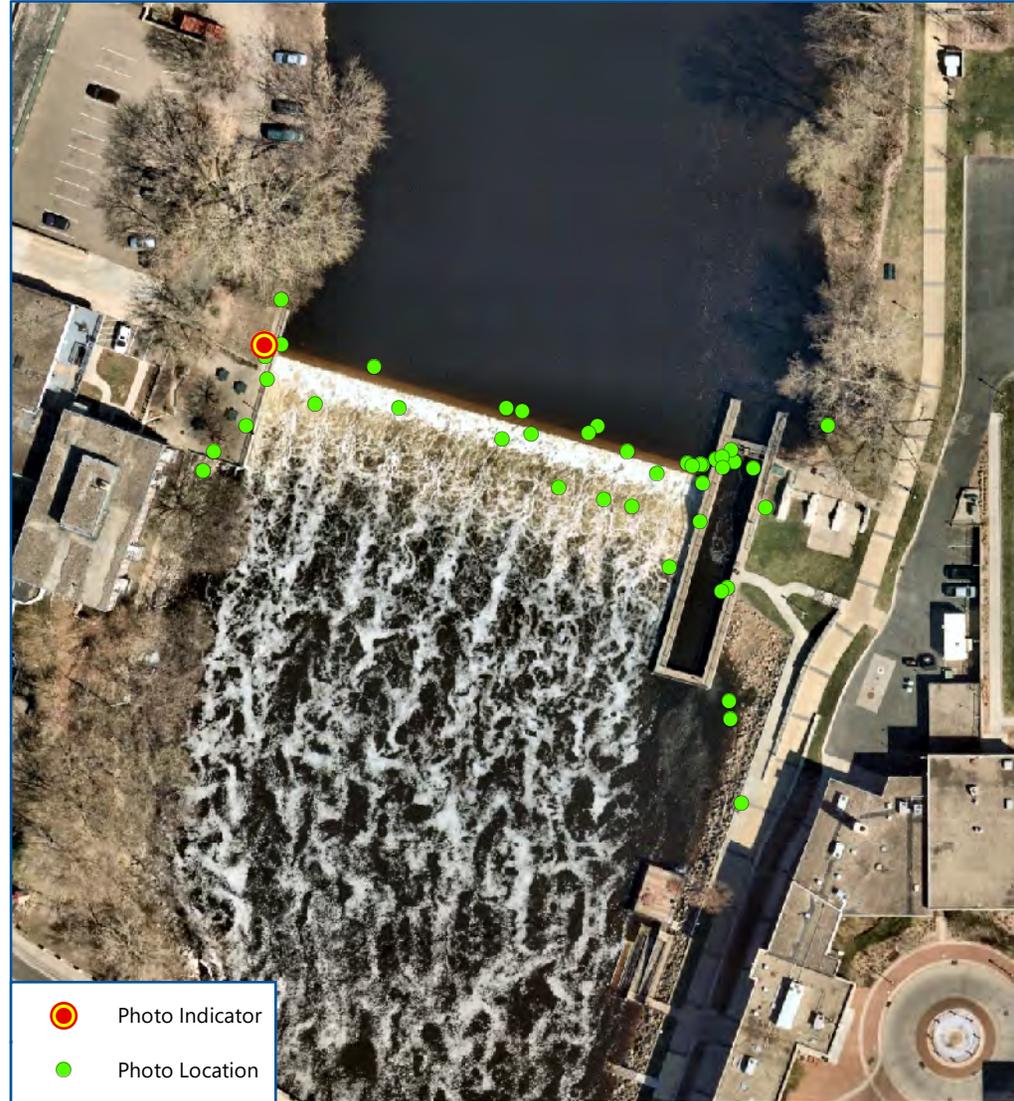
Comment: Right abutment general condition, general weathering, some staining and vertical cracking

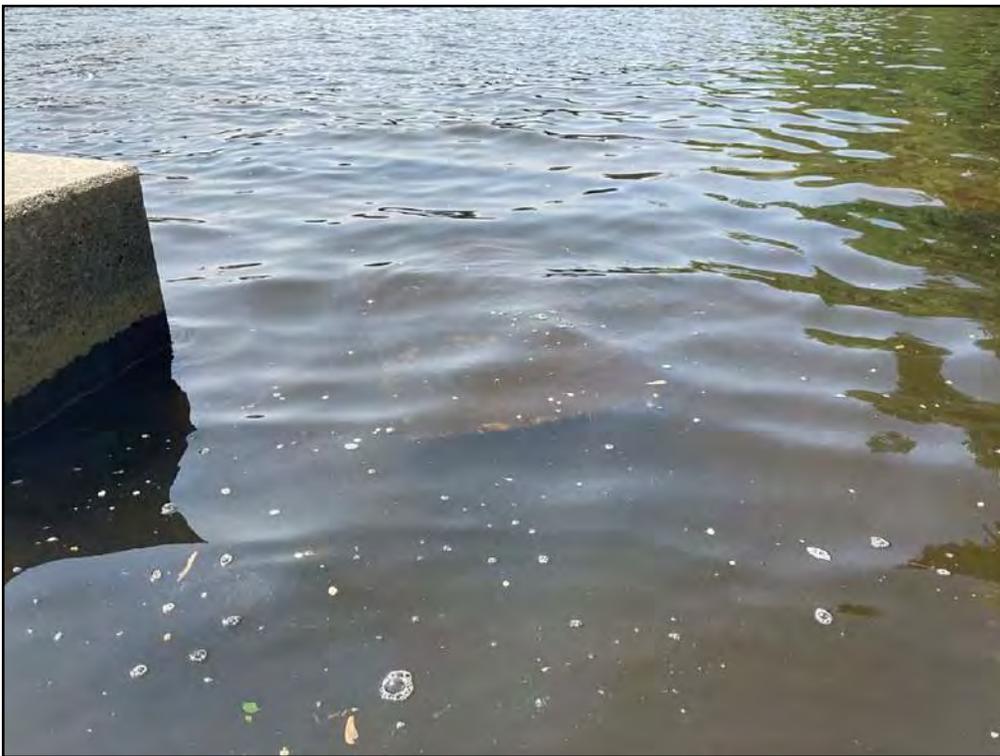
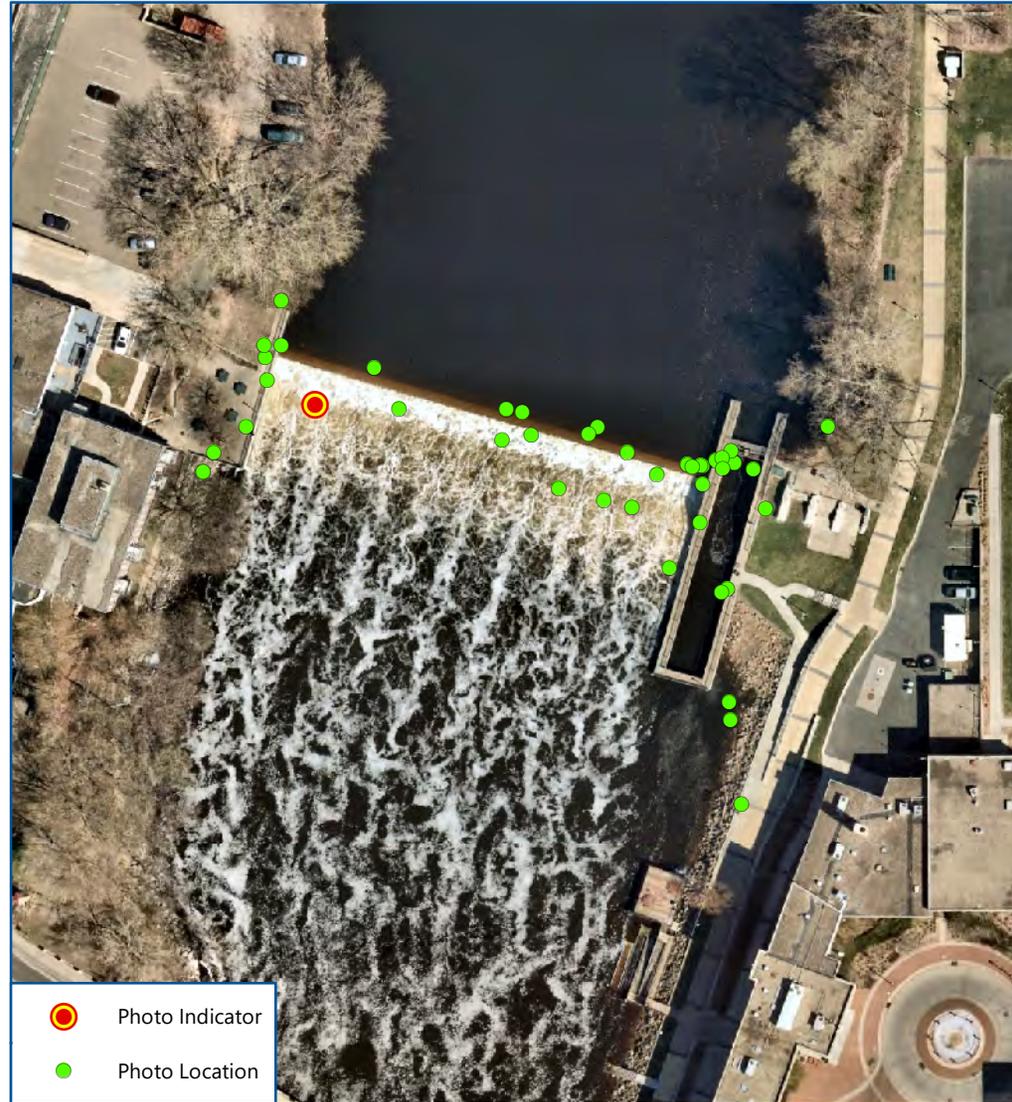
Comment: Spalling on 4 baffle block corners and tops. Exposed rebar on right one

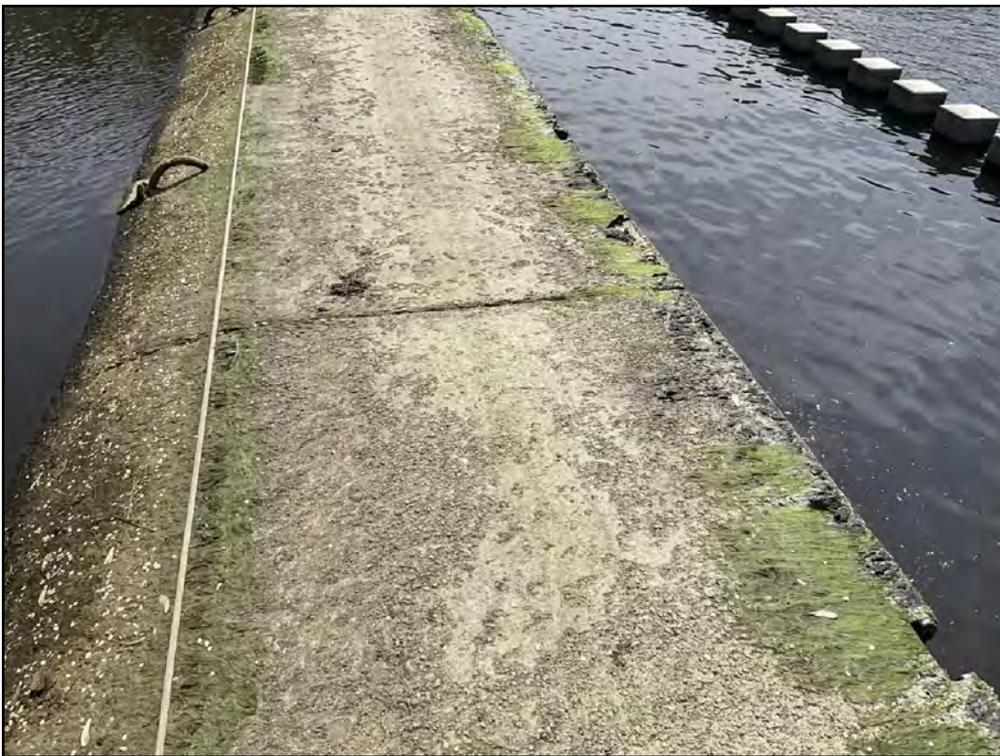
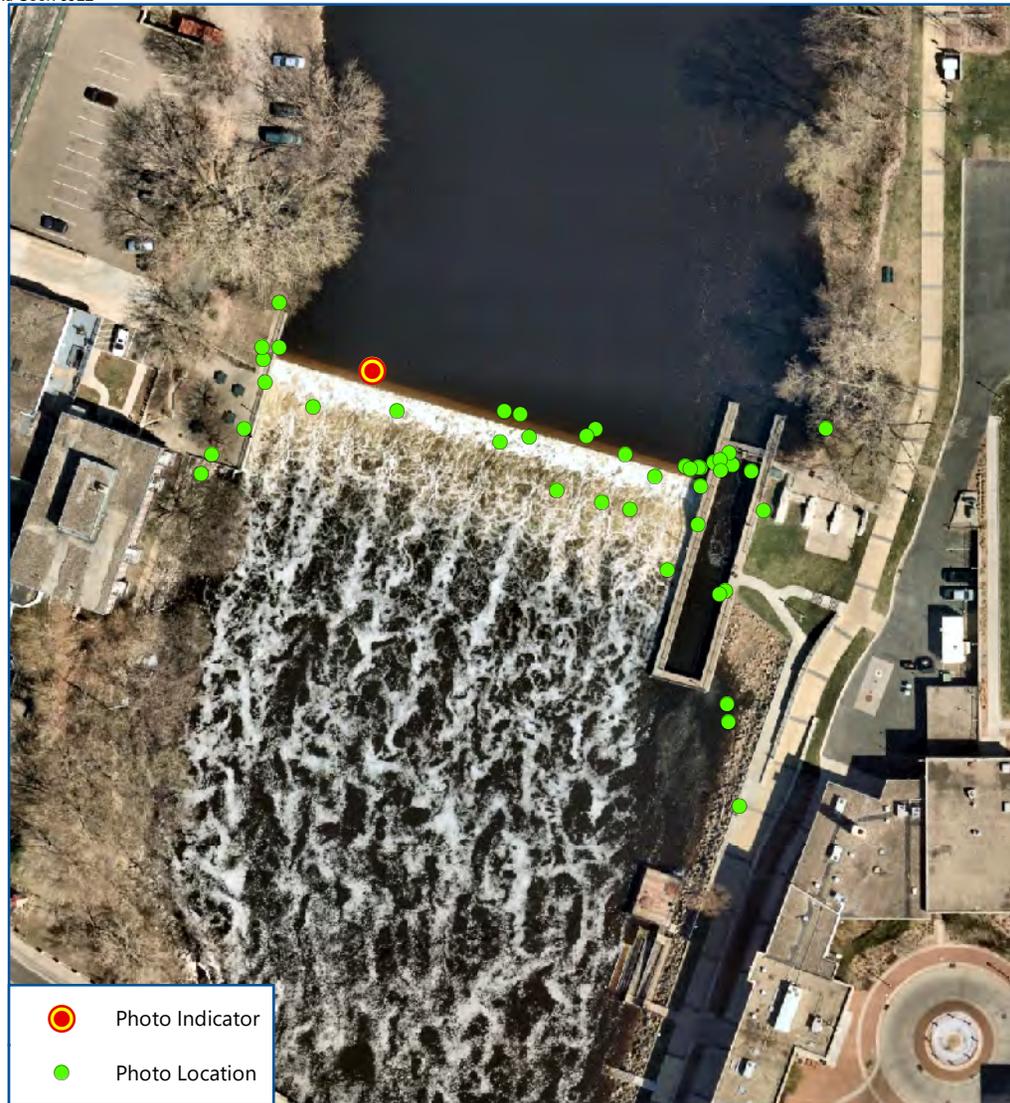
Comment: Missing baffle block. Appears to be tipped over immediately downstream

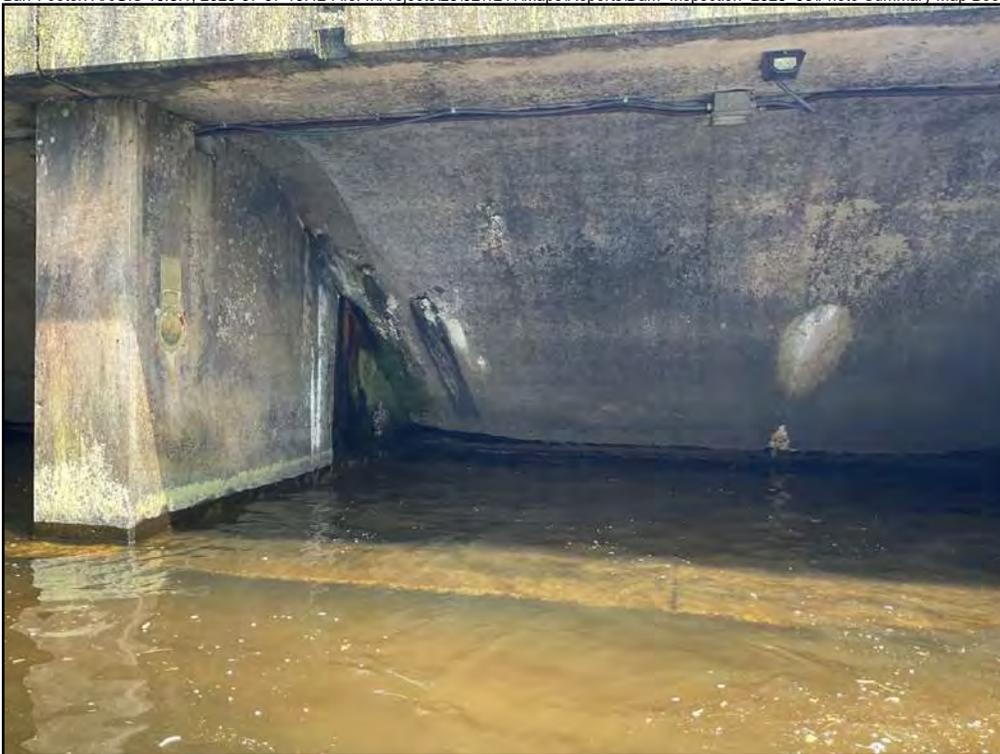
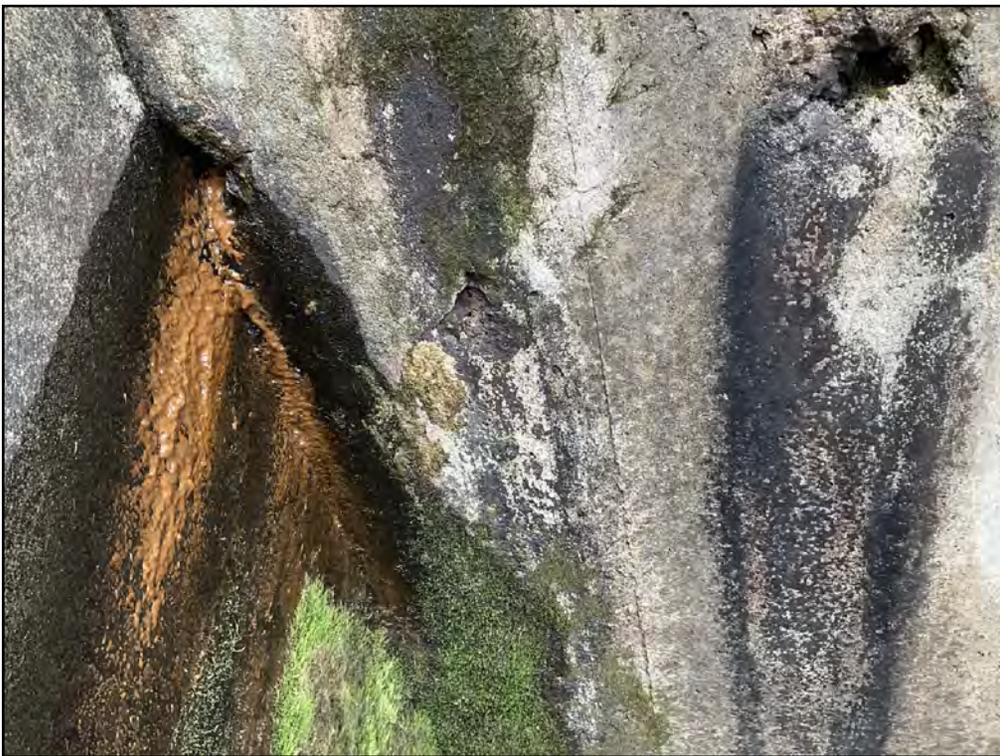
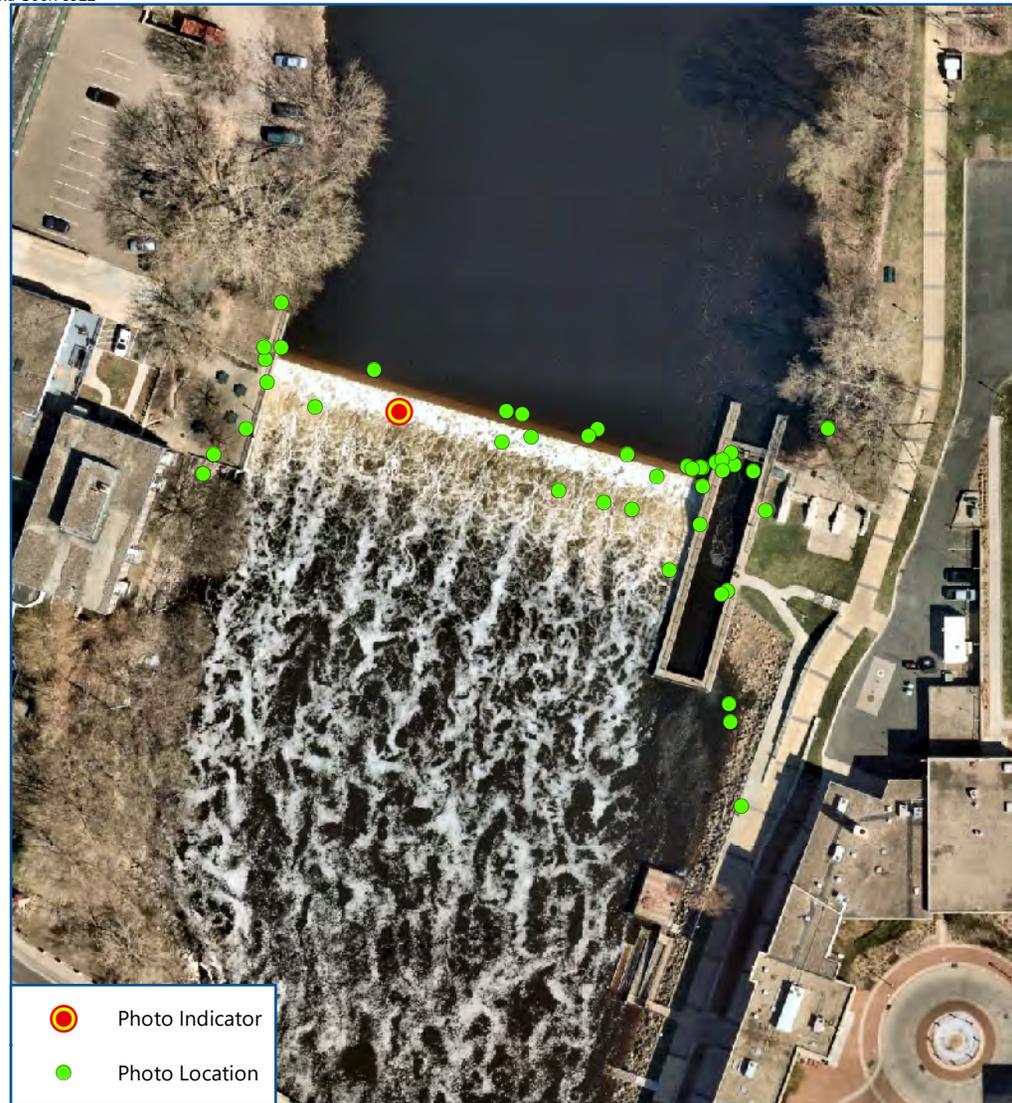
Comment: General condition, superficial degradation, exposed aggregate

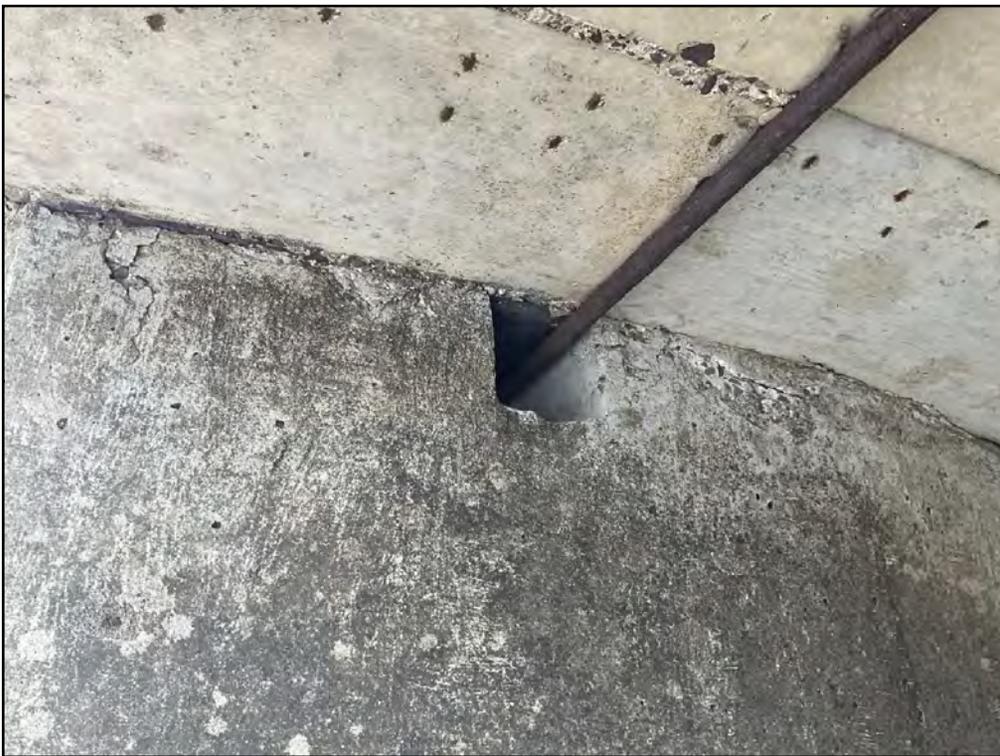
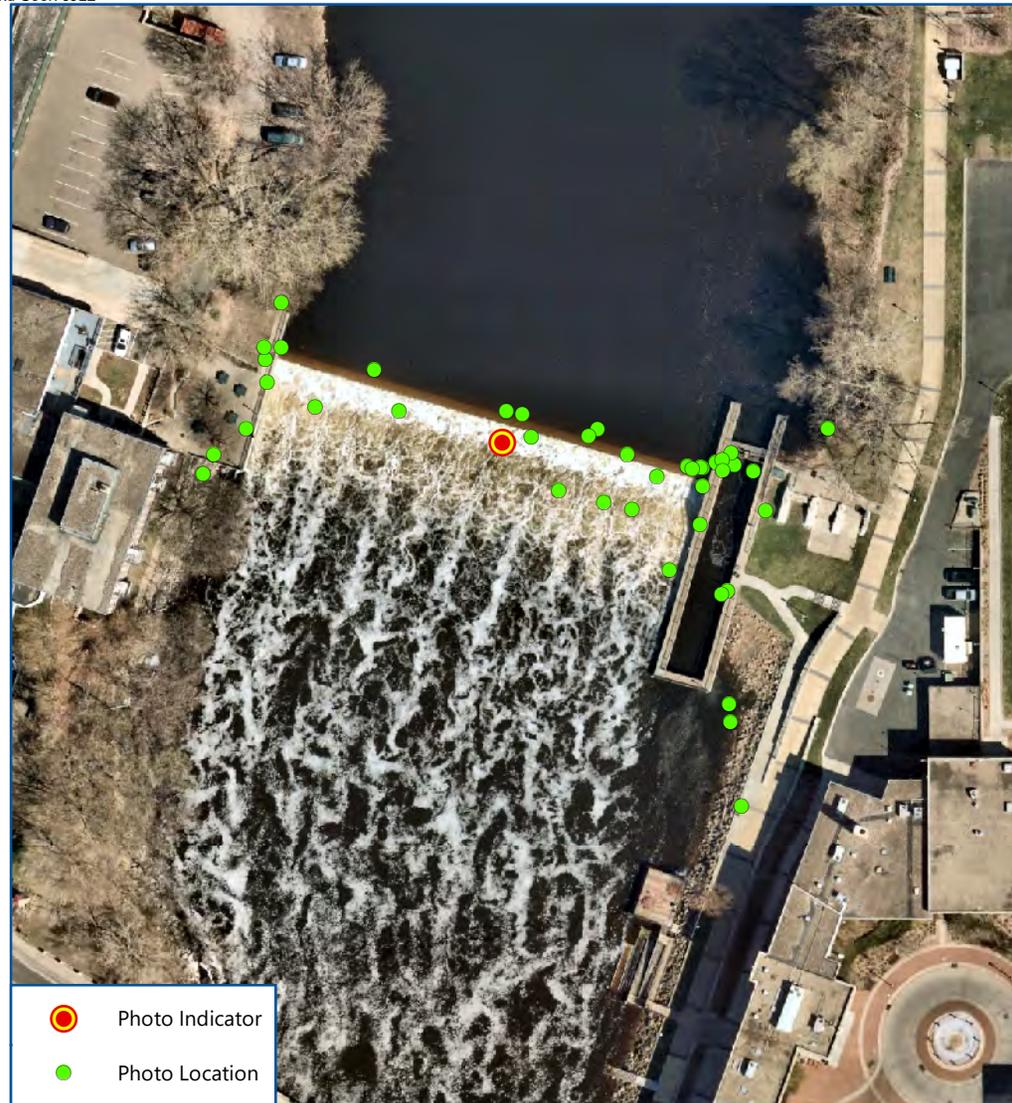
Comment: Bay 9, minor seepage, mineral deposits, construction deficiency exhibiting exposed rebar

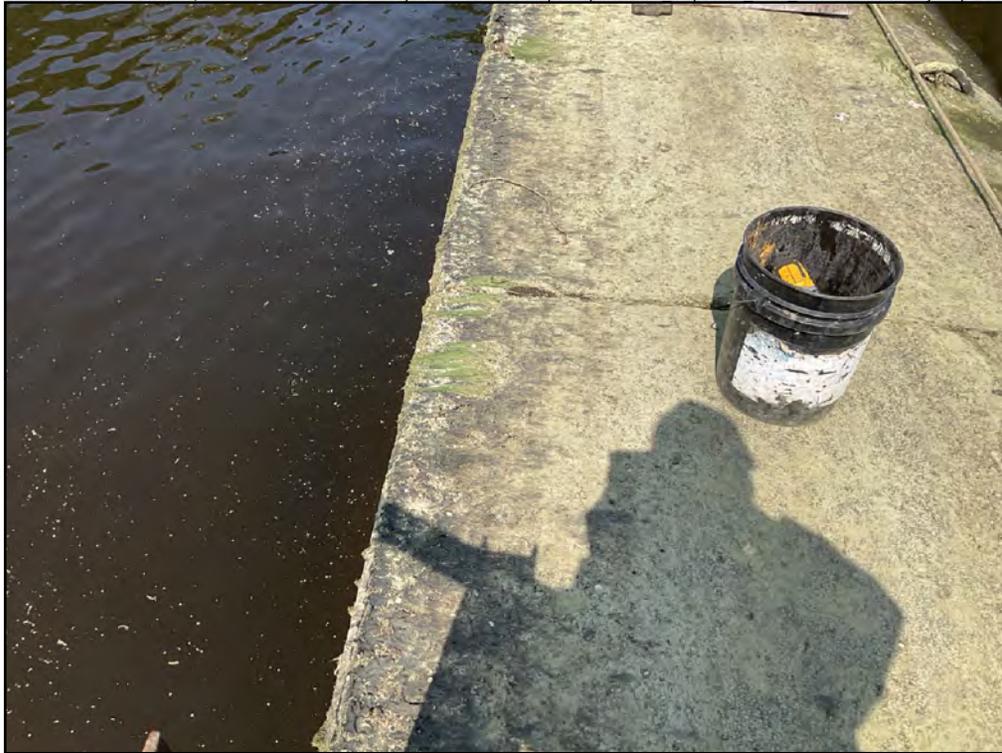
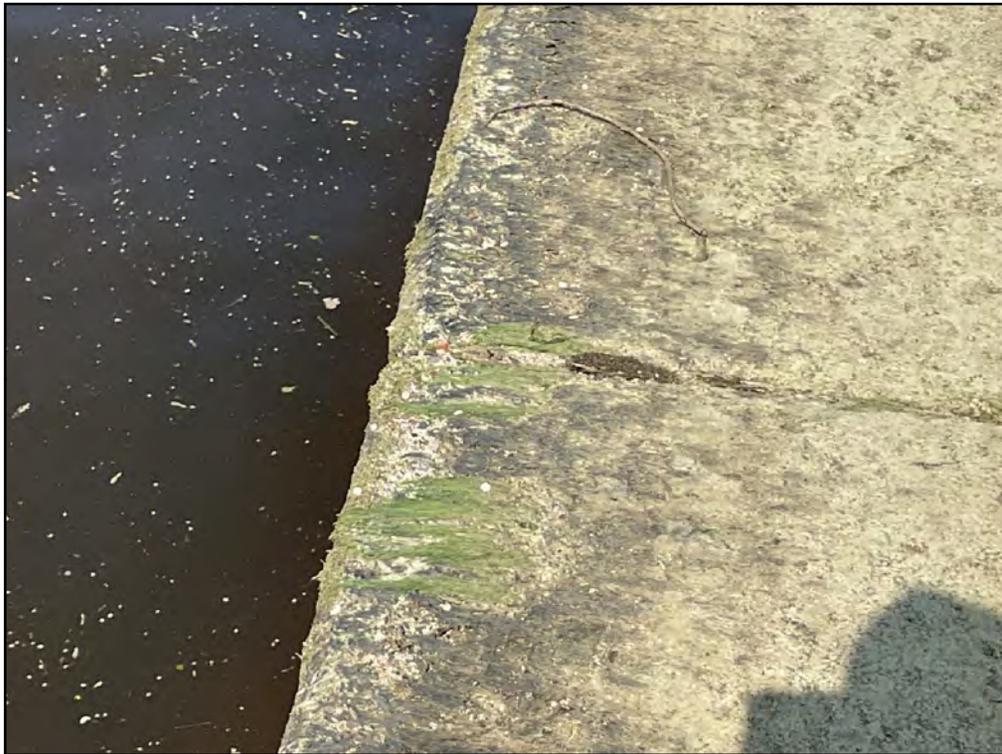
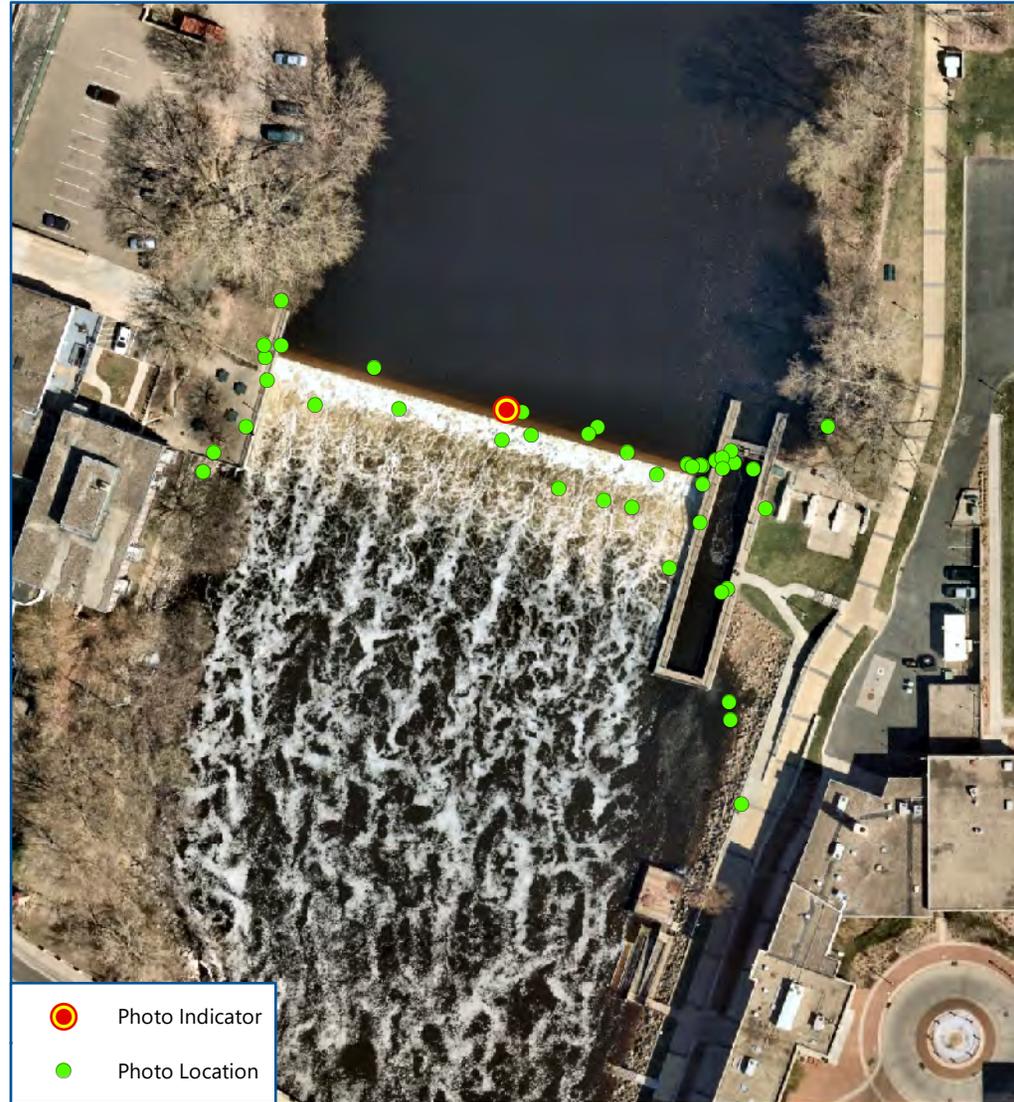
Comment: Bay 6, some spalling present at top of right pier

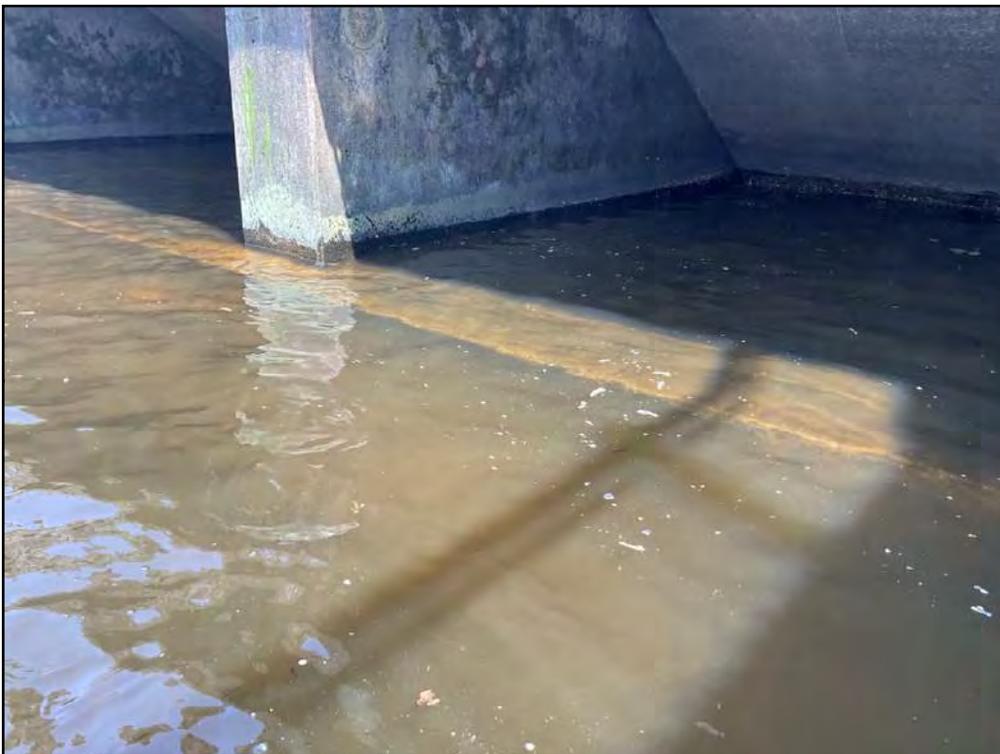
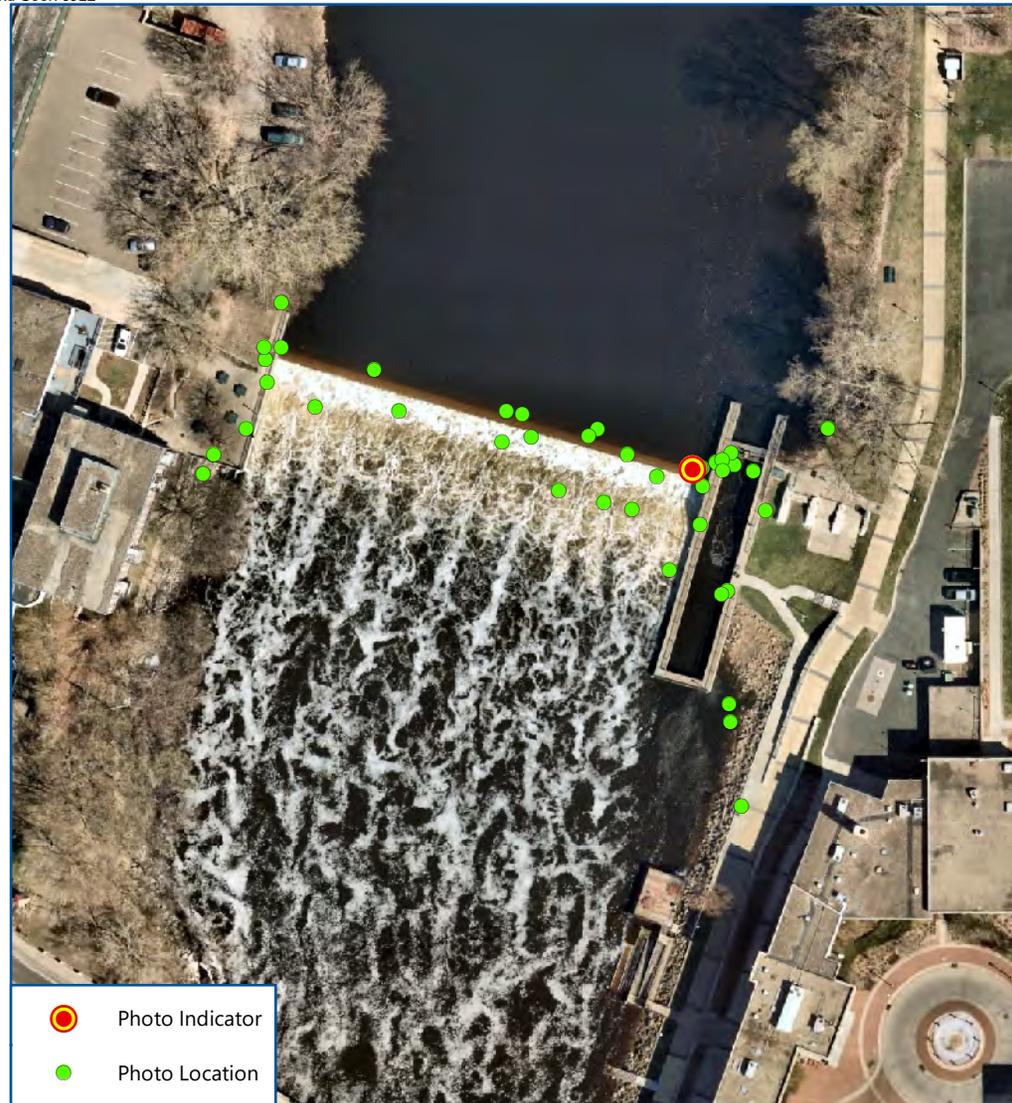
Comment: Left abutment, general condition, superficial aging

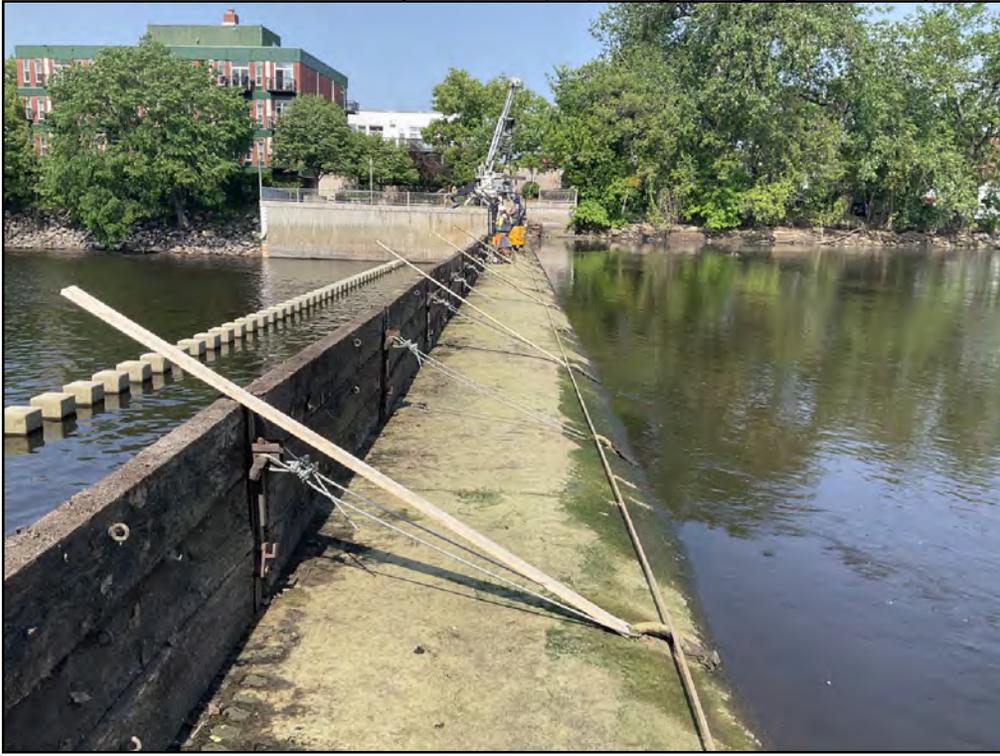
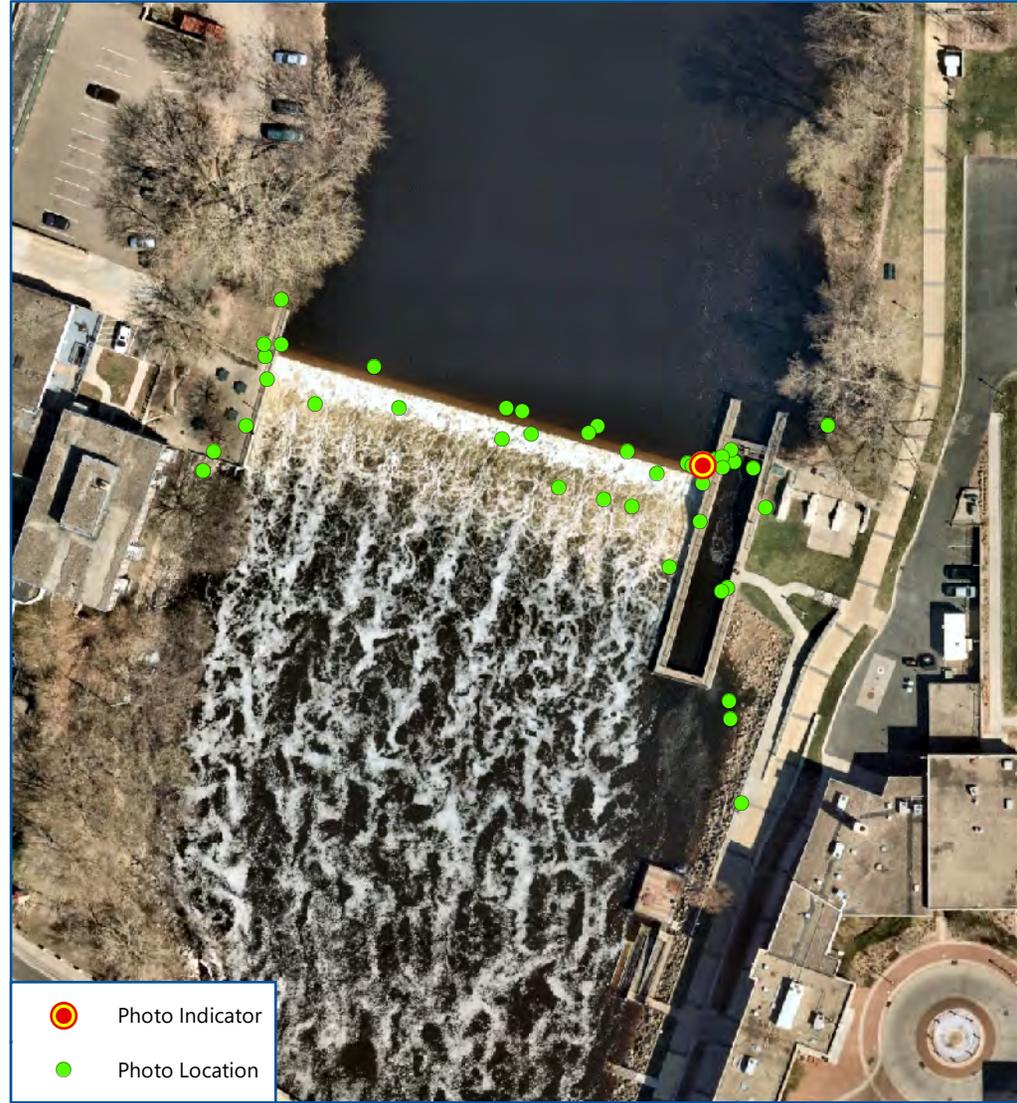
Comment: Flash board, wood heavily deteriorated, superficial rust on vertical posts, new cables
