2023 Dam Inspection Report

Rum River Dam

Prepared for
City of Anoka

November 2023

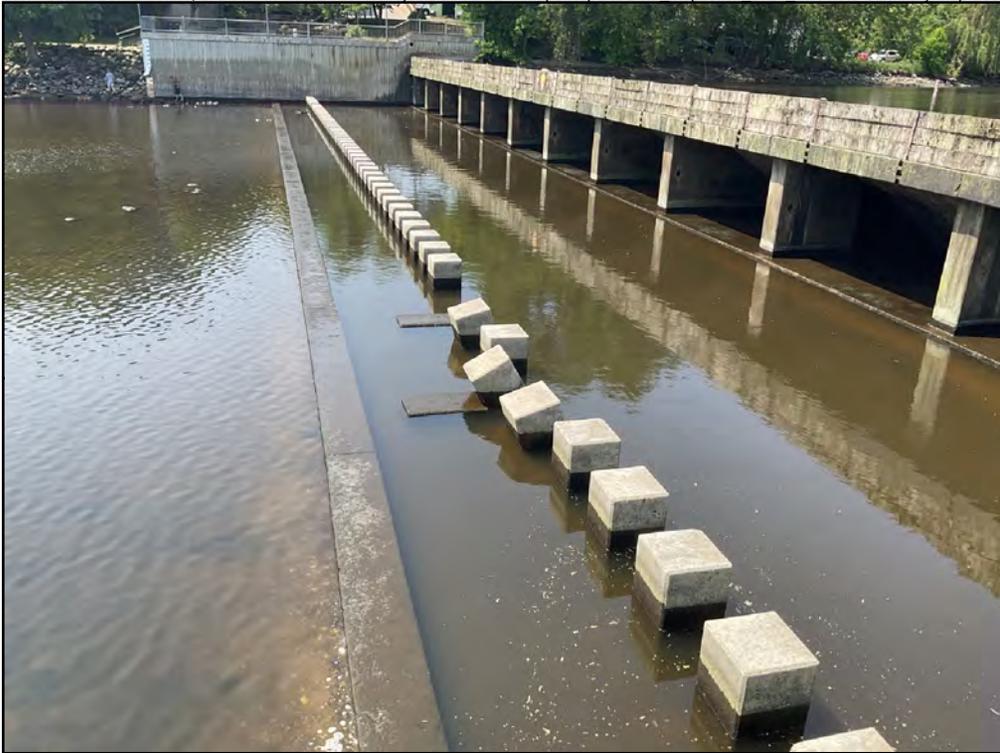
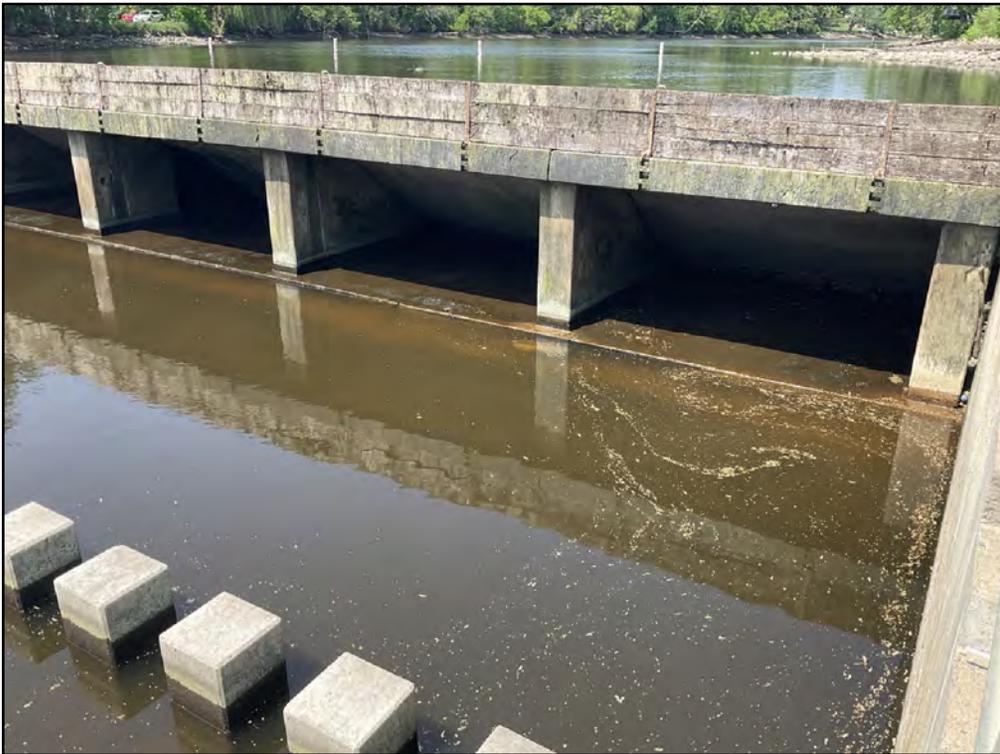
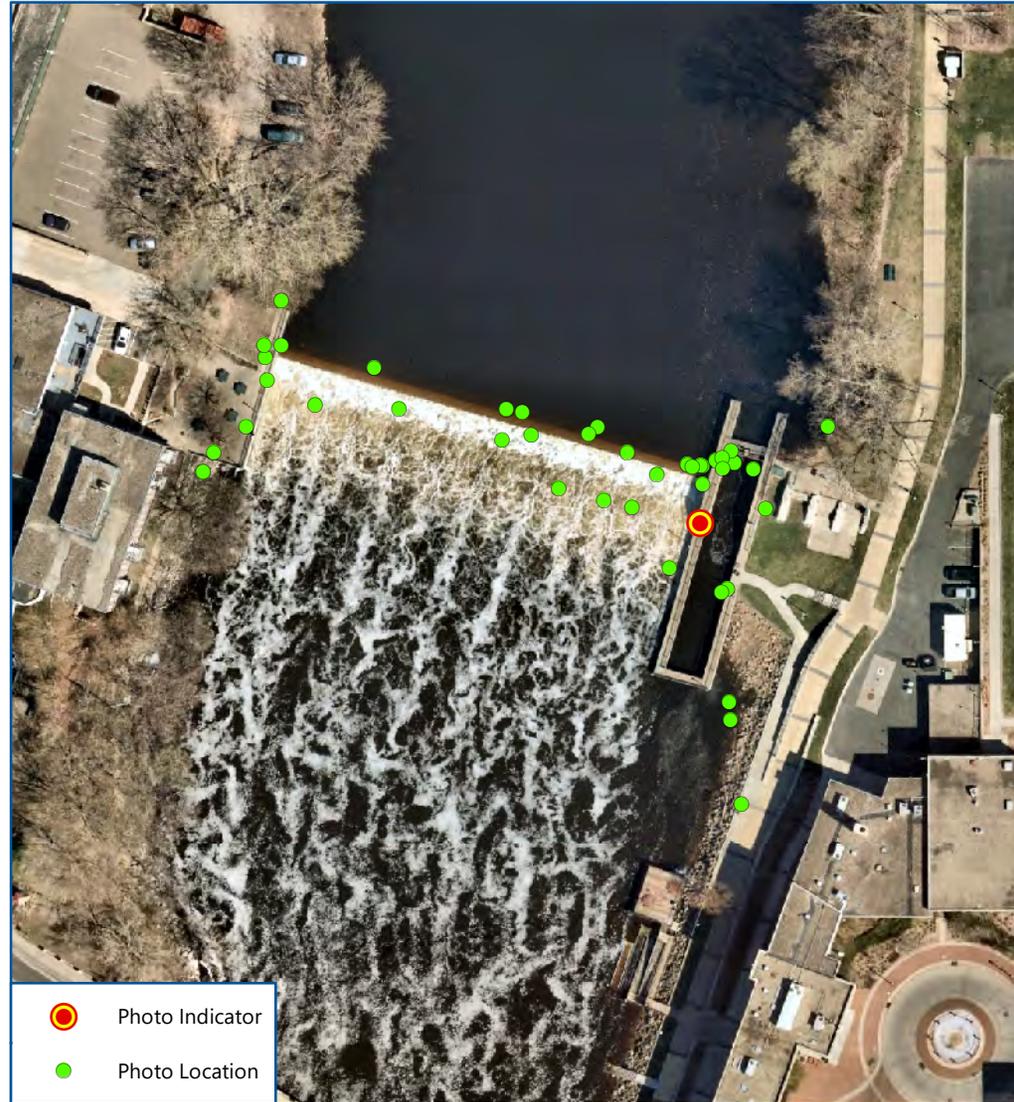
Comment: General condition at left training wall, dampness observed, no flowing water

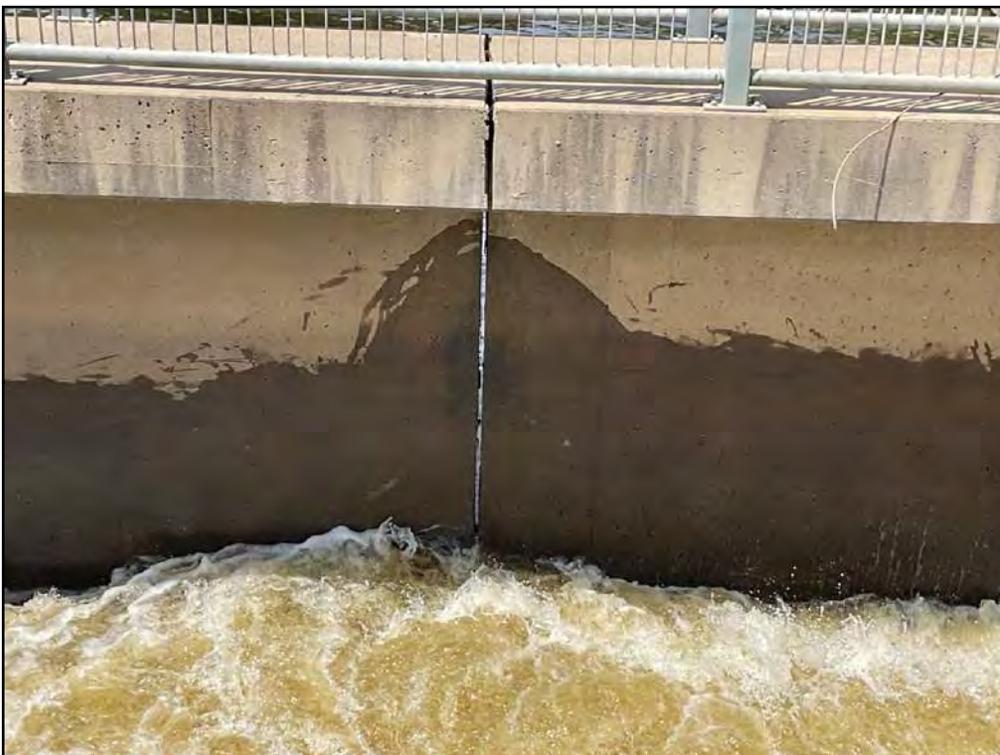
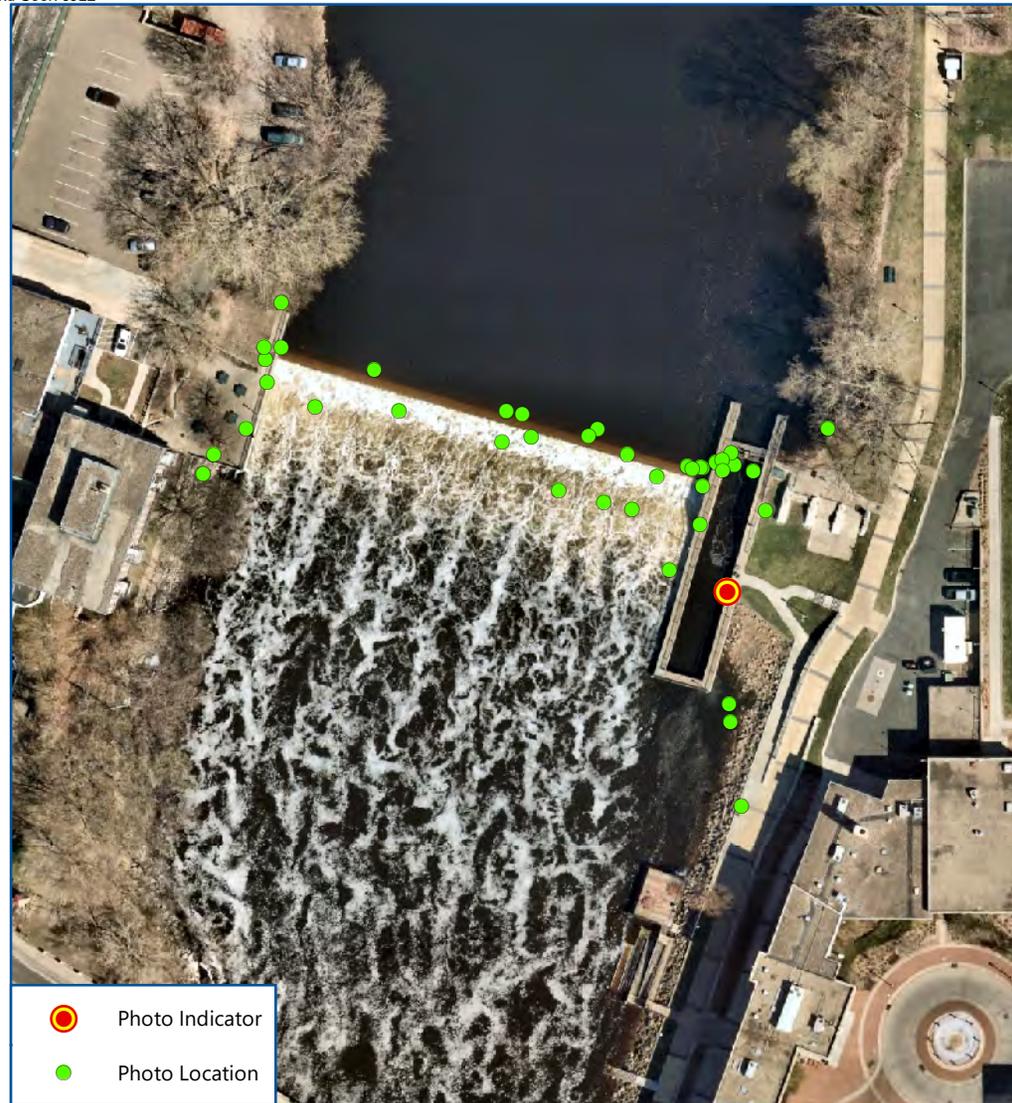
Comment: Spalling on sidewalk, no rebar visible

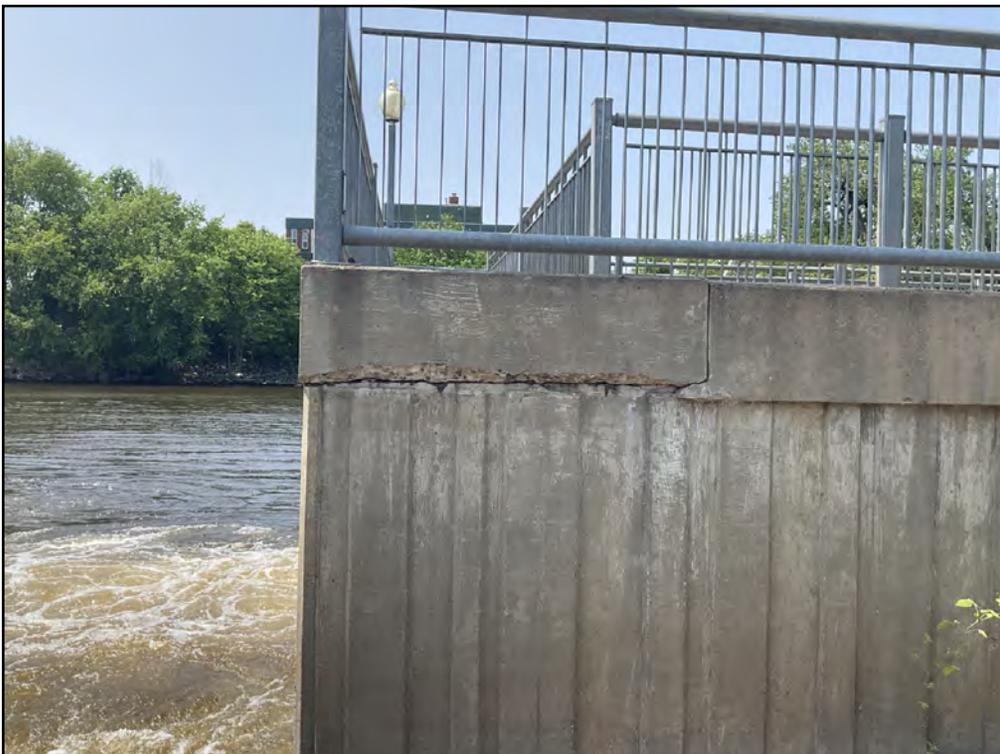
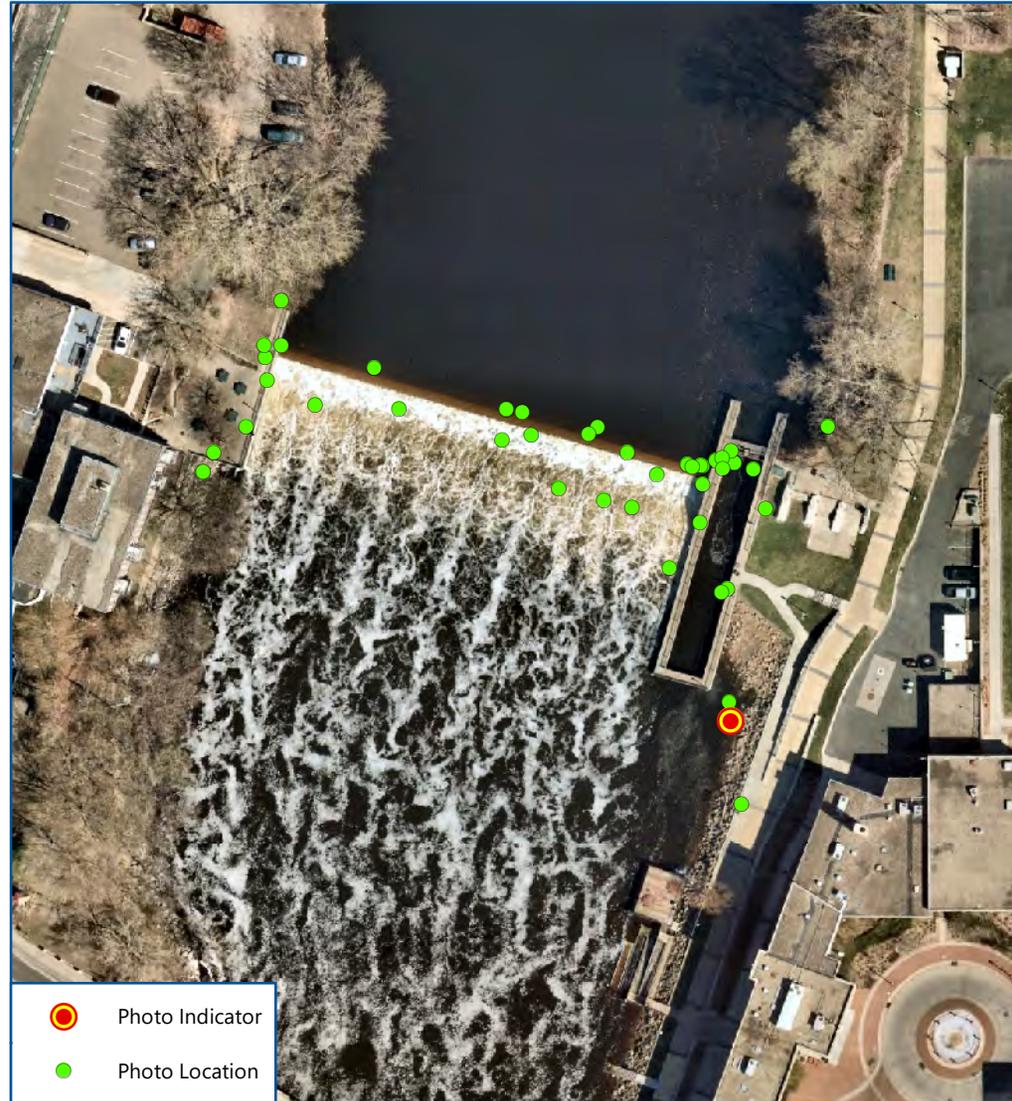
Comment: Typical condition of land side of abutment wall. Some cracking in top slab edge.

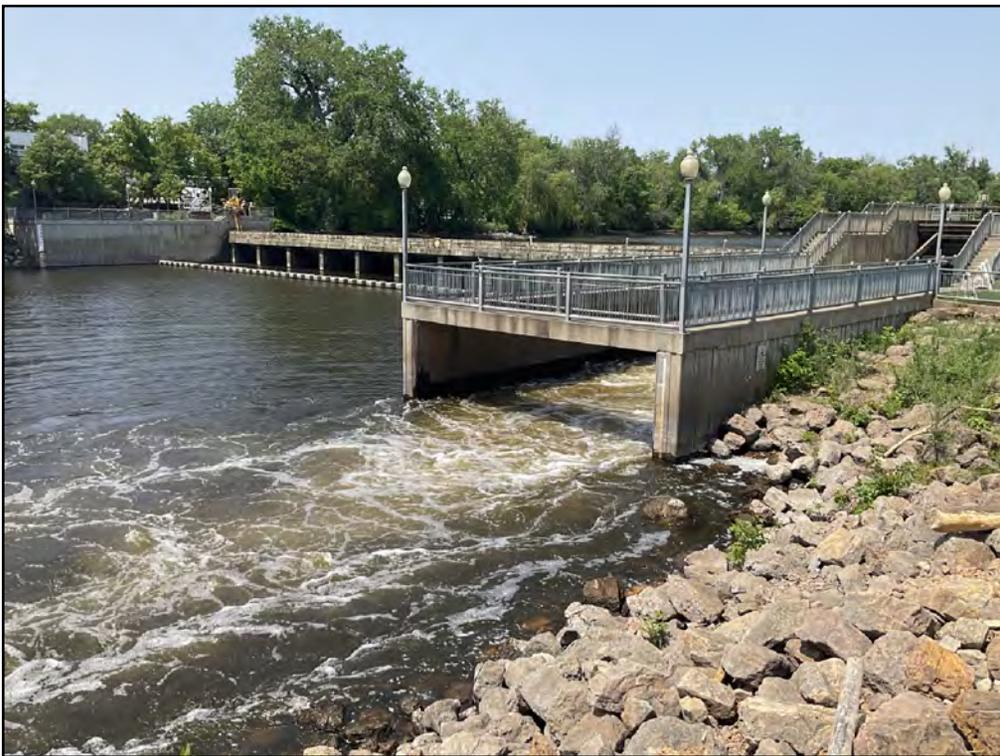
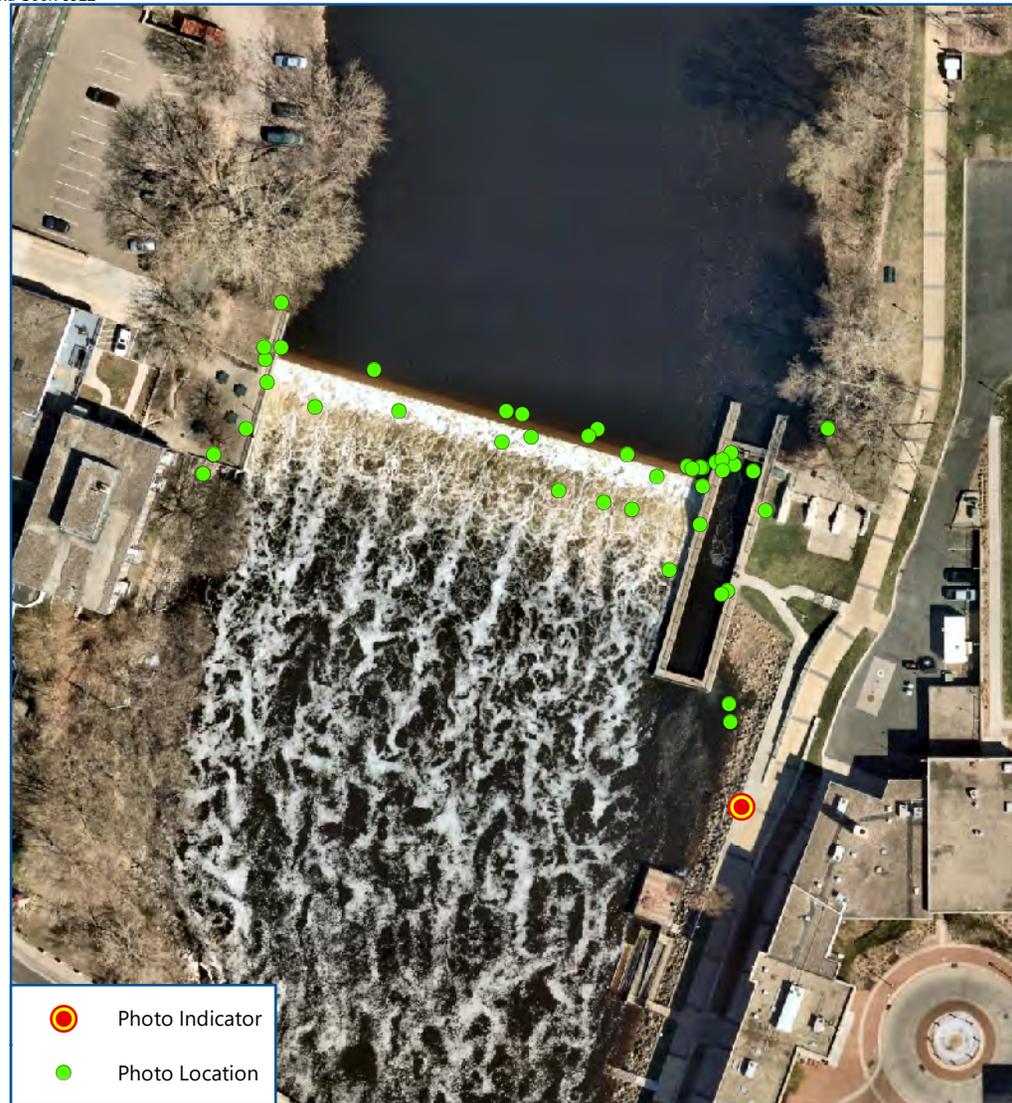
Comment: Operators bridge I'm acceptable condition. Spalling at end of bridge at top of wall.

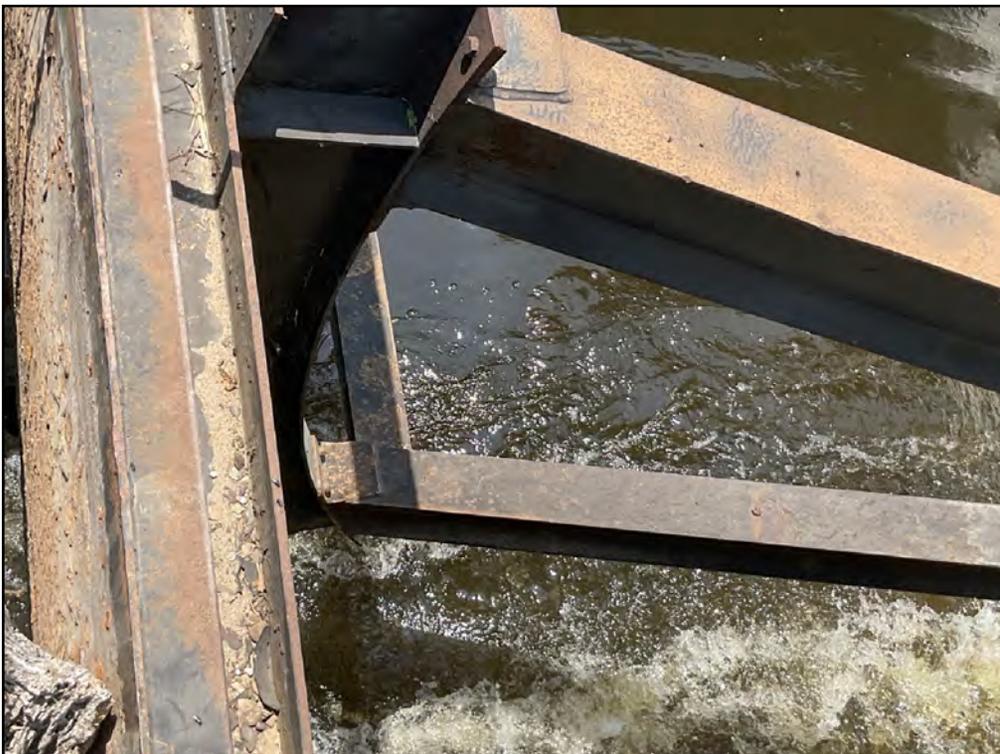
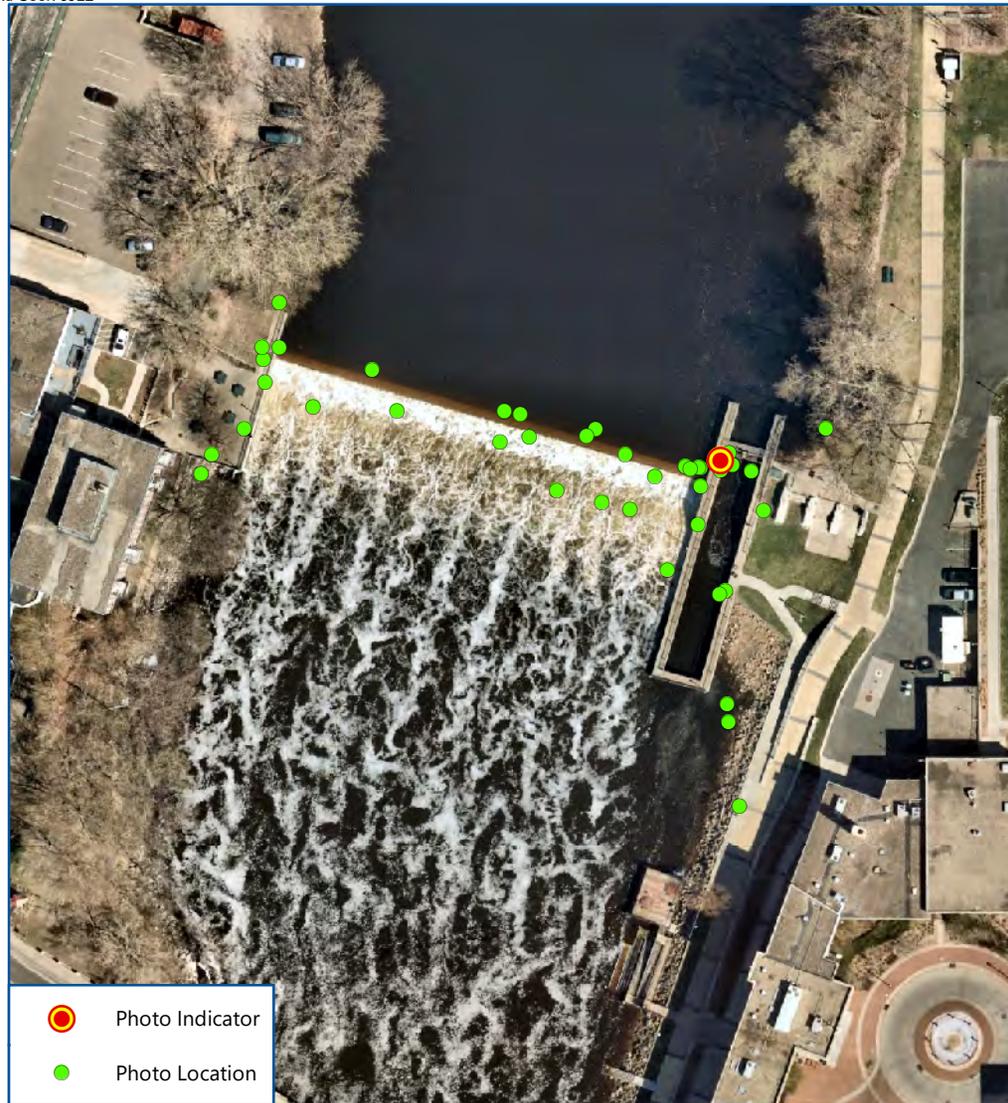
Comment: Cap missing on walkway on right side of tainter gate

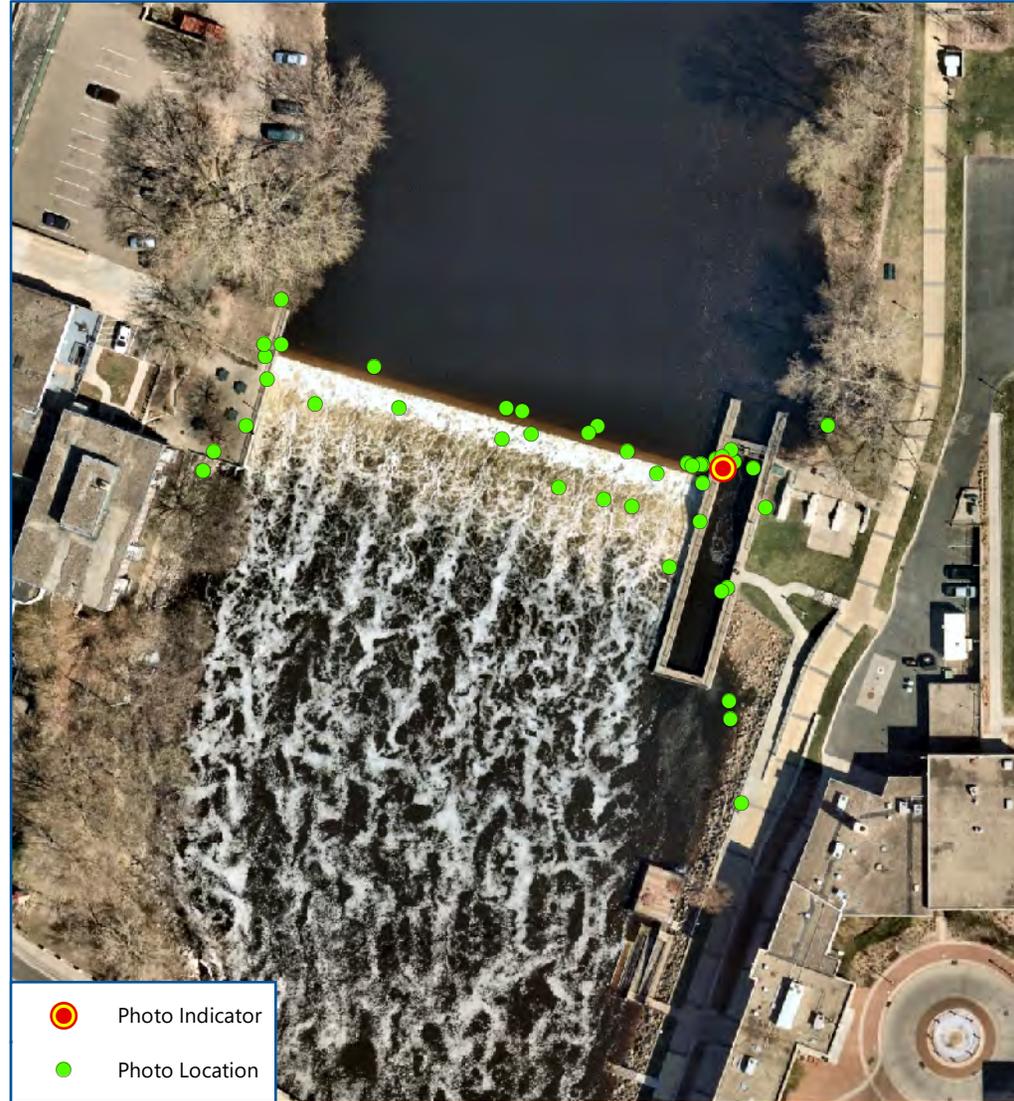
Comment: Surface rust on strut arms and tainter gate upstream face, bent flange on brace

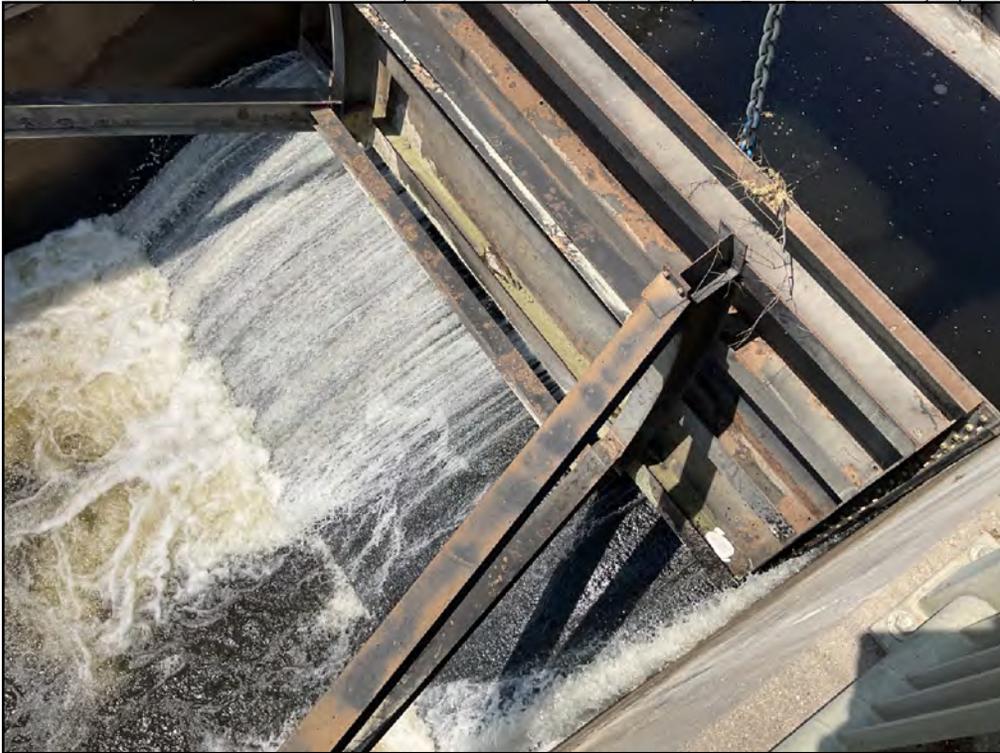
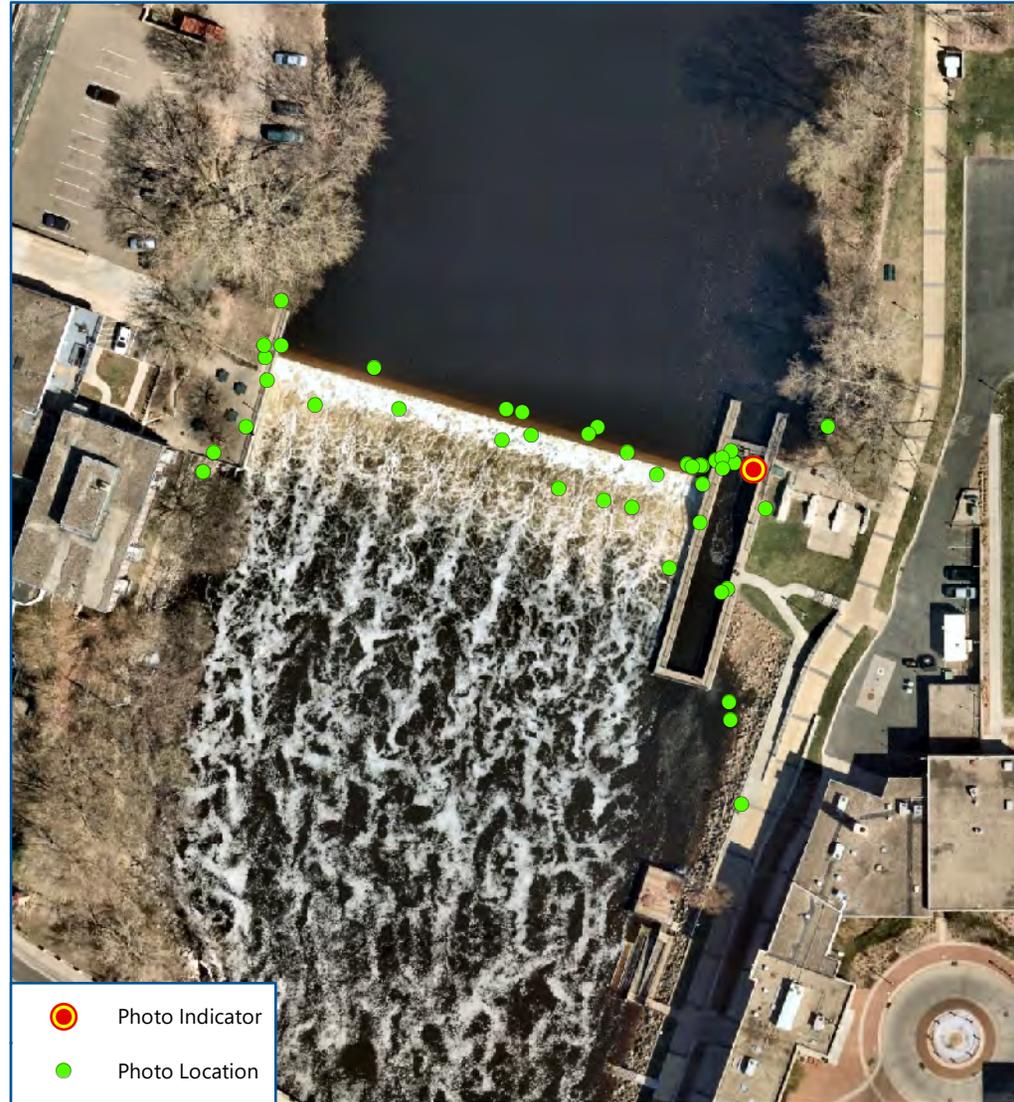
Comment: Tainted gate from ds side, minor surface rust, walls in good condition
