2023 Dam Inspection Report

Rum River Dam

Prepared for
City of Anoka

November 2023

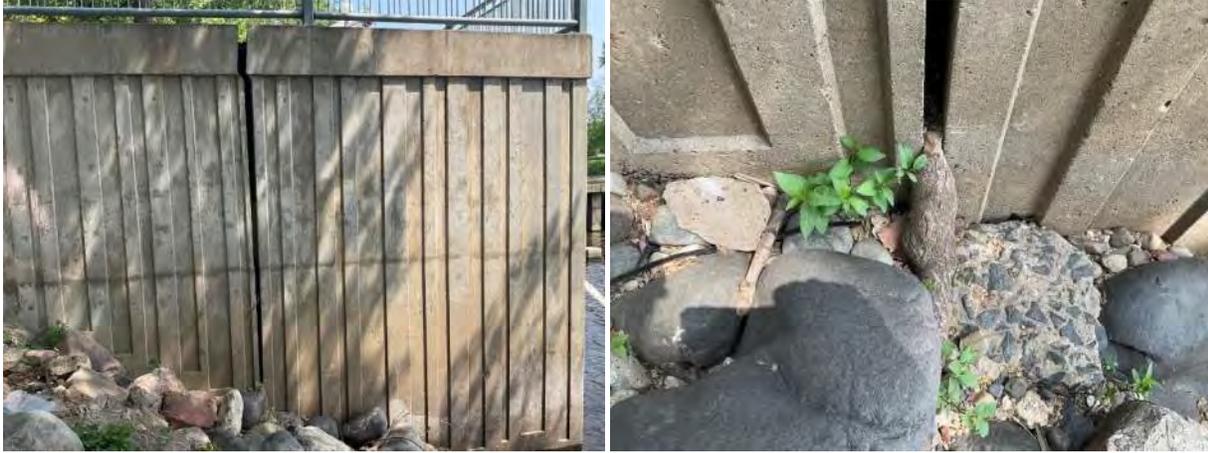
Figure 1 Right Abutment Wall Displacement and Vegetation

The downstream abutment appears to be leaning riverward (Appendix A – Photo Log 2; Figure 1). The gap at the top measured at 3.50 inches. Stanley Consultants observed this displacement in 1996 measuring it at 2.75 inches (Stanley Consultants, October 1996). Assuming this gap was 0 inches as of the original 1966 construction, the movement trend is provided in Figure 2. This magnitude of movement does pose a concern. While this could be an indication of destabilization of the wall which would require repair, the leveling off trend with time minimizes the concern. Furthermore, the wall is founded on piles reducing the risk of scour undermining the foundation. A root measuring approximately 2" in diameter was observed.

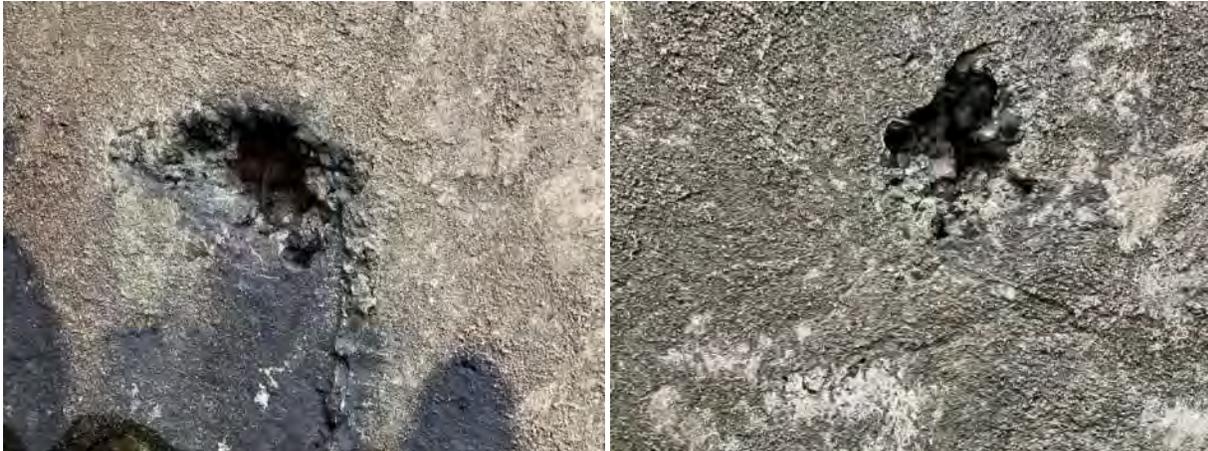
Figure 3 Bay 3 honey combing and exposed rebar

Bay 3 - Appendix A, Photo Log 21; Figure 3

The spalls observed in bays 3 and 9 are likely honeycombing from the original construction. Exposed rebar was observed.

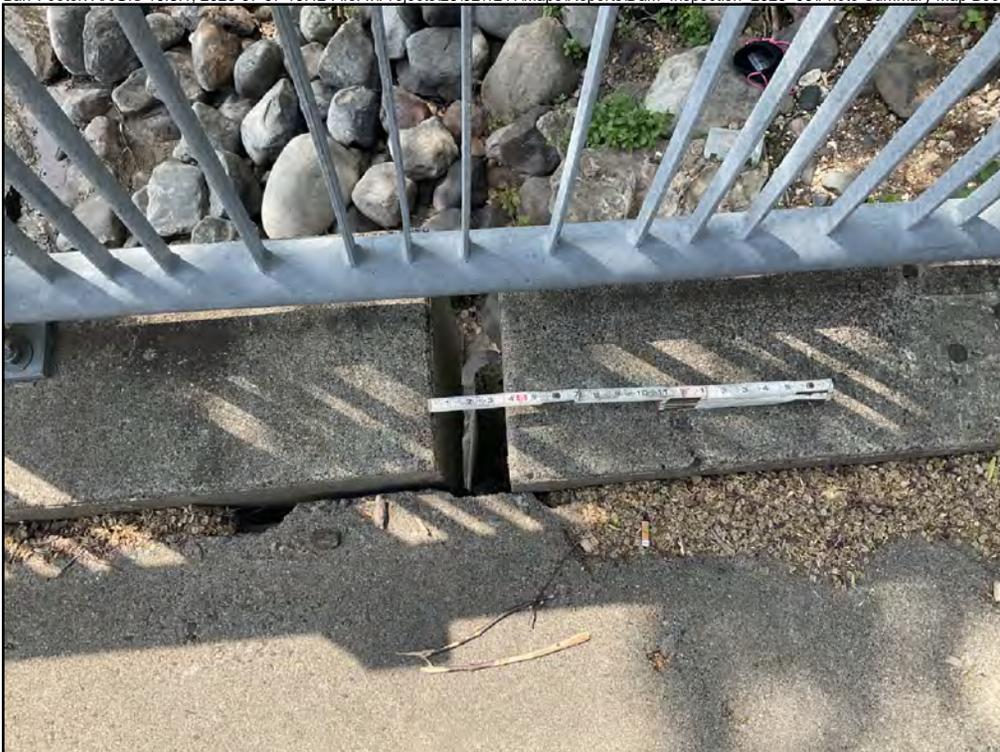
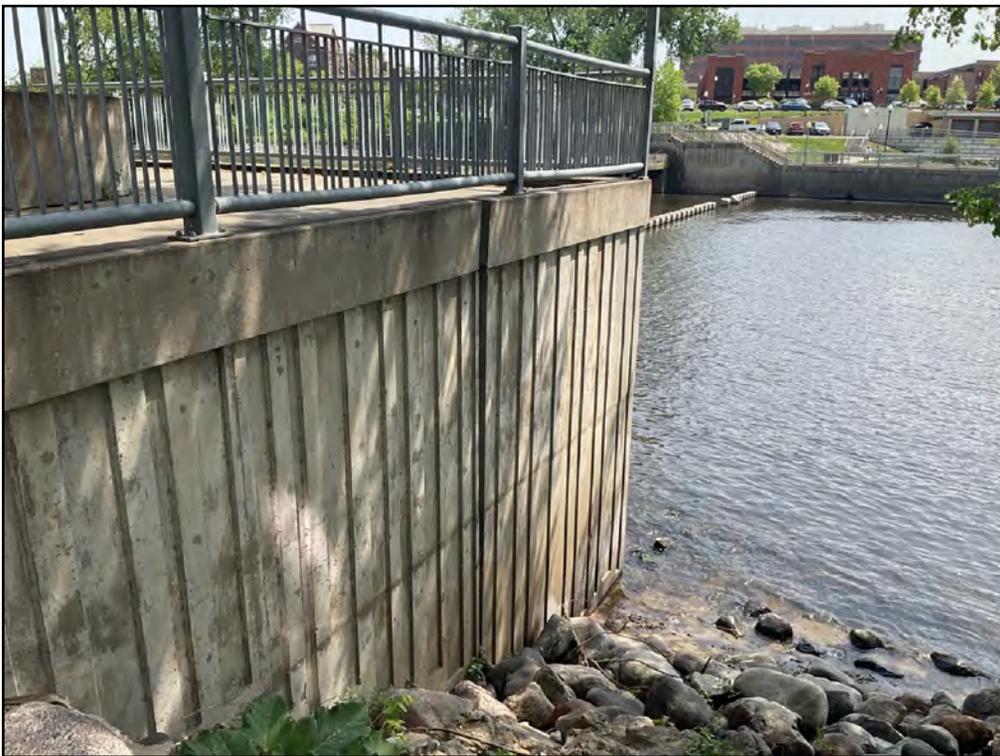
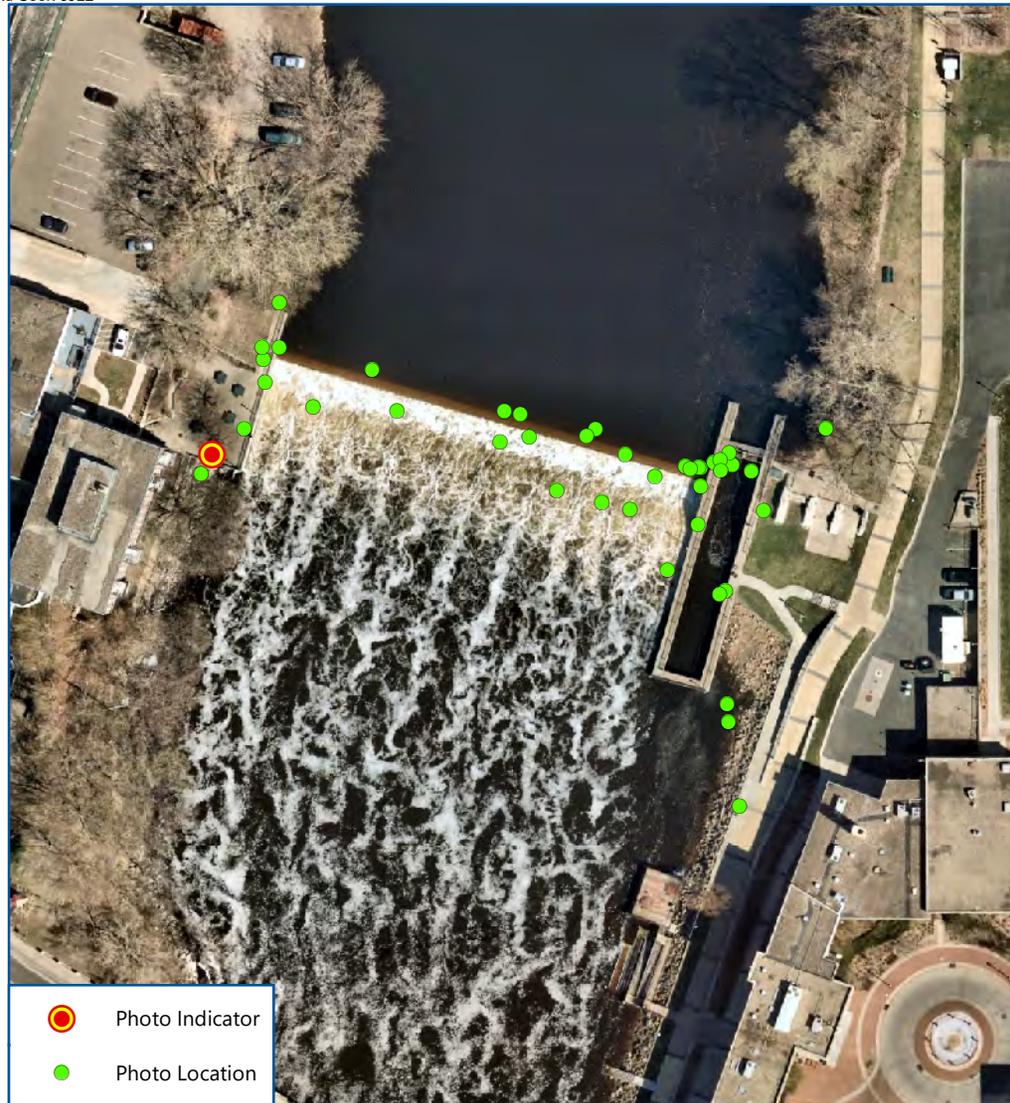
Comment: Erosion where downstream wing wall ties in with bank.

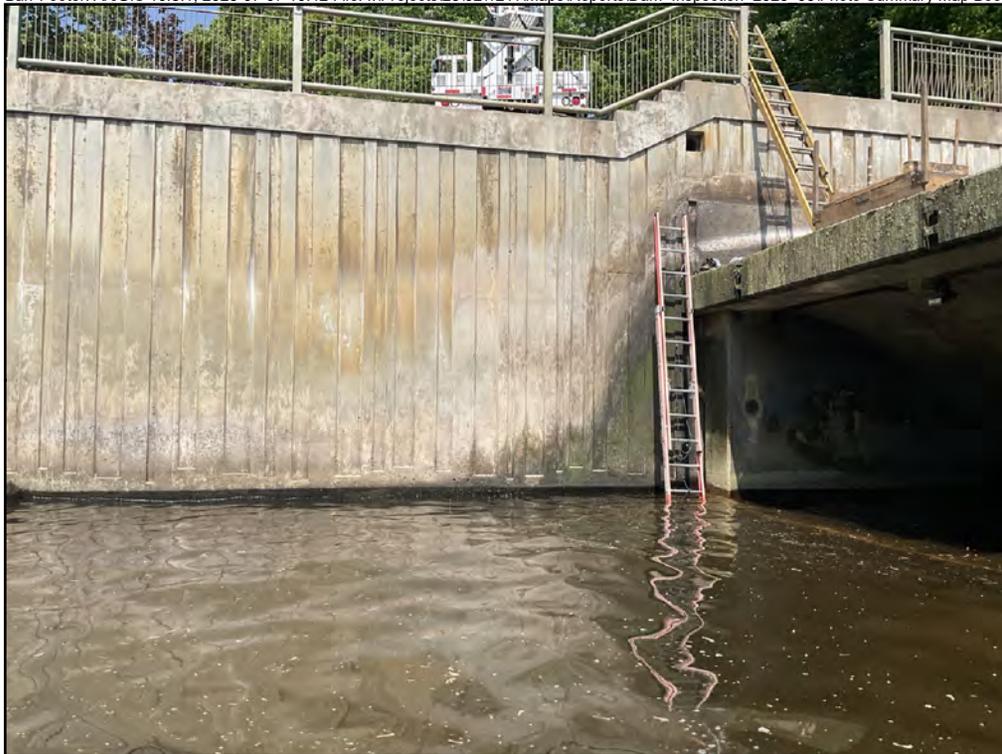
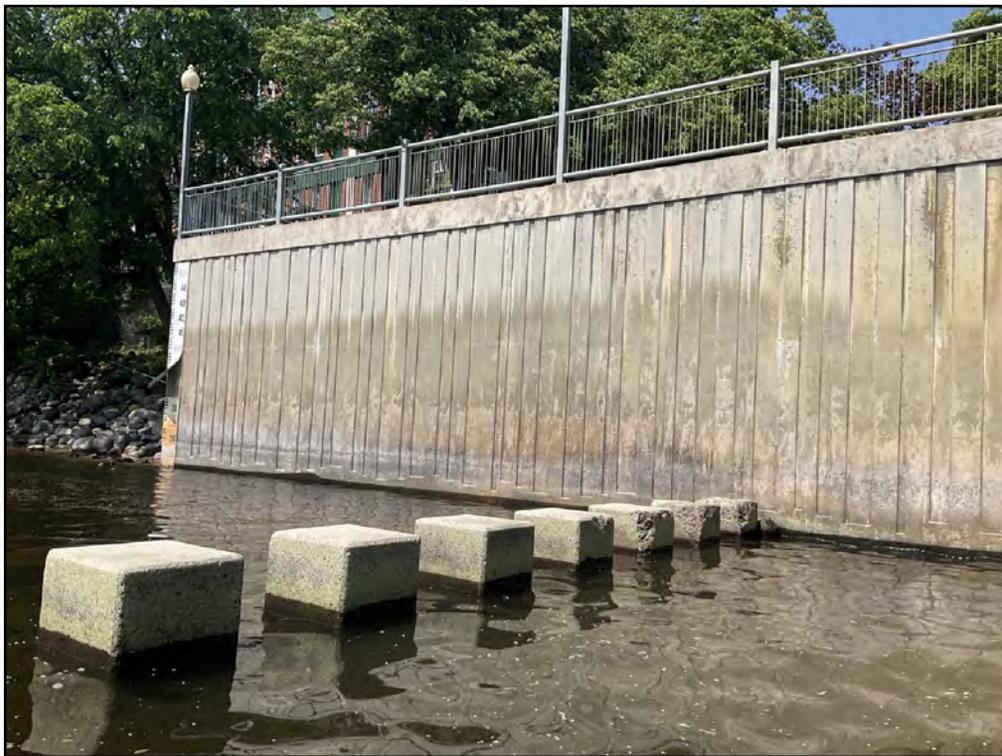
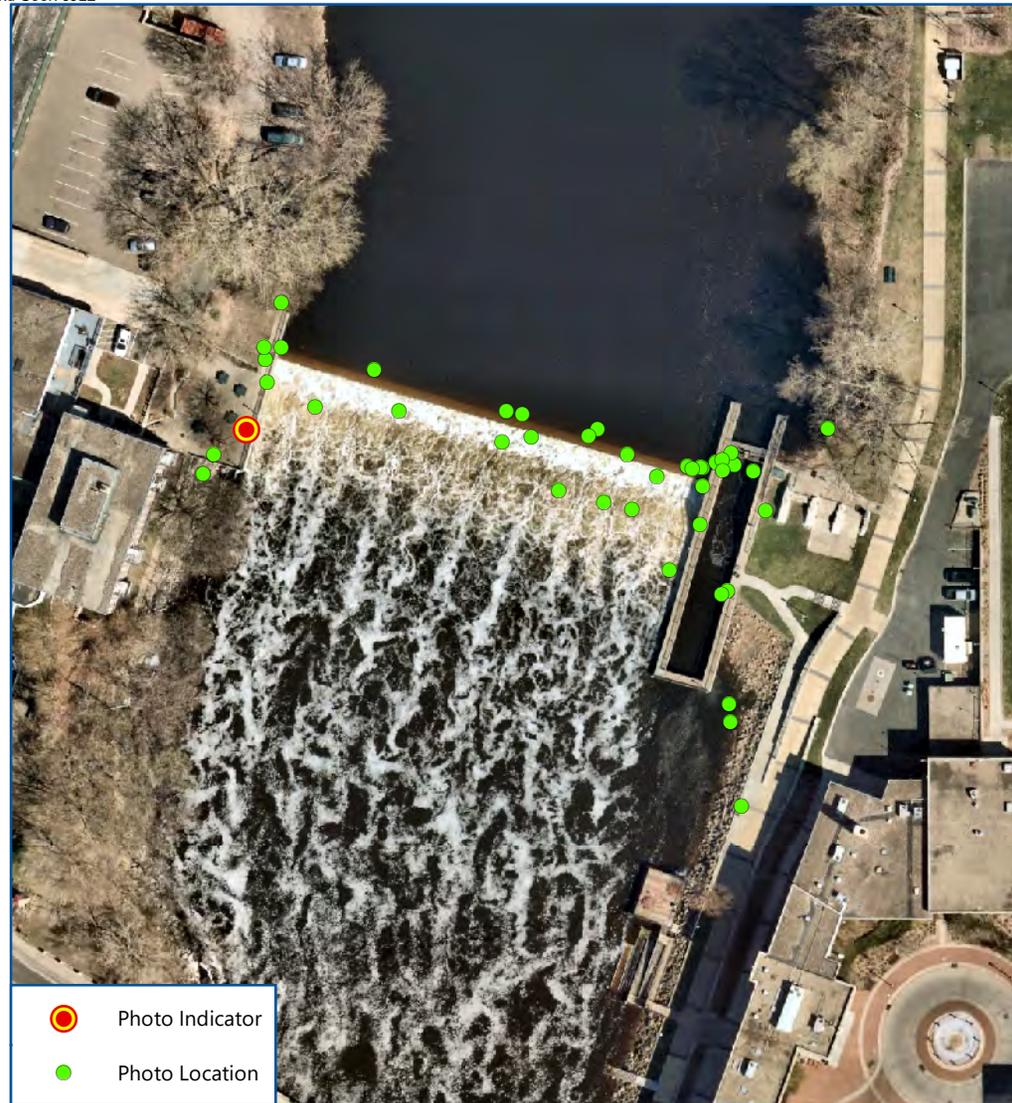
Comment: Downstream wing wall joint expansion indicates tilting of the wall. Joint expanded past keyway.

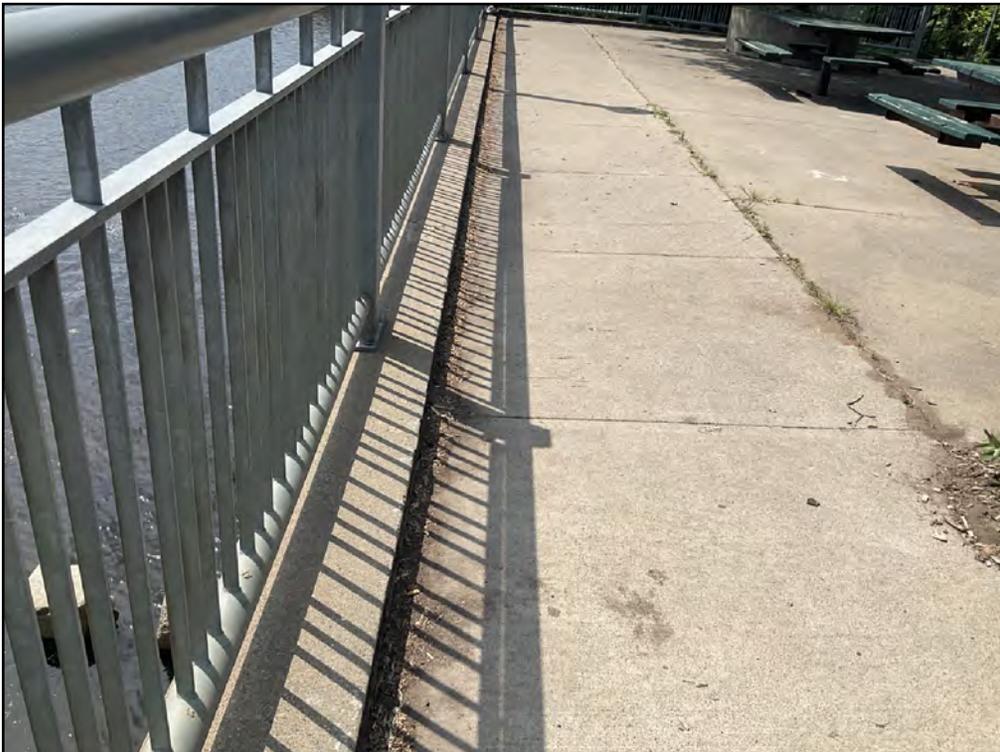
Comment: Right abutment general condition, general weathering, some staining and vertical cracking

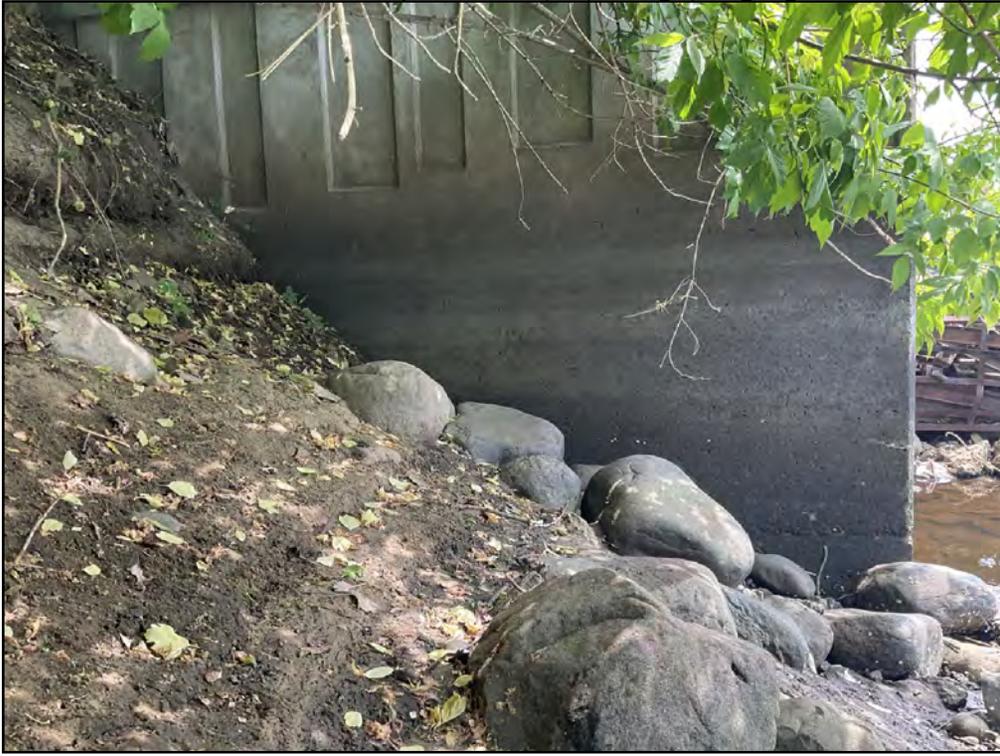
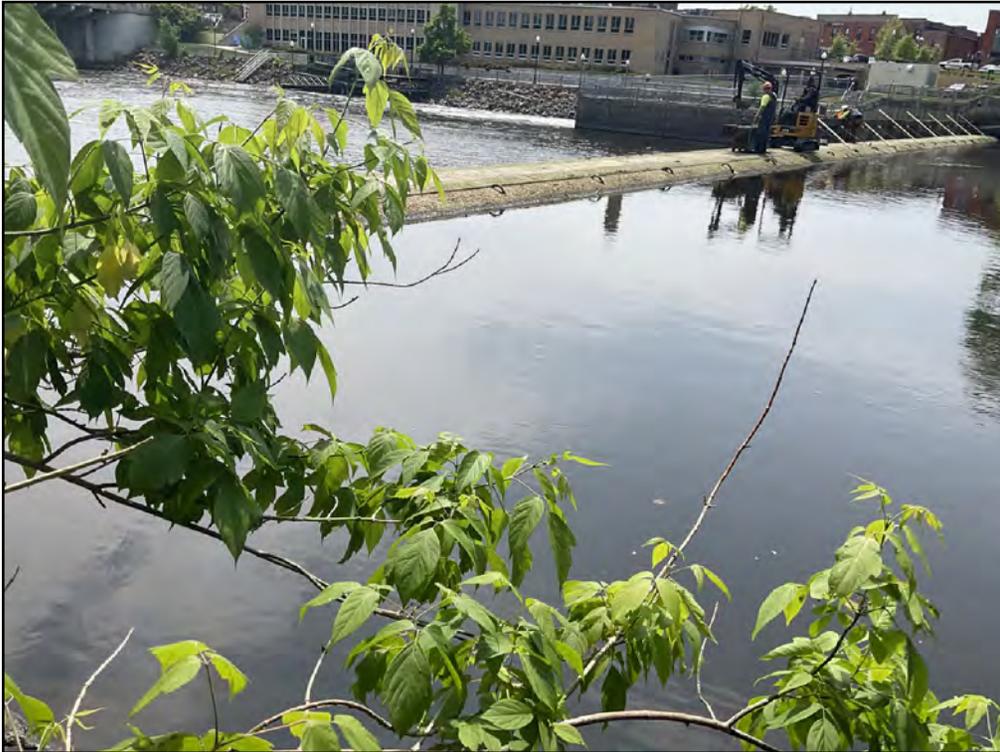
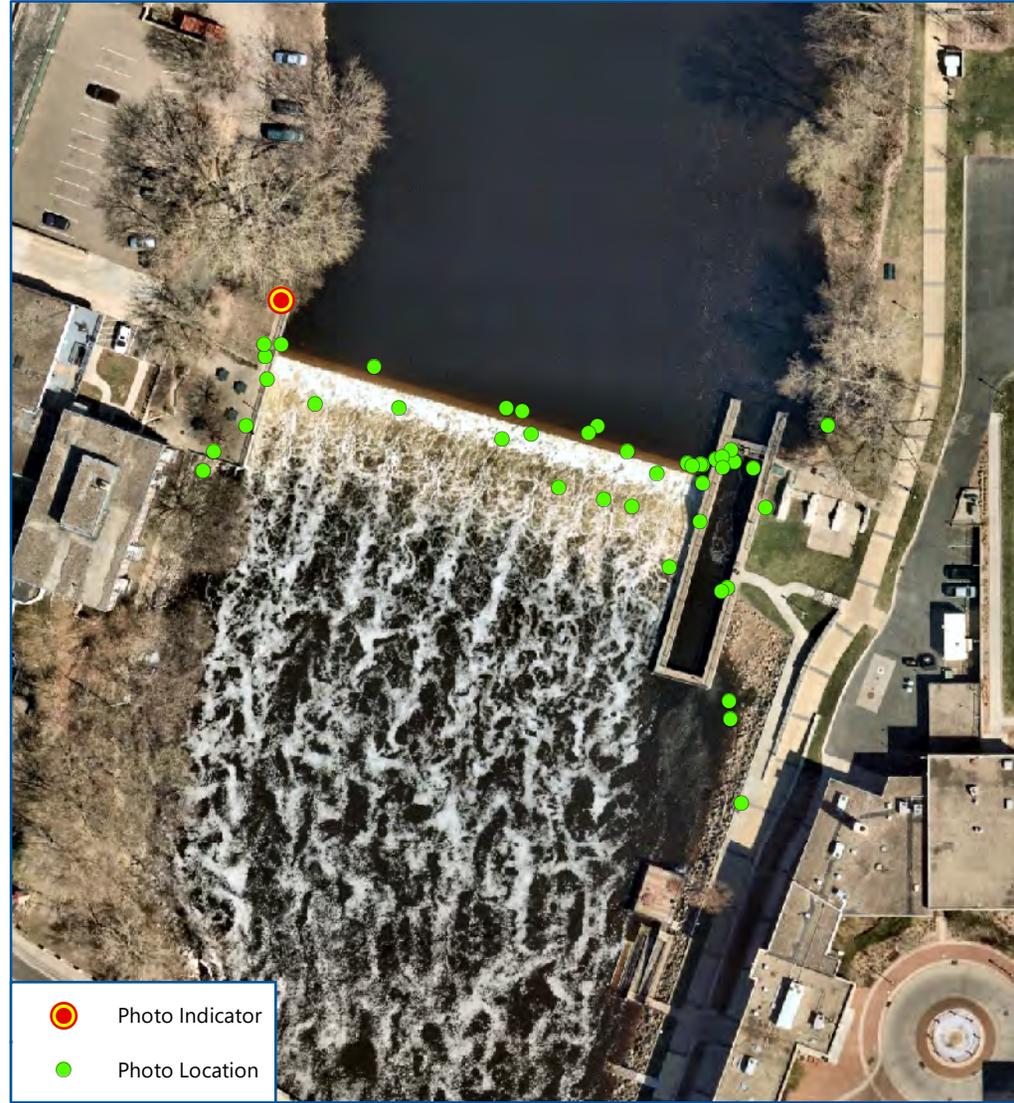
Comment: Sloping slab at backside of right abutment wall

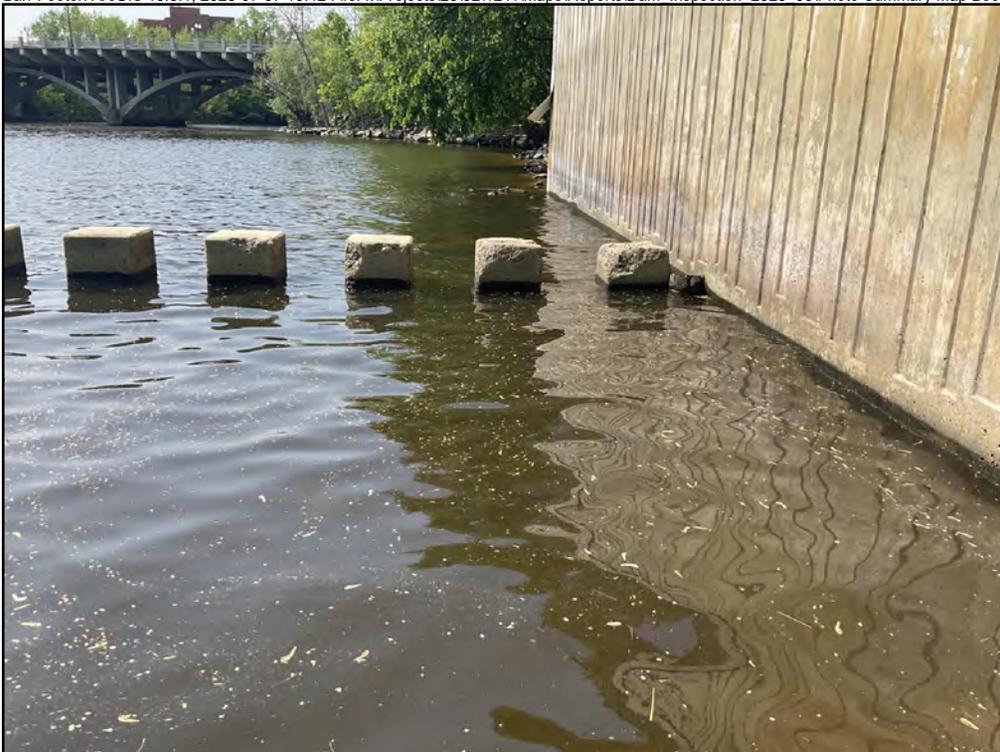
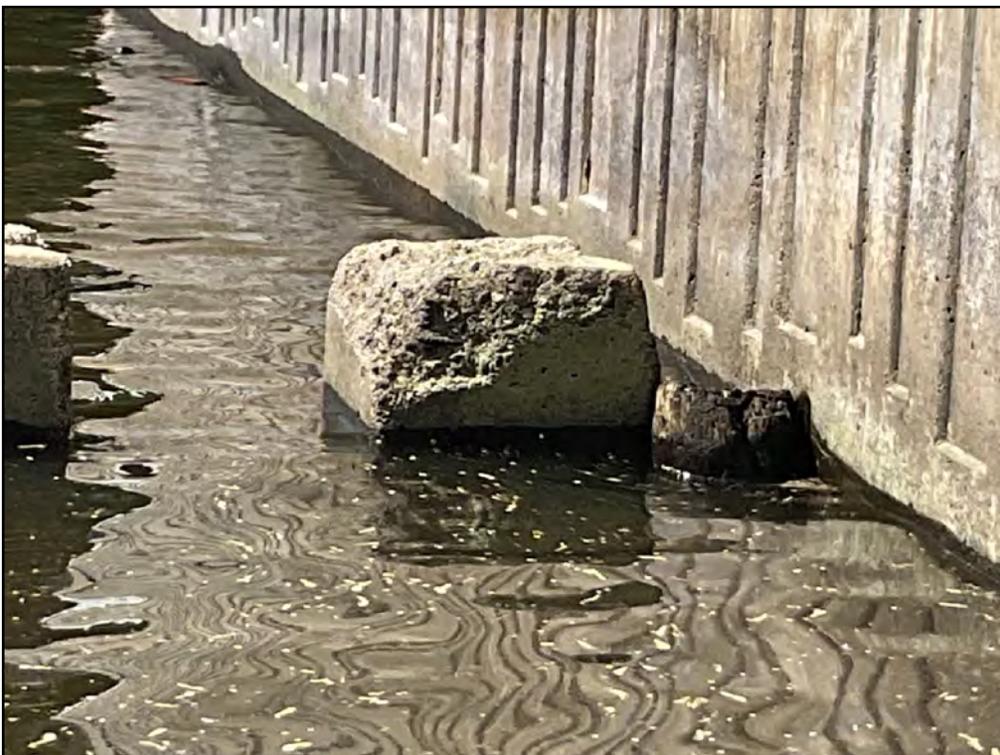
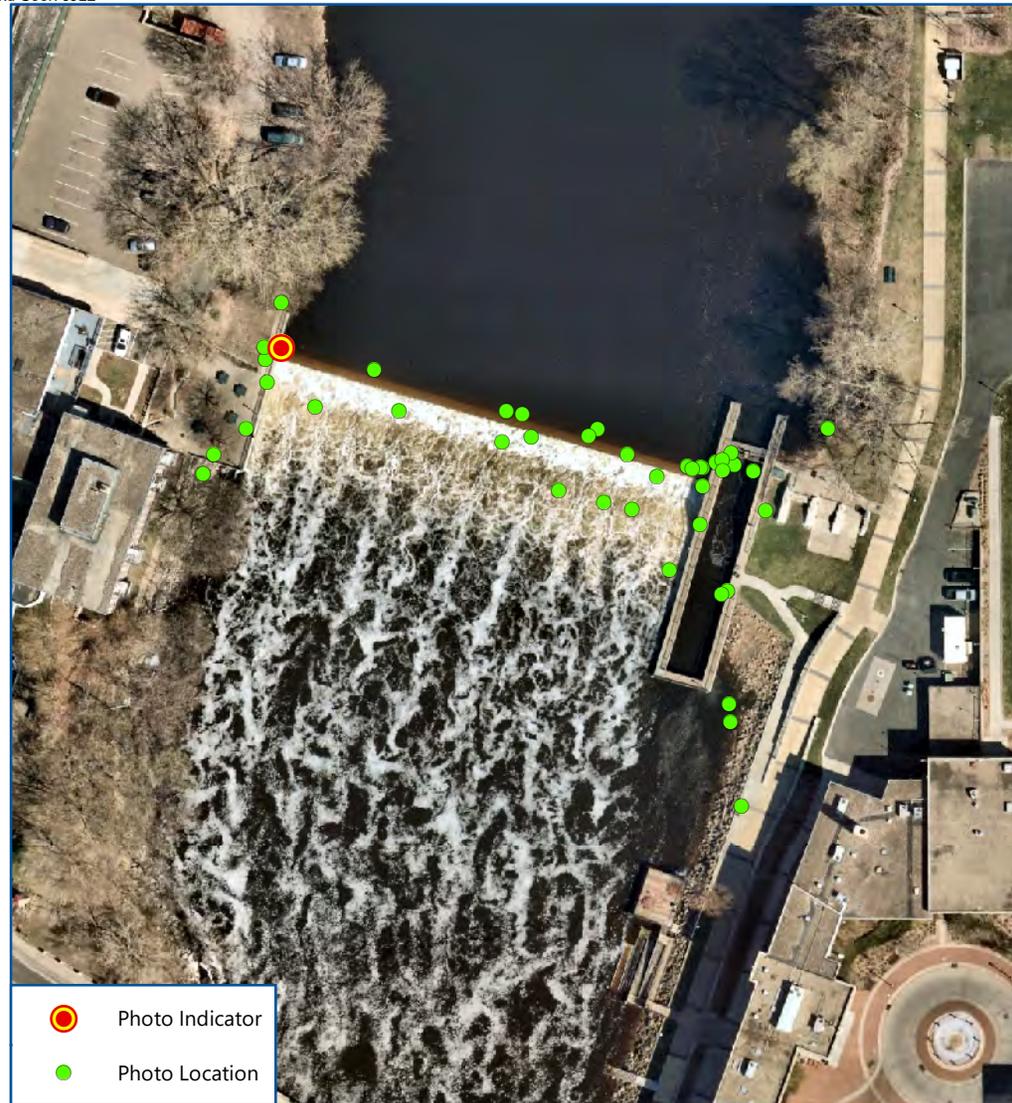
Comment: Erosion evident at upstream wing wall tie in.

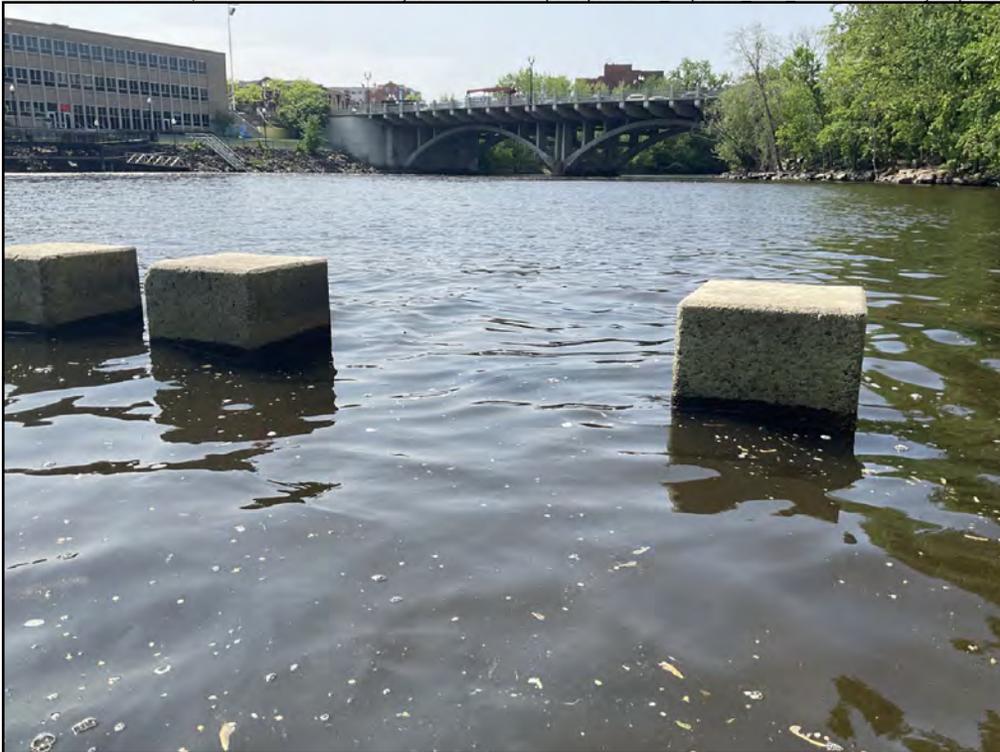
Comment: Spalling on 4 baffle block corners and tops. Exposed rebar on right one

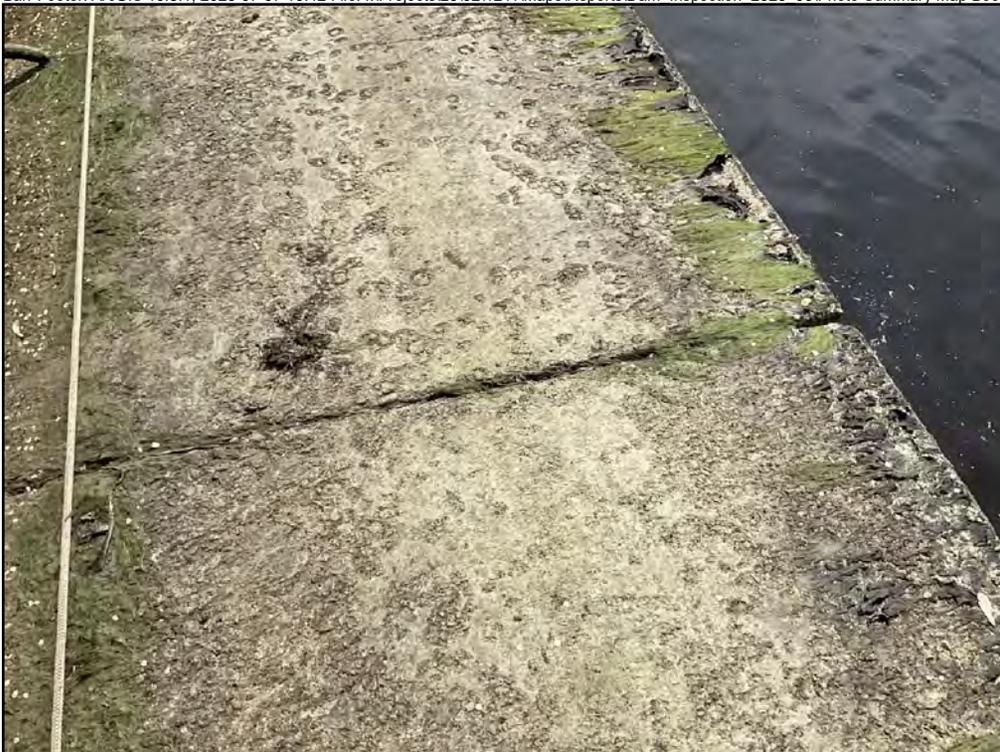
Comment: Missing baffle block. Appears to be tipped over immediately downstream

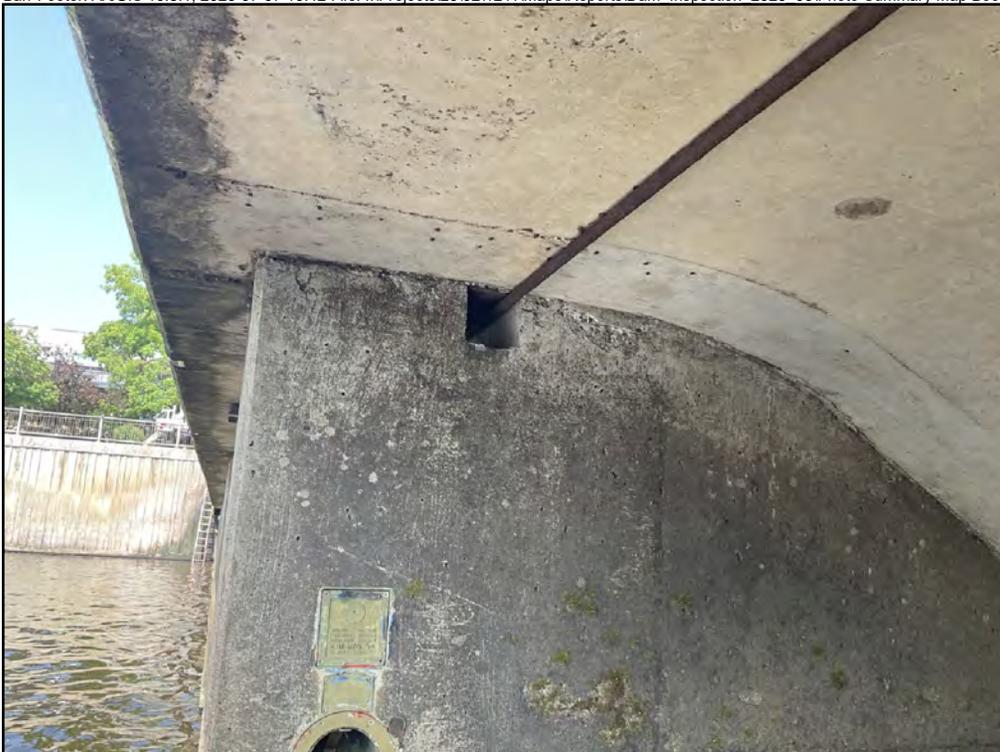
Comment: Bay 9, minor seepage, mineral deposits, construction deficiency exhibiting exposed rebar

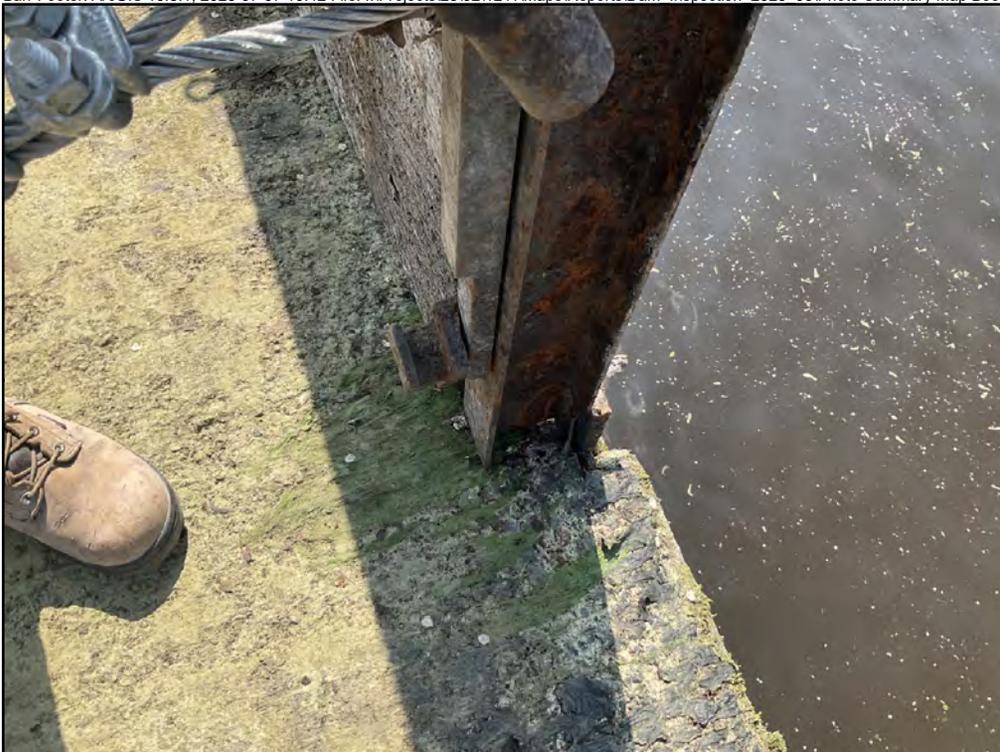
Comment: Condition under flashboard, some superficial spalling

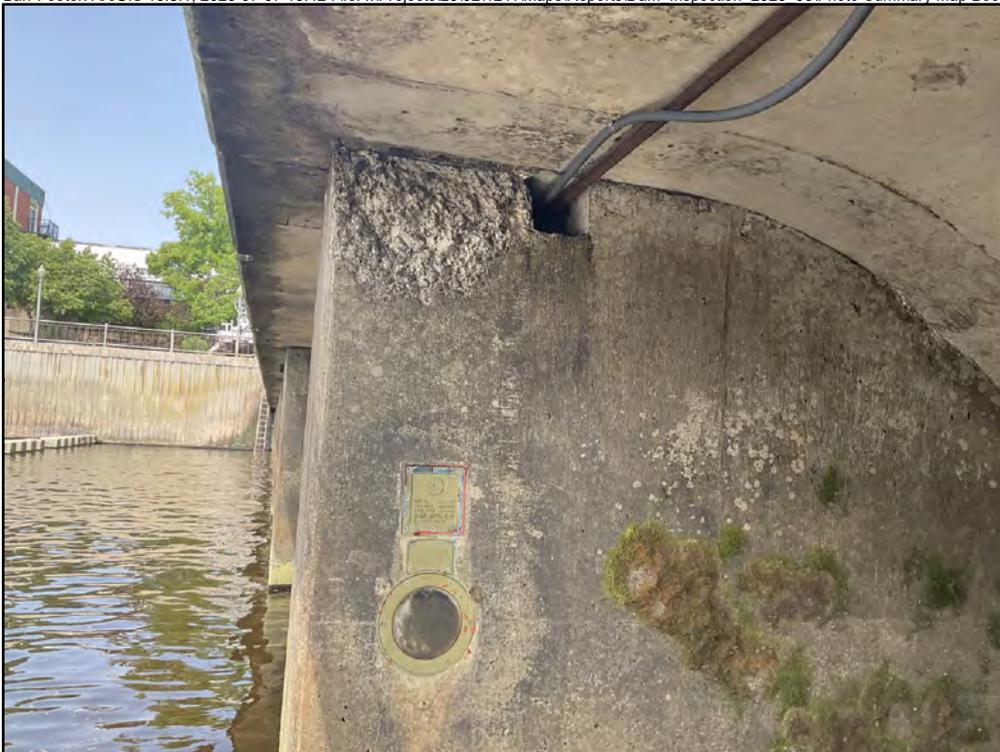
Comment: Spall approx. 12"x4"x1" deep, additional smaller spalls in vicinity, no exposed rebar

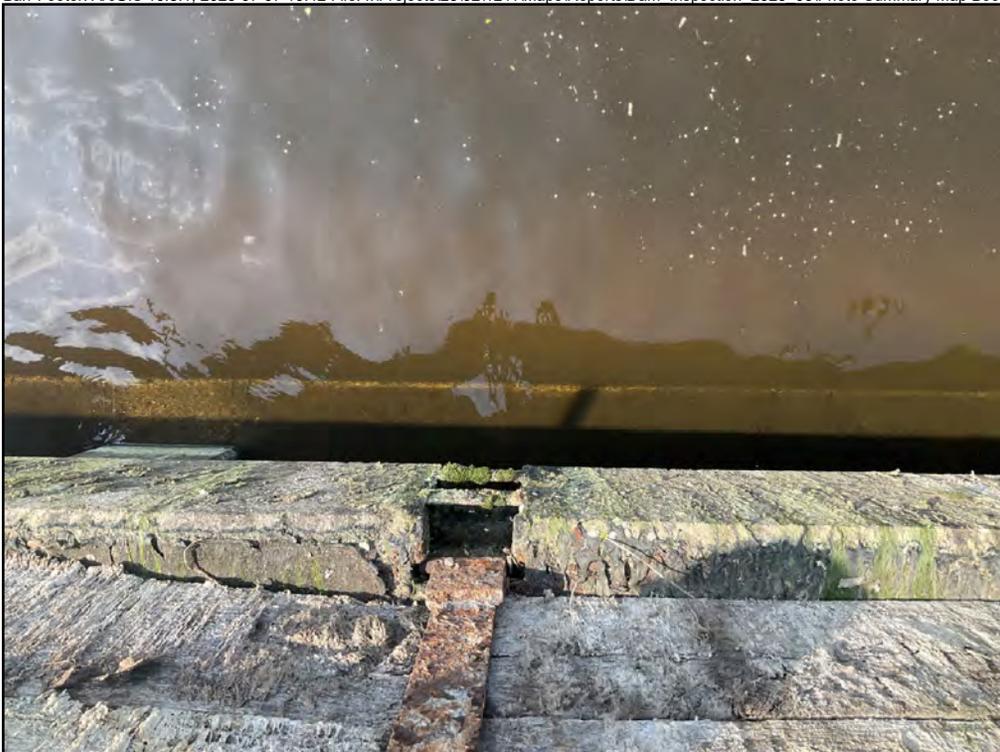
Comment: Corner spalls on 3 baffle blocks

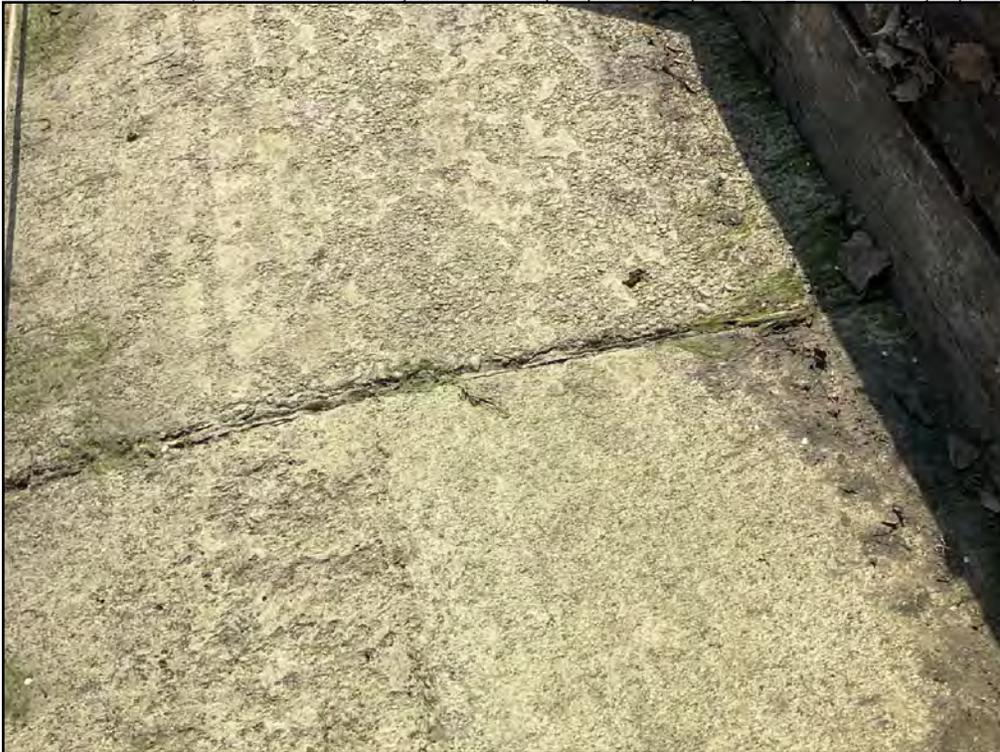
Comment: General condition of downstream face at flashboard post, superficial rust present on steel embeds, superficial spalling on concrete

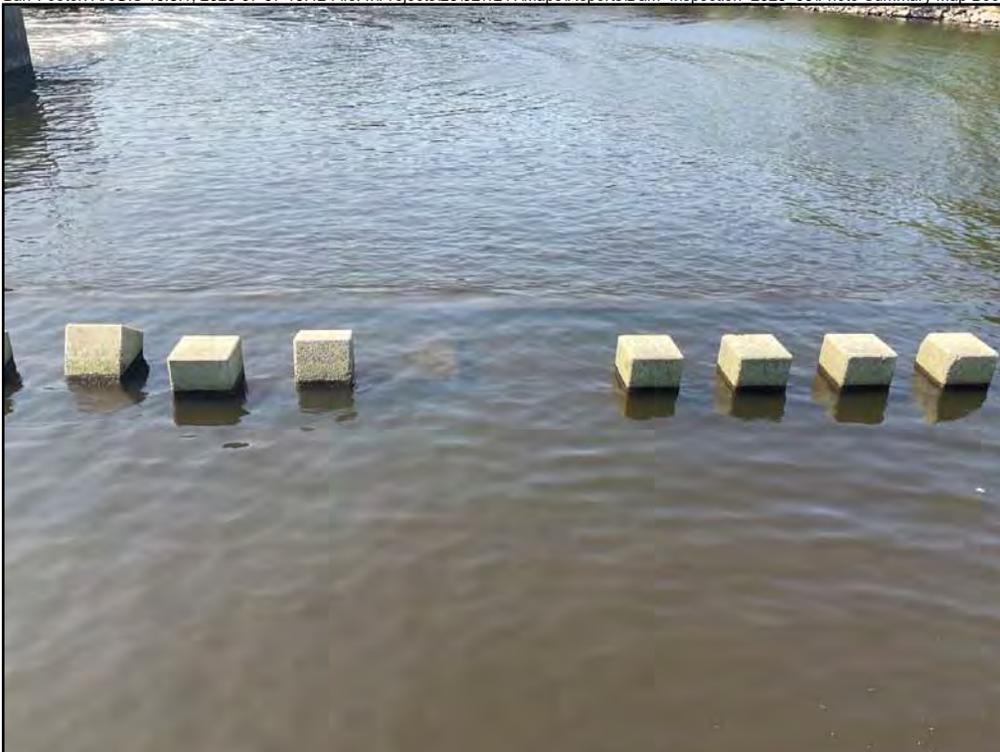
Comment: General condition of joint, expansion joint material present, some superficial spalling at corners

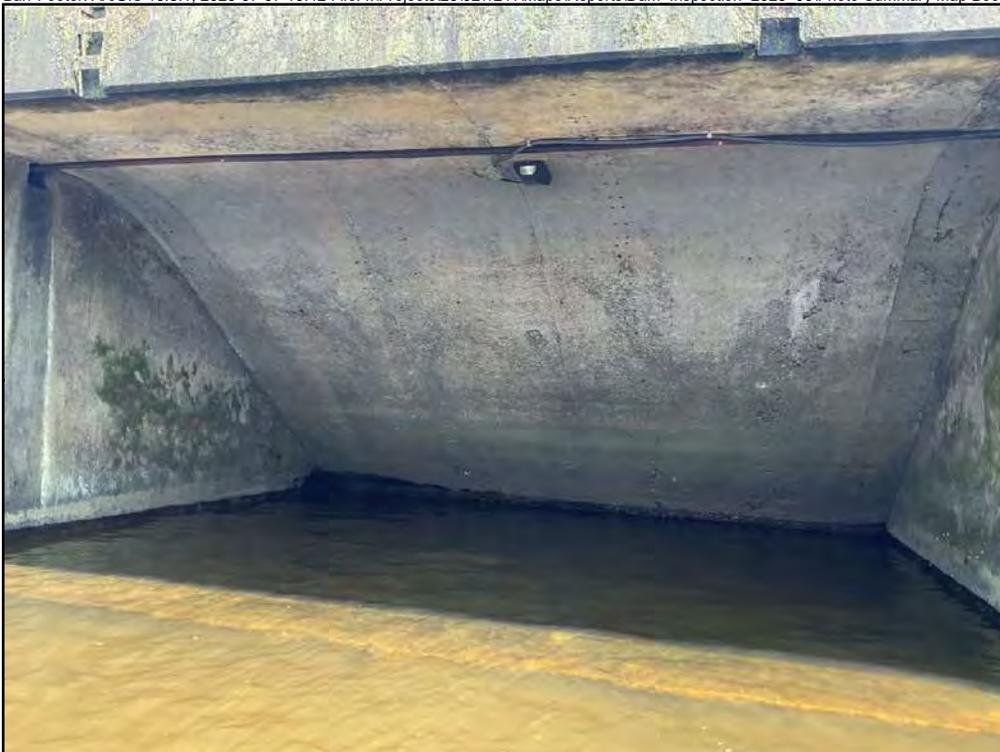
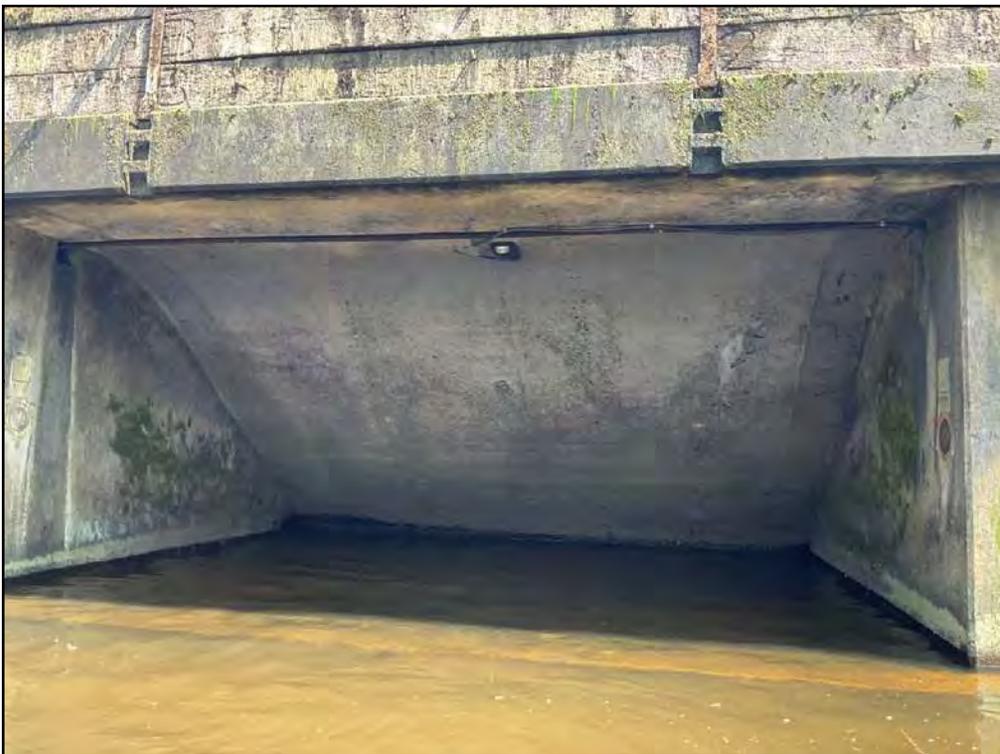
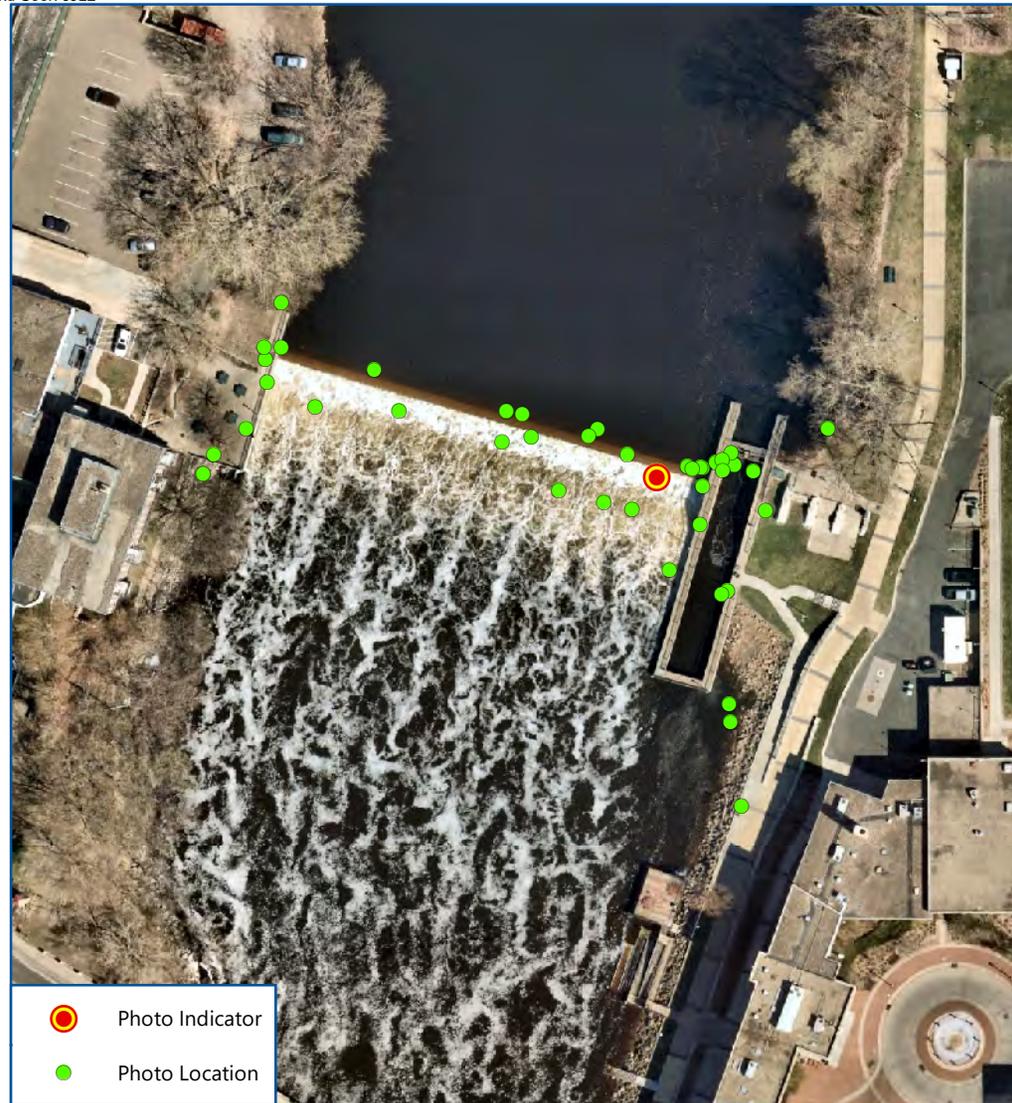
Comment: Two displaced baffle blocks, additional concrete block present downstream of right displaced baffle block

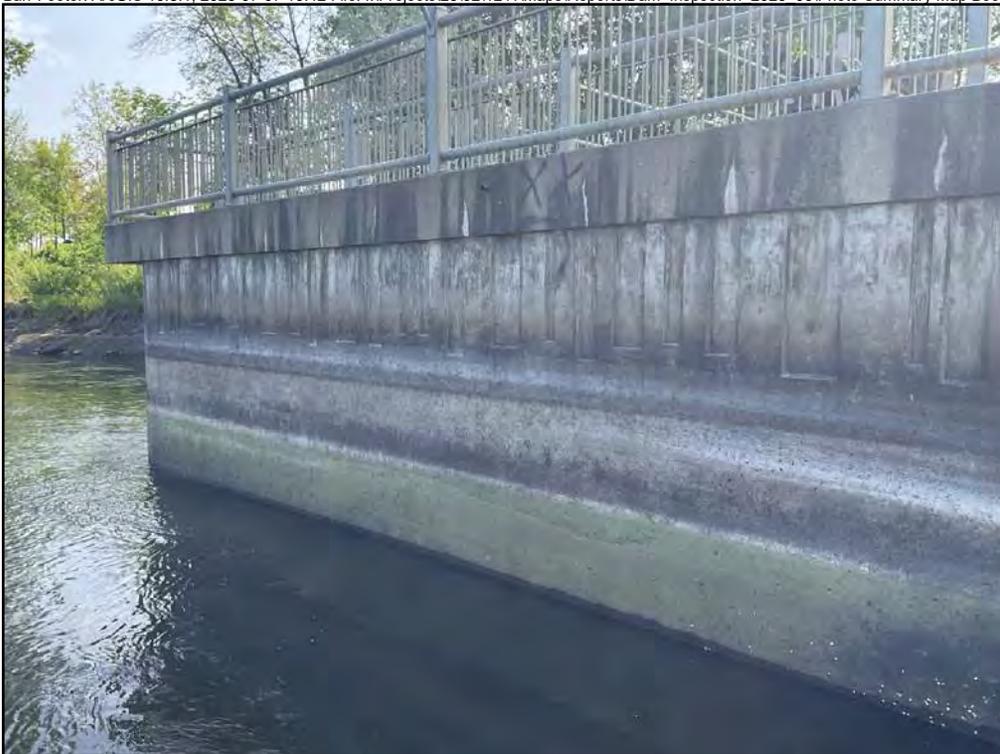
Comment: Seepage through base of two joints on left training wall

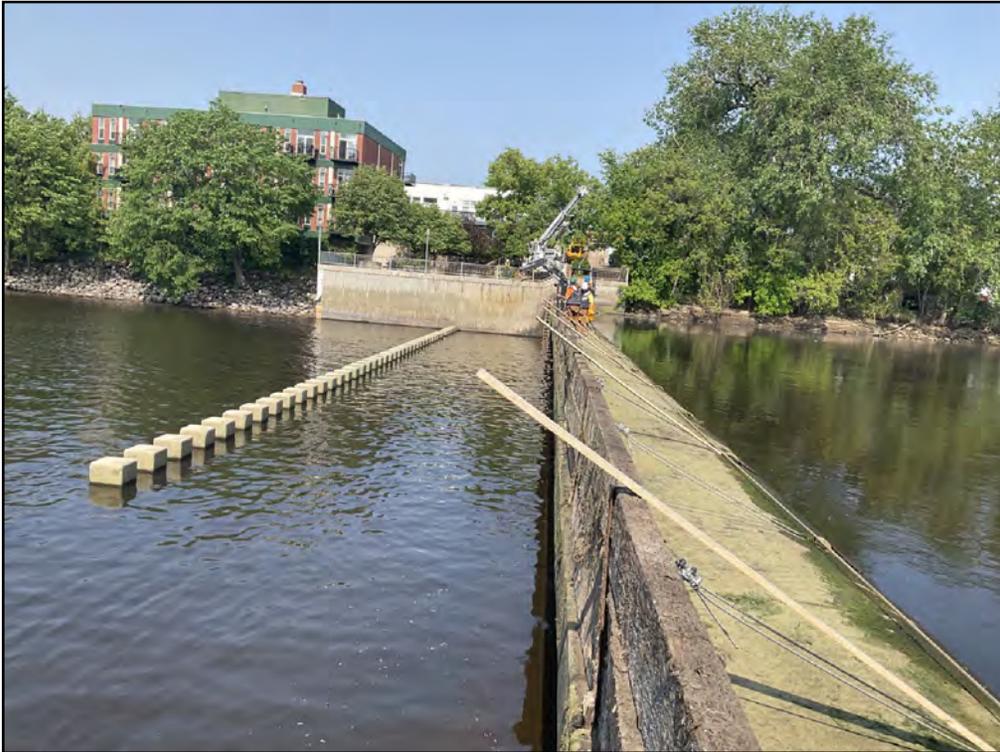
Comment: Flash board, wood heavily deteriorated, superficial rust on vertical posts, new cables
