2023 Dam Inspection Report

Rum River Dam

Prepared for
City of Anoka

November 2023

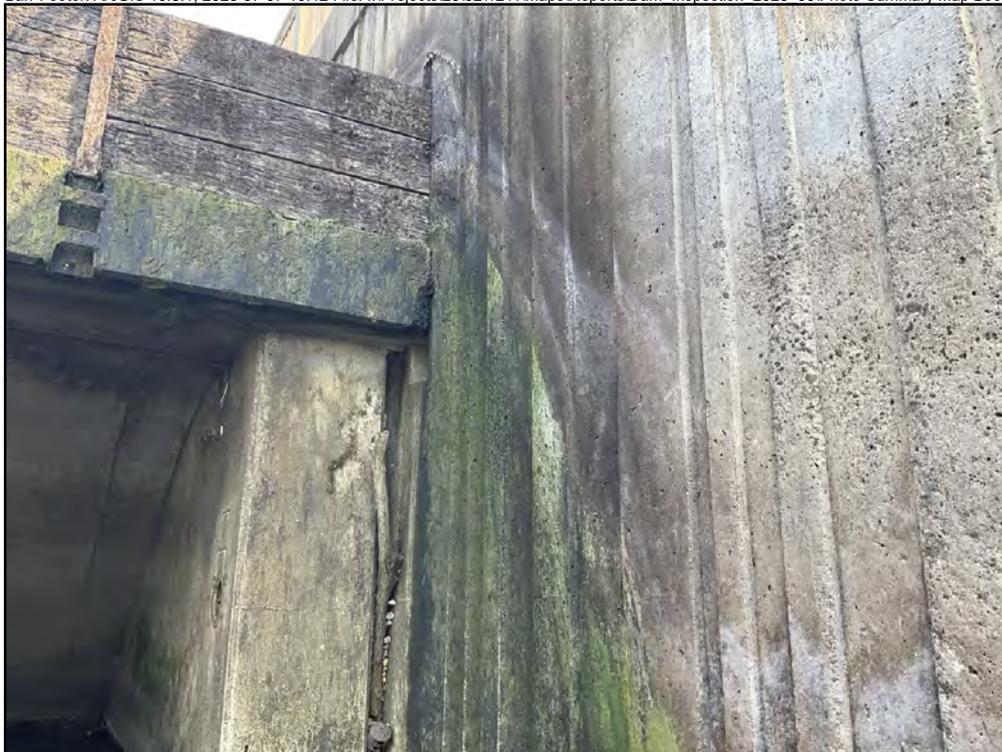
Comment: Spillway surface, superficial scour (less than 1"), portions of exposed aggregate

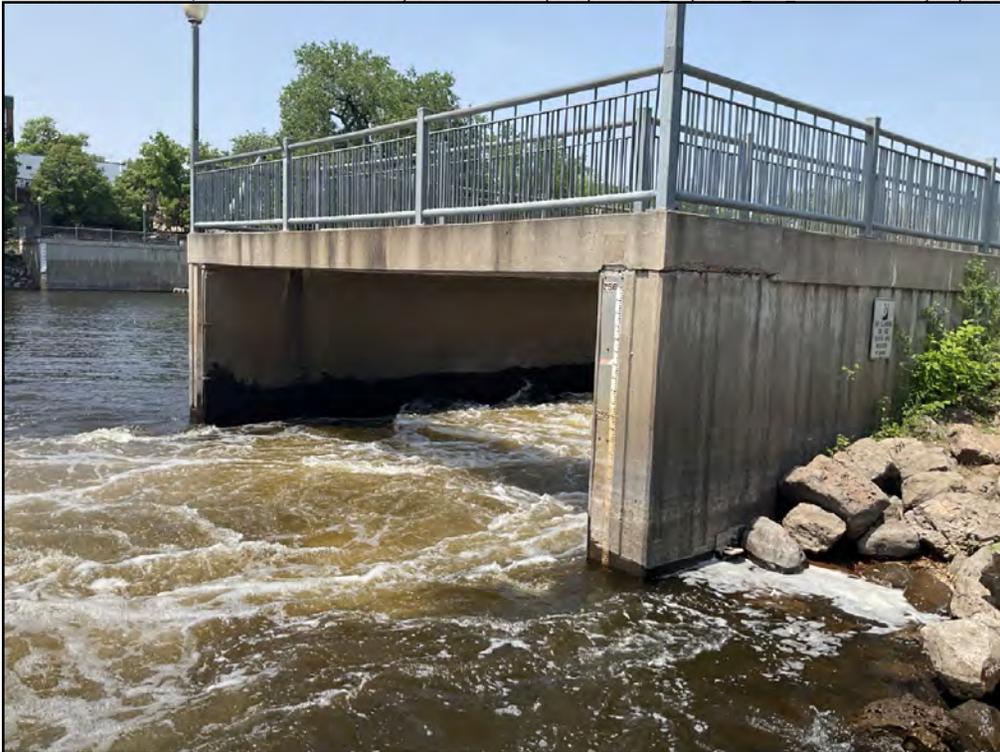
Comment: Typical condition of land side of abutment wall. Some cracking in top slab edge.

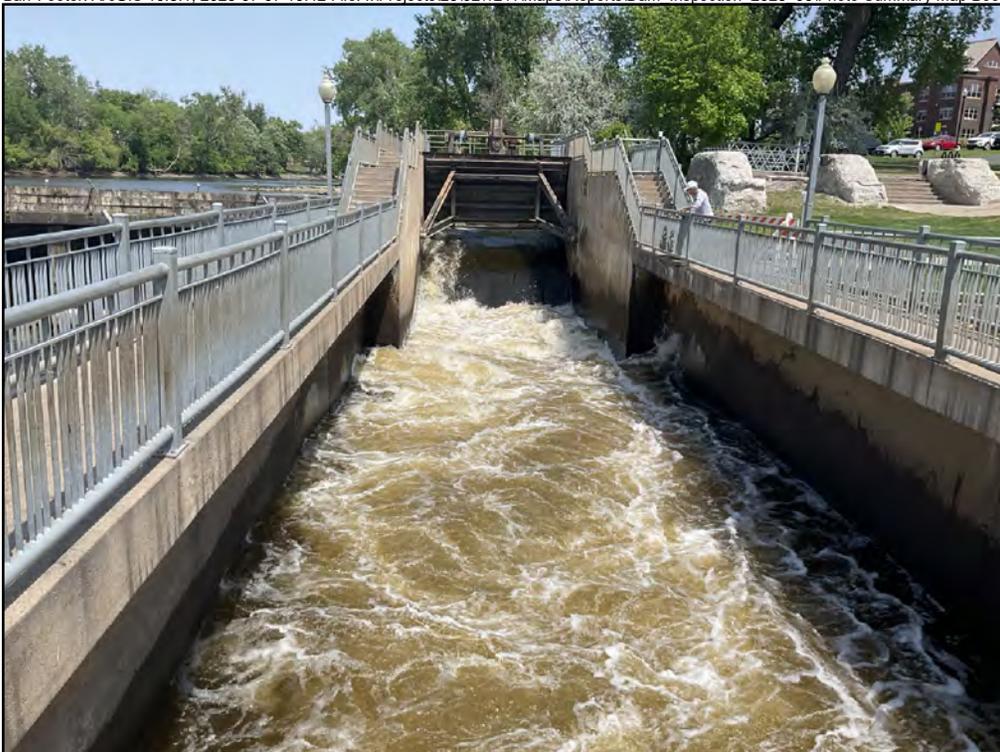
Comment: General condition upstream side of tainter gate

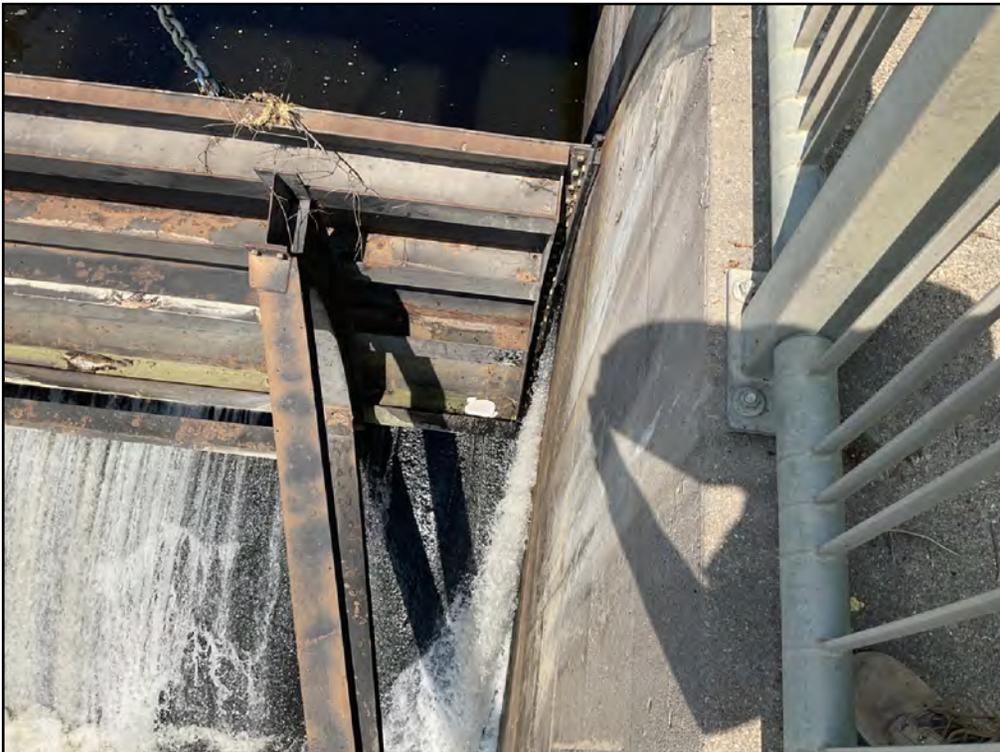
Comment: Tainted gate from ds side, minor surface rust, walls in good condition

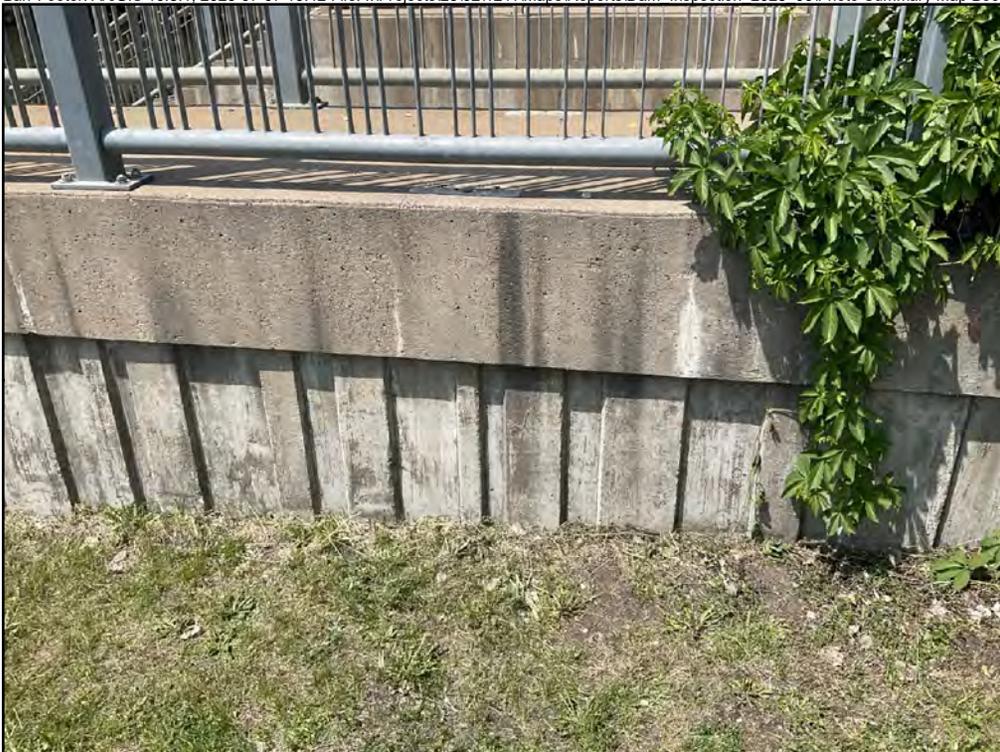
Comment: More leakage through left sill after closing gate. Some spalling on gate spillway

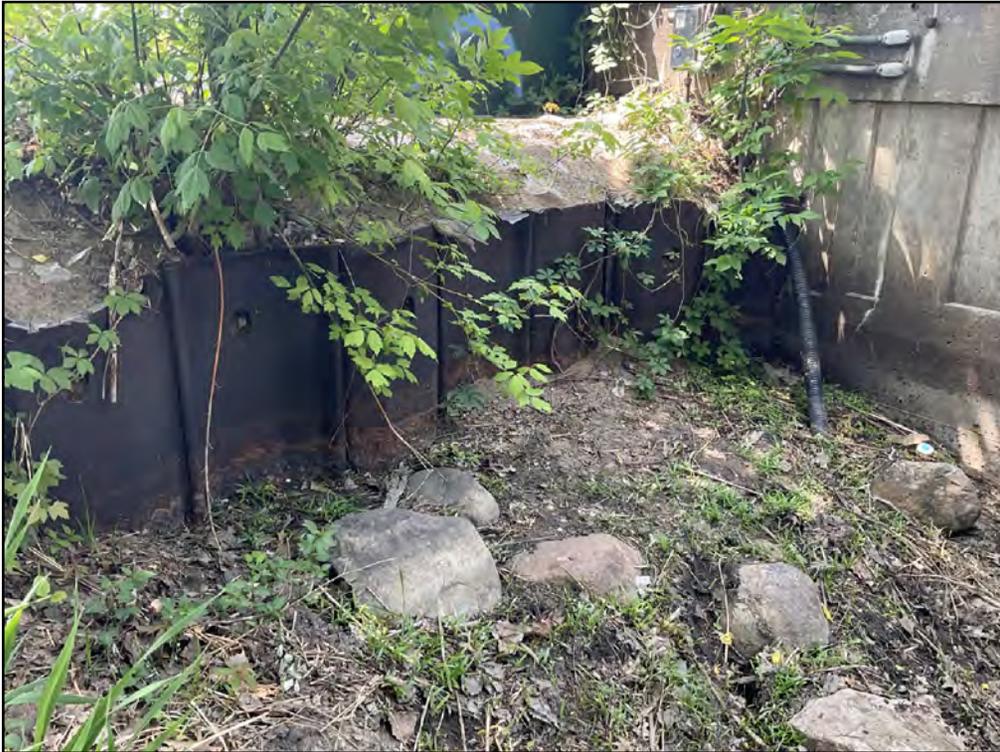
Comment: Left retaining wall general condition, minor superficial cracking

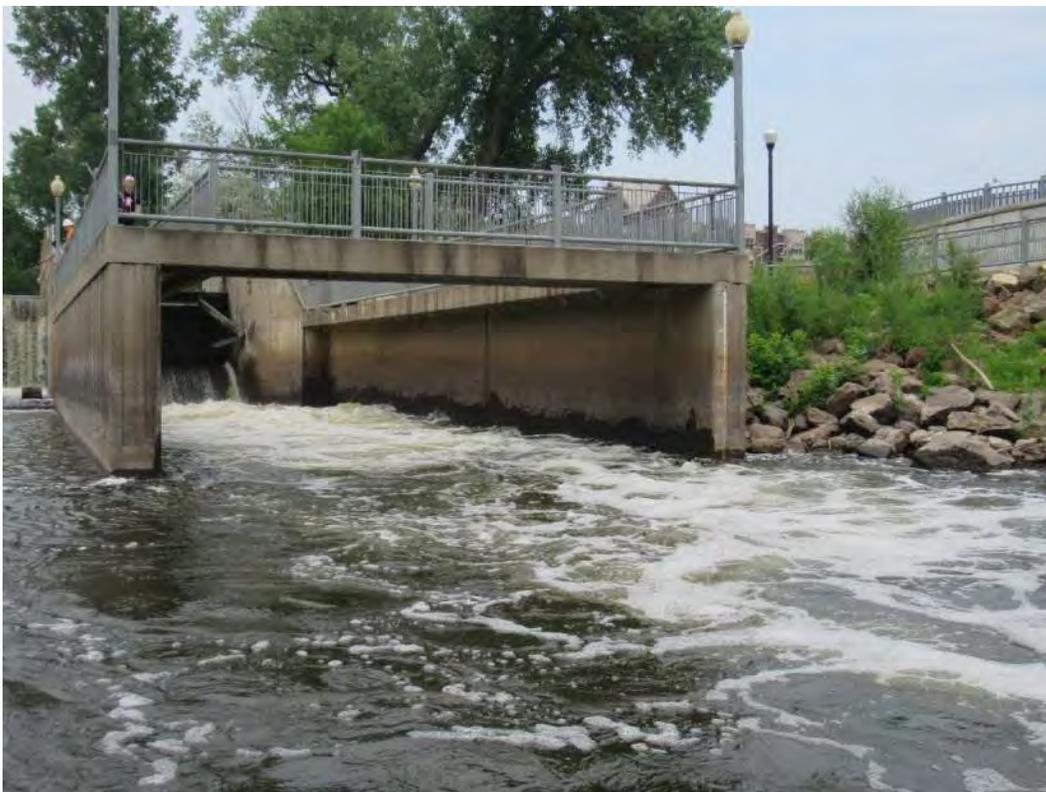
- At the time of the inspection, water was flowing into the structure through one of the cold joints (See '[Appendix A, Figure 14](#)').
- West Bulkhead Slot:

Figure 14 – Downstream, Tainter Gate Structure: Water Flowing Through Cold Joint

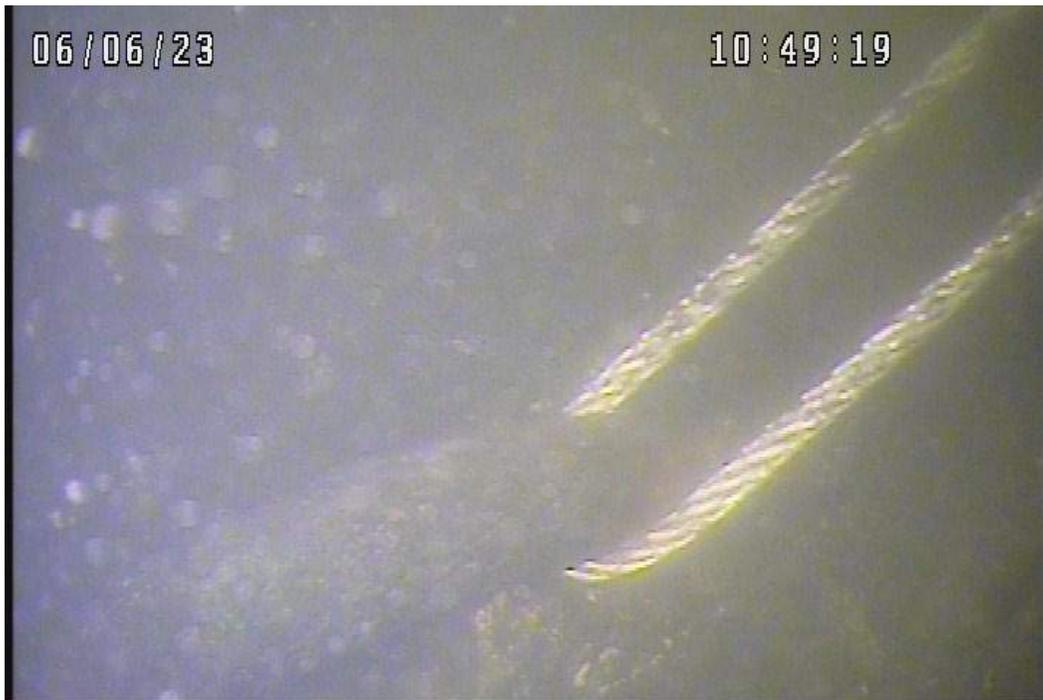
- The Crosby clips were in satisfactory condition throughout (See [‘Appendix A, Figure 20’](#)).
 - The anchor points for the clips were in satisfactory condition with no cracking found (See [‘Appendix A, Figure 21’](#)).

Figure 20 – Upstream, Spillway: Condition of Crosby Clips

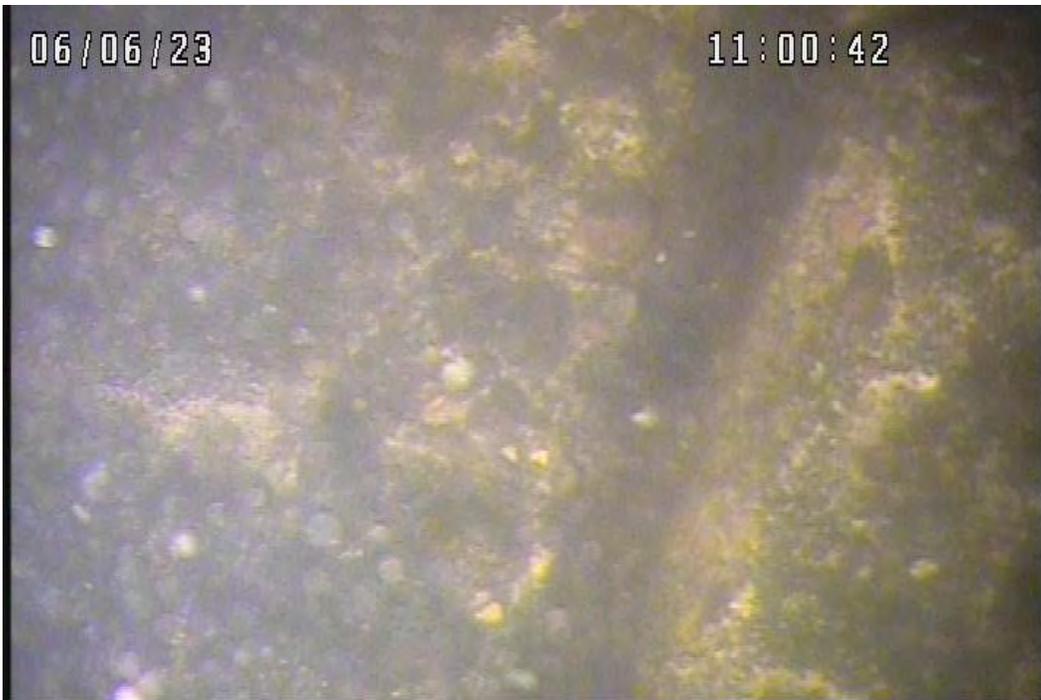
Figure 21 – Upstream, Spillway: Condition of Anchor Points

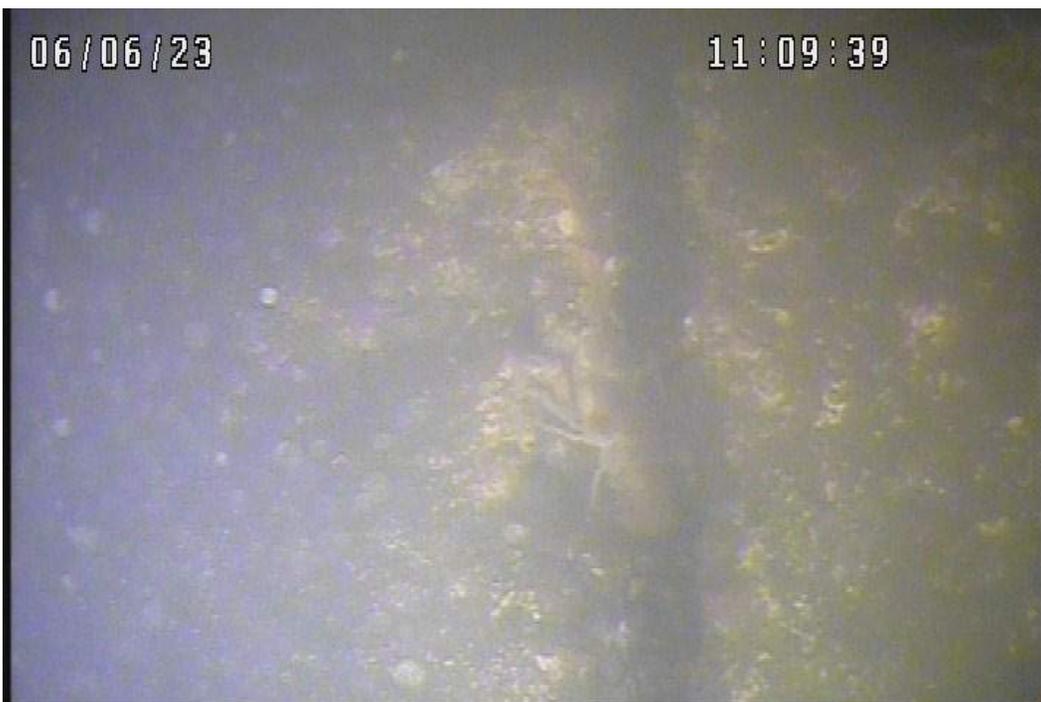
- The brackets attached to the flashboards experienced moderate rust.
- **Station 1:** An area of spalling was present on a cold joint approximately a quarter of the way across the spillway (See [‘Appendix A, Figure 22’](#)).

Figure 22 – Upstream, Spillway: Spalling at Cold Joint

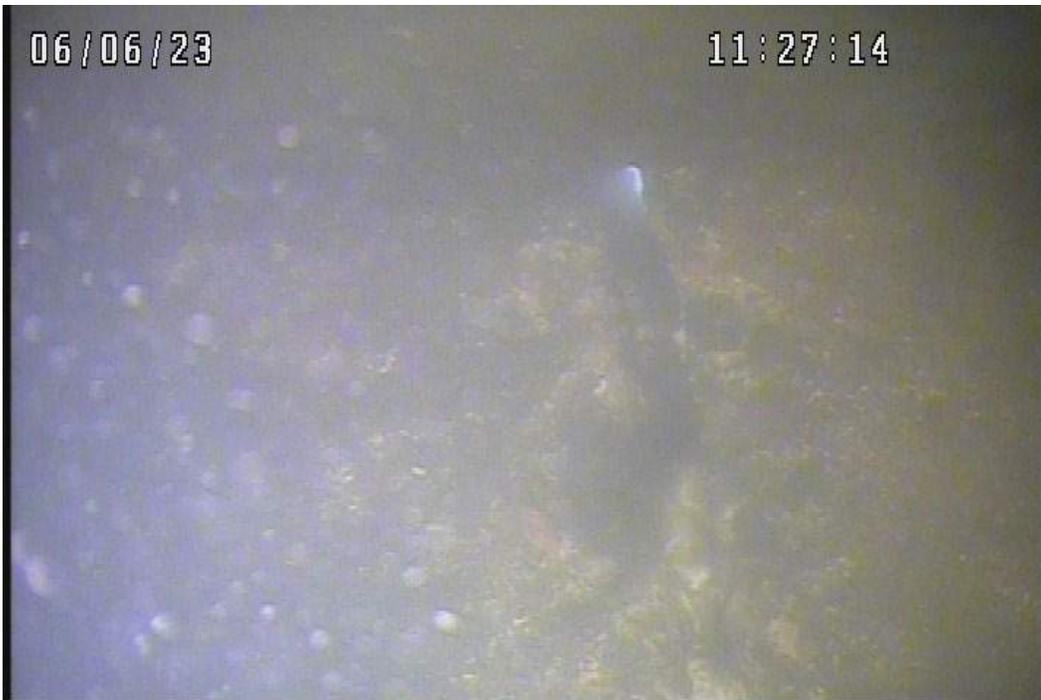
- **Station 3:** An area of spalling was present approximately three quarters of the way across the spillway (See [‘Appendix A, Figure 25’](#)).
 - The spalling was present 21-inches upstream of the flashboards and 13-inches to the west of the cold joint.

- The spalling measured 7-inches long by 13-inches wide by 1-inch deep.
- **Station 4:** Near the east end of the spillway, the cold joint had expanded, and the diver was able to see light through the cold joint (See [‘Appendix A, Figure 26’](#)).

Figure 25 – Upstream, Spillway: Spalling

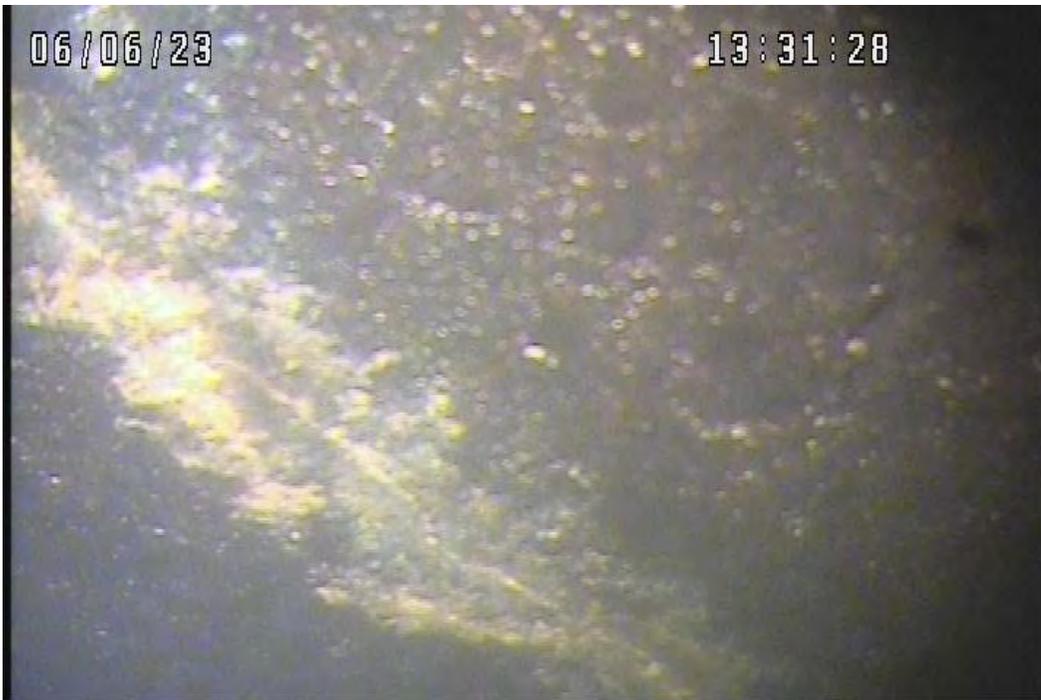
- Due to the gate leaking, the diver was unable to inspect the gate itself.
- Sill:
 - The sill had a vertical face that measured up to 30-inches tall.
 - The vertical face was at its tallest near the center of the sill.
 - No areas of undermining were present.
- West Bulkhead Slot:
 - Prior to inspection, a rock was present in the slot. The diver removed the rock from the area to prevent any future issues with sealing the gate.
 - The concrete at the bulkhead slot was in satisfactory condition.
 - The embedded steel experienced moderate rust nodules throughout (See [‘Appendix A, Figure 27’](#)).
- East Bulkhead Slot:
 - The concrete at the bulkhead slot was in satisfactory condition.

Figure 27 – Upstream, Tainter Gate West Bulkhead Slot: Rust Nodules
